ASSATEAGUE BEACH COAST GUARD STATION

STATION HOUSE, GARAGE, AND BOATHOUSE

Historic Structure Report

2007

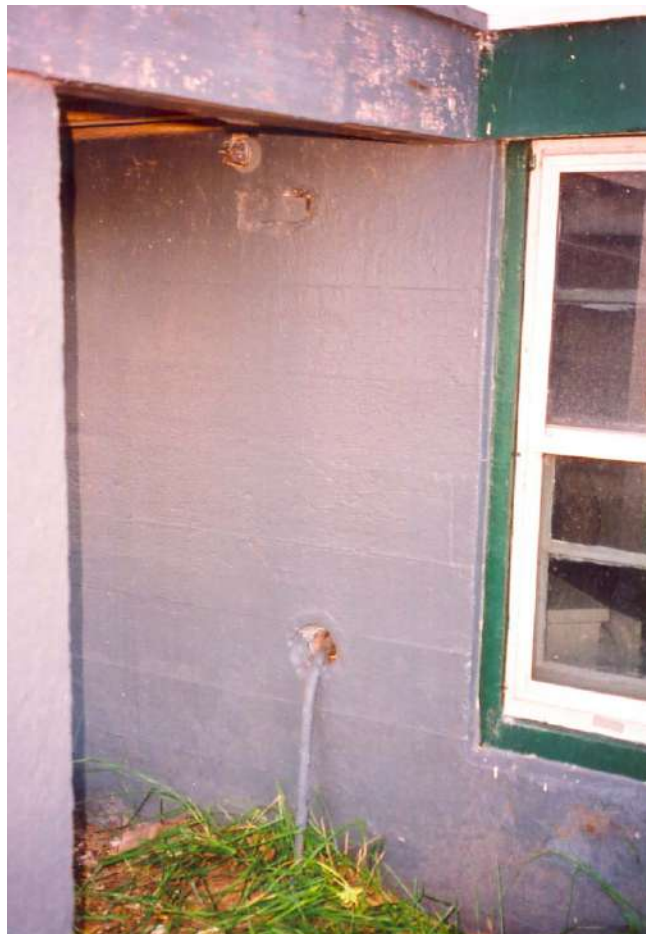
Electrical wires run underground to the building from poles on the site; conduit emerges on the exterior of the west wall of building north (left) of window W008 and enters through a hole in the foundation wall above grade (fig. 48).

Figure 48. Station House: North elevation, foundation wall under rear porch, showing former opening for conduit from water tanks [near top of view] and opening for electrical conduit (1999).

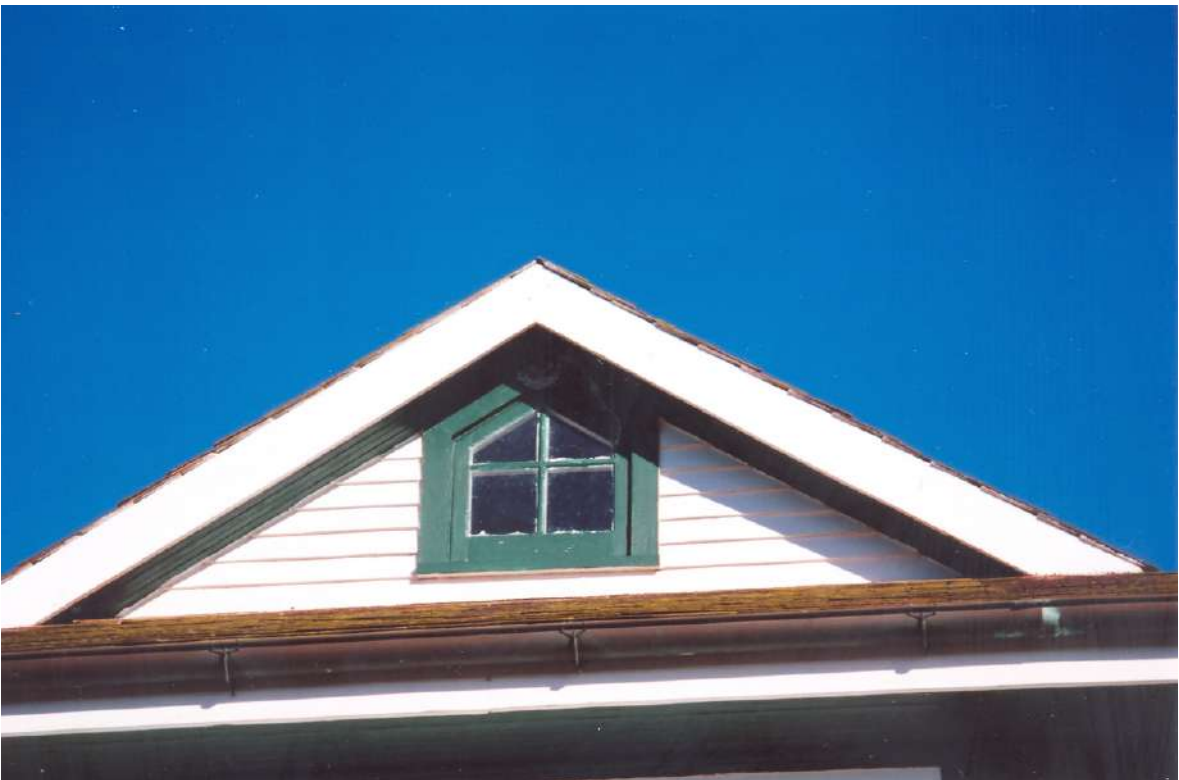
Figure 50. Station House: West elevation, window W302 (1999).
