**OLD HARBOR LIFE-SAVING STATION
Provincetown, Massachusetts**

HISTORIC STRUCTURE REPORT

**Cape Cod National Seashore
South Wellfleet, Massachusetts**

June 1988

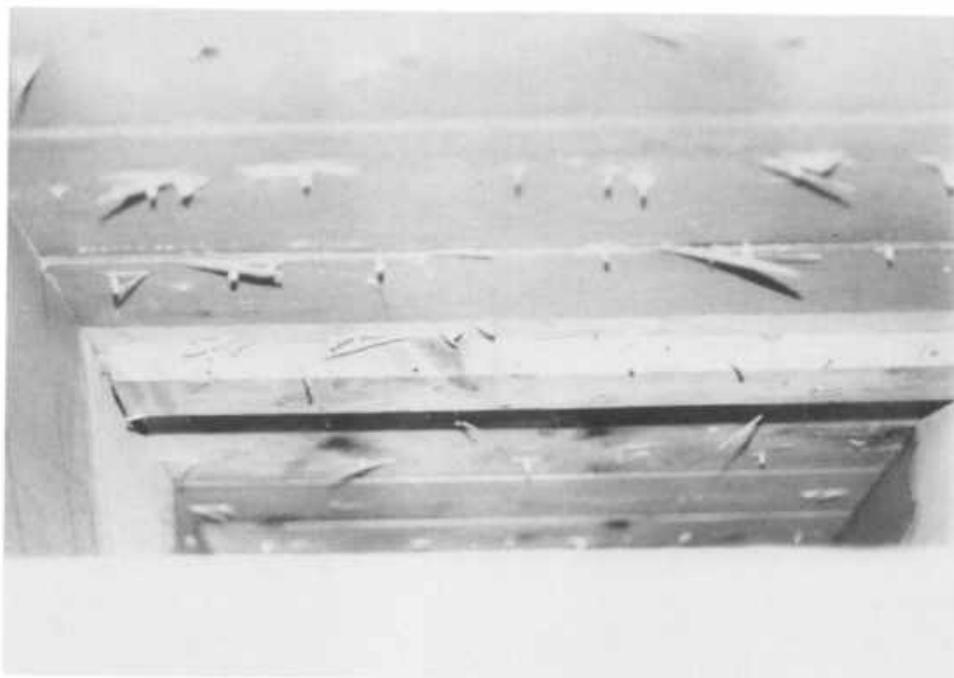
Illustration 9. Ceiling of Quarters, Paint Evidence
of 1910 Relocation of Original Knee Wall.

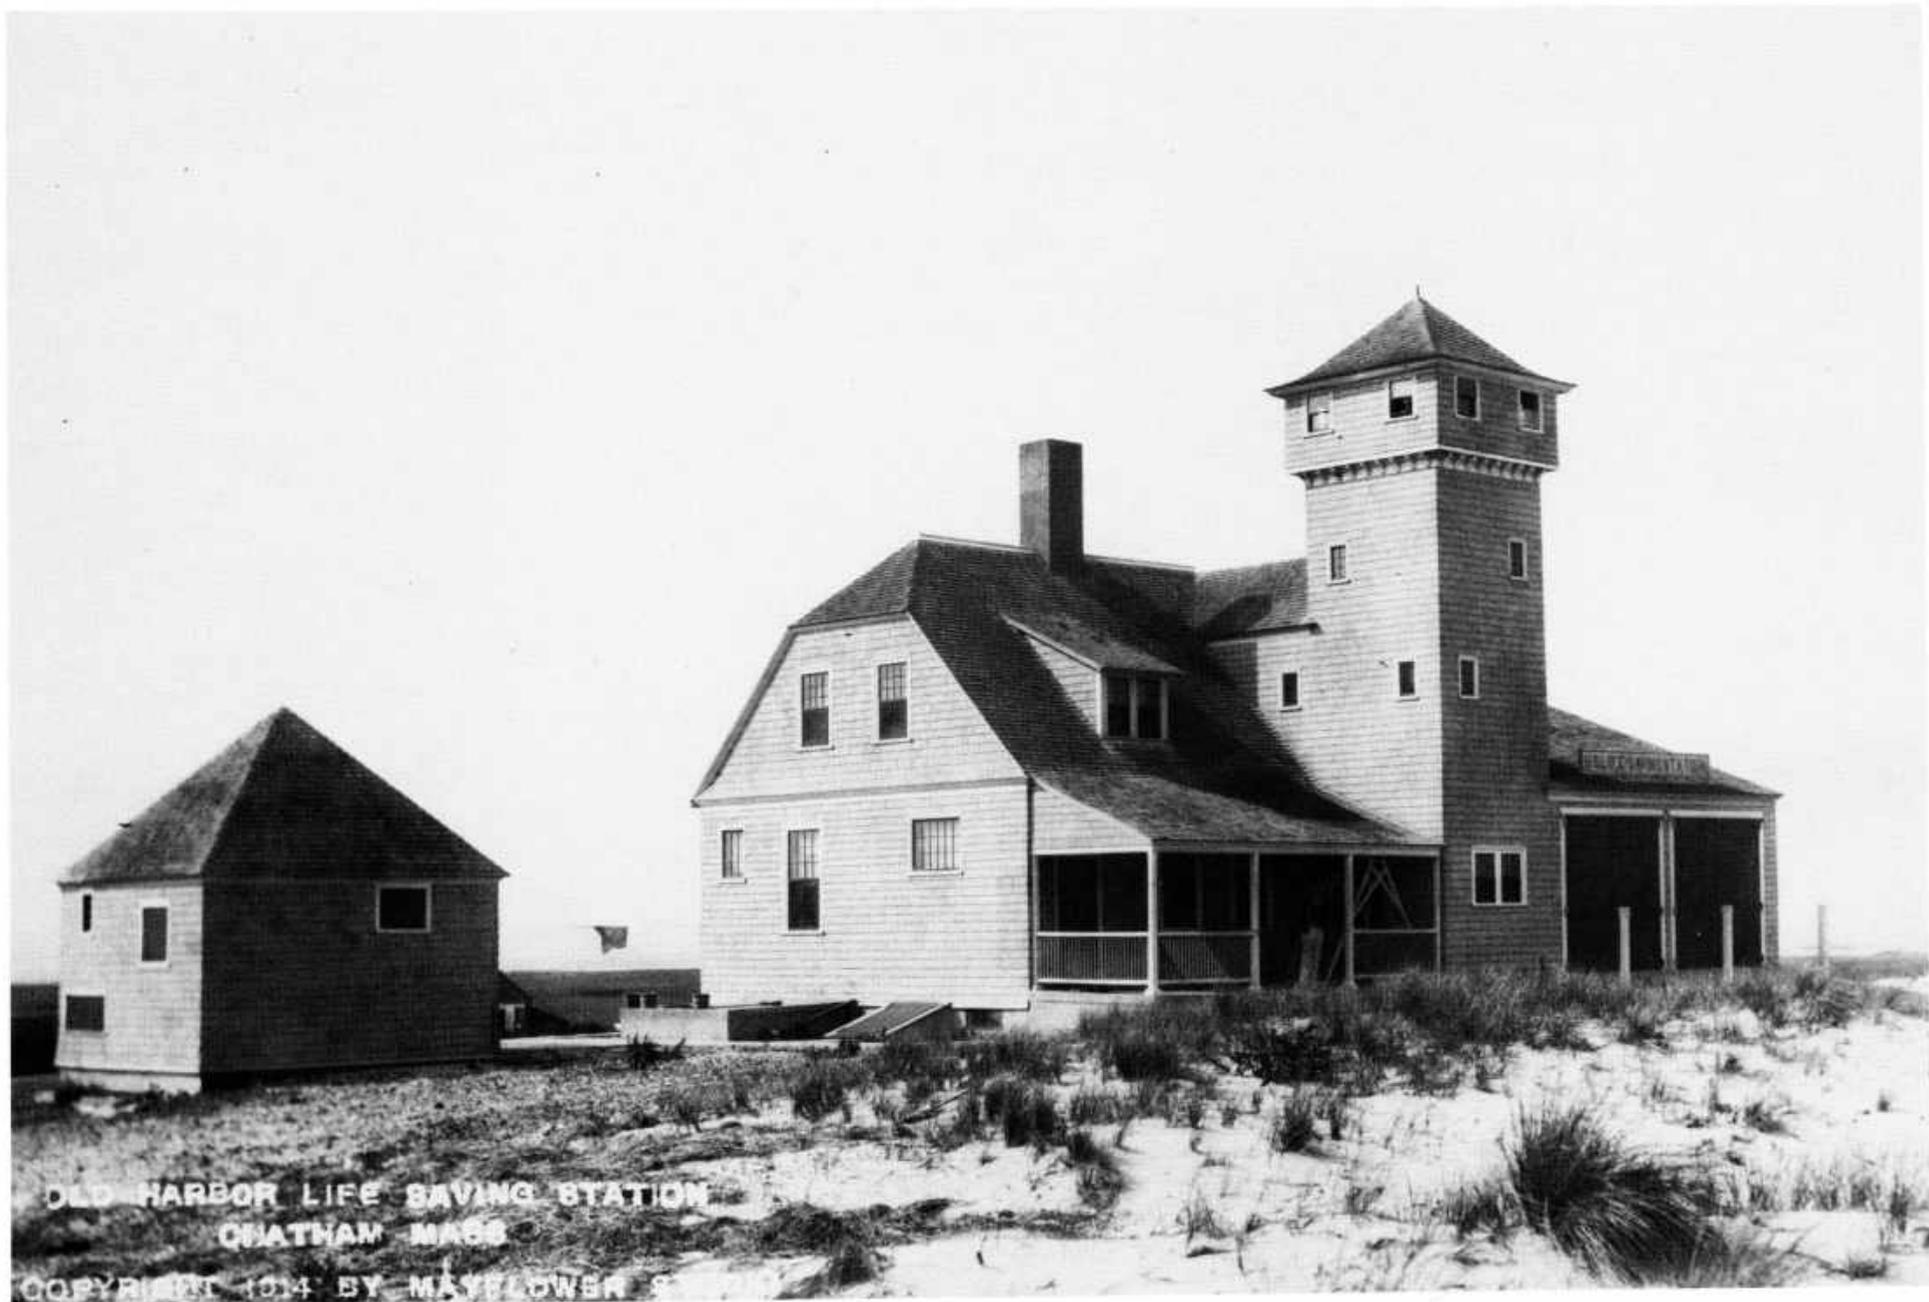
The seacoast environment continued to decay the materials with which the Old Harbor station was built. Figure 13 shows the station in 1914. By that time, the sheathing below the sill board of the Boat Room had rotted, as had the boat ramp in front of the Boat Room's north doors, and the gutter on what is now the east side of the station.¹²⁶ Whether or not these items were replaced is unknown; no authorization for repairs was found, but considering the nature of past approvals, repairs probably were authorized and completed.

Illustration 13. Exterior View of Old Harbor Life-Saving Station, 1914.

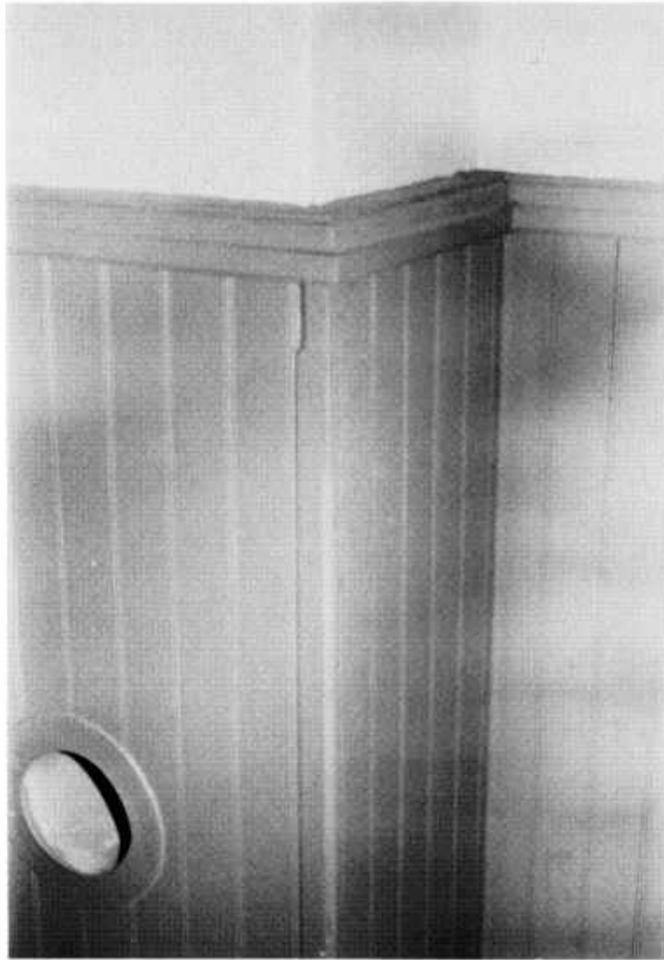
Illustration 38. Mess Room: Reproduction Chimney Wainscot With Original Corner Piece.

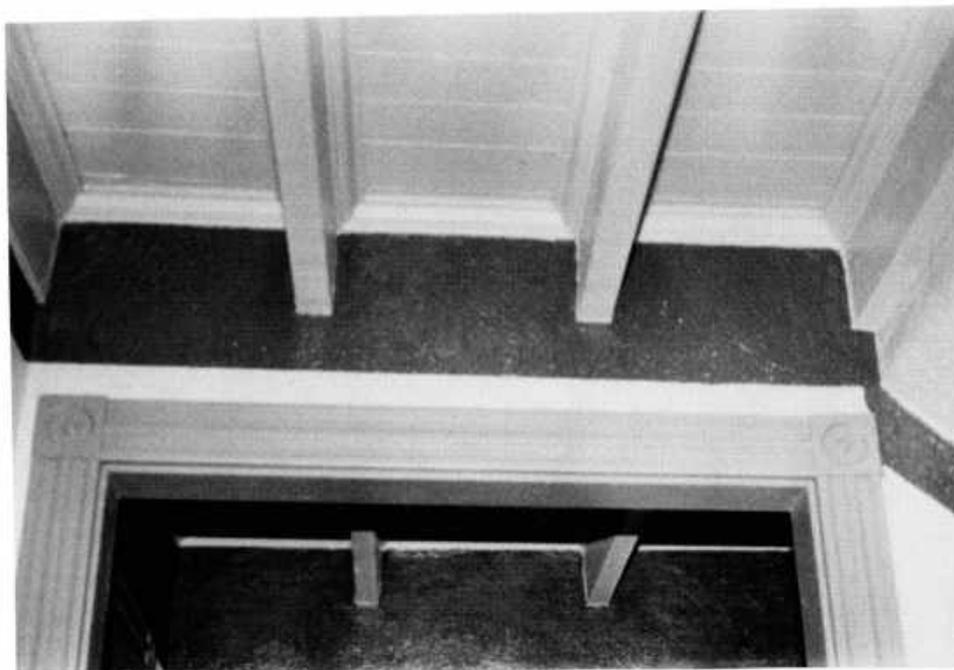
Illustration 46. First-Floor Stair Hall:
Cornice Paint on South Wall.

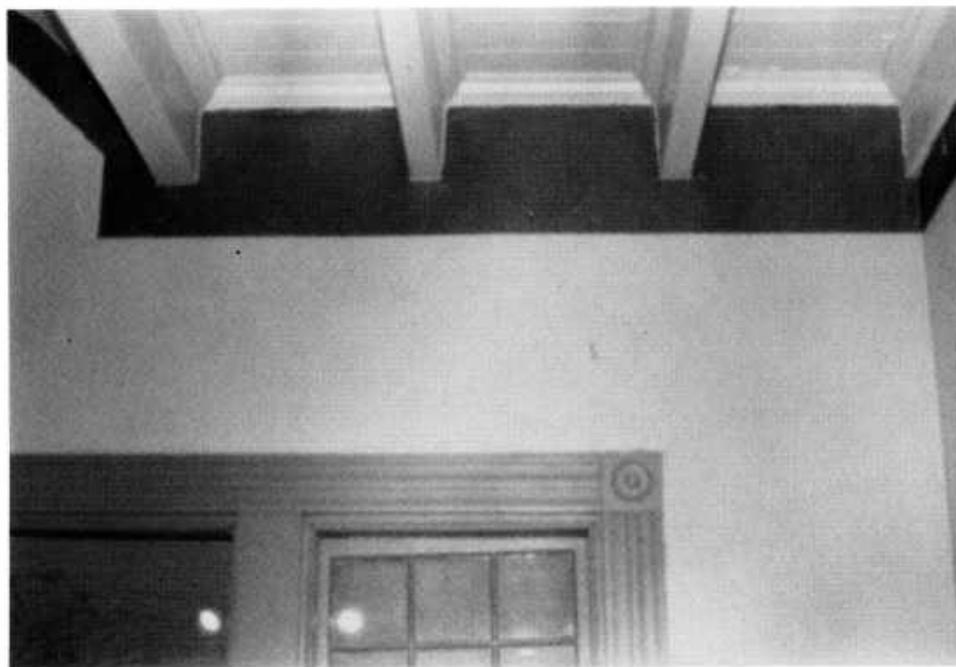
Illustration 47. First-Floor Stair Hall:
Cornice Paint on North Wall.

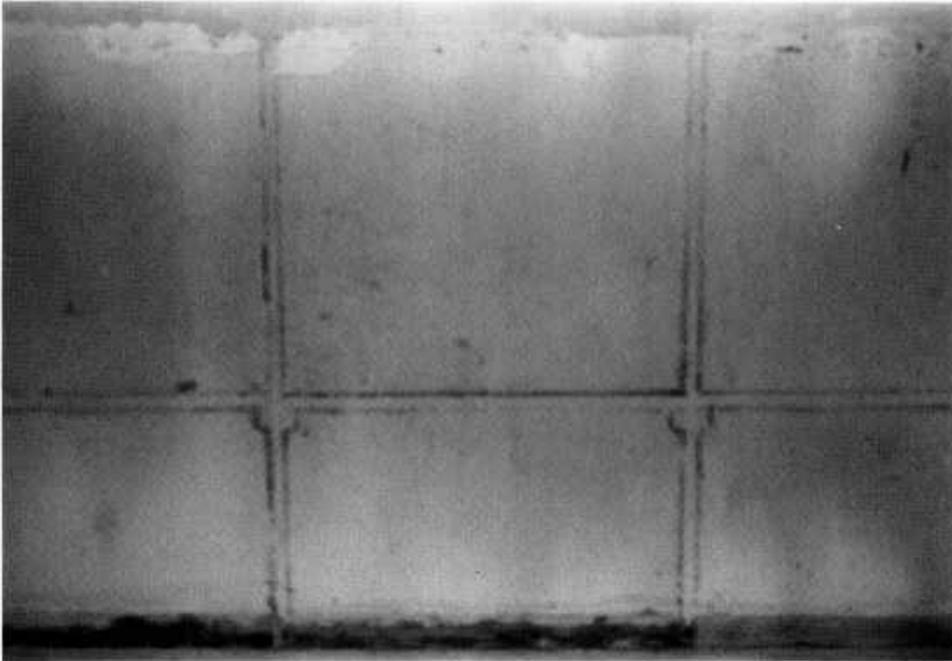
Illustration 50. Locker Room: Evidence of Former East-Wall Lockers.

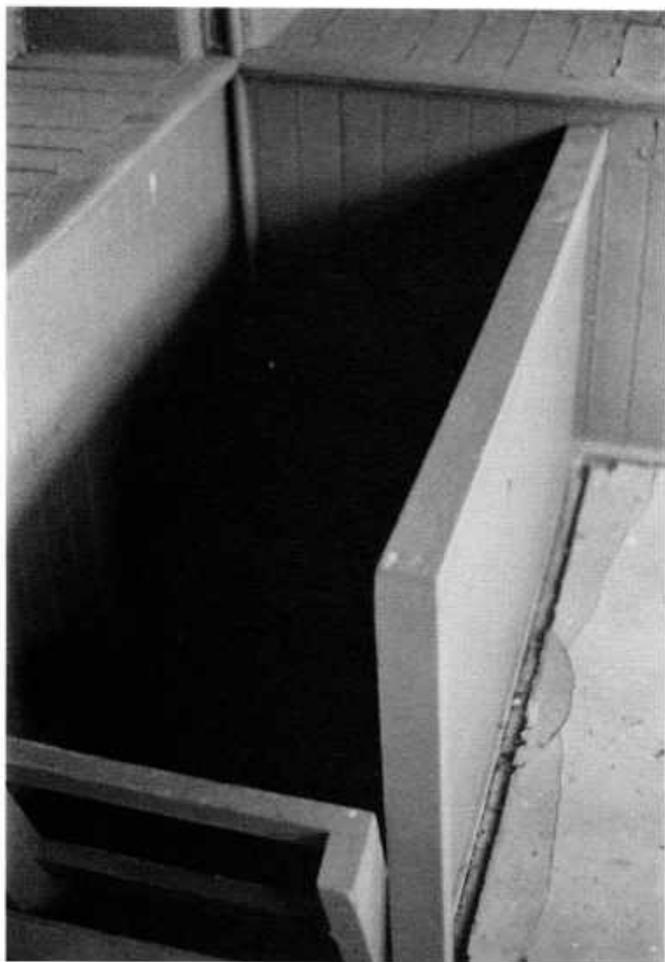
Illustration 56. Lookout:
Posthistoric Opening in Floor.
