# U.S. COAST GUARD NAUSET STATION DWELLING AND BOATHOUSE

Cape Cod National Seashore  
Eastham, Massachusetts

**HISTORIC STRUCTURE REPORT**

January 2008

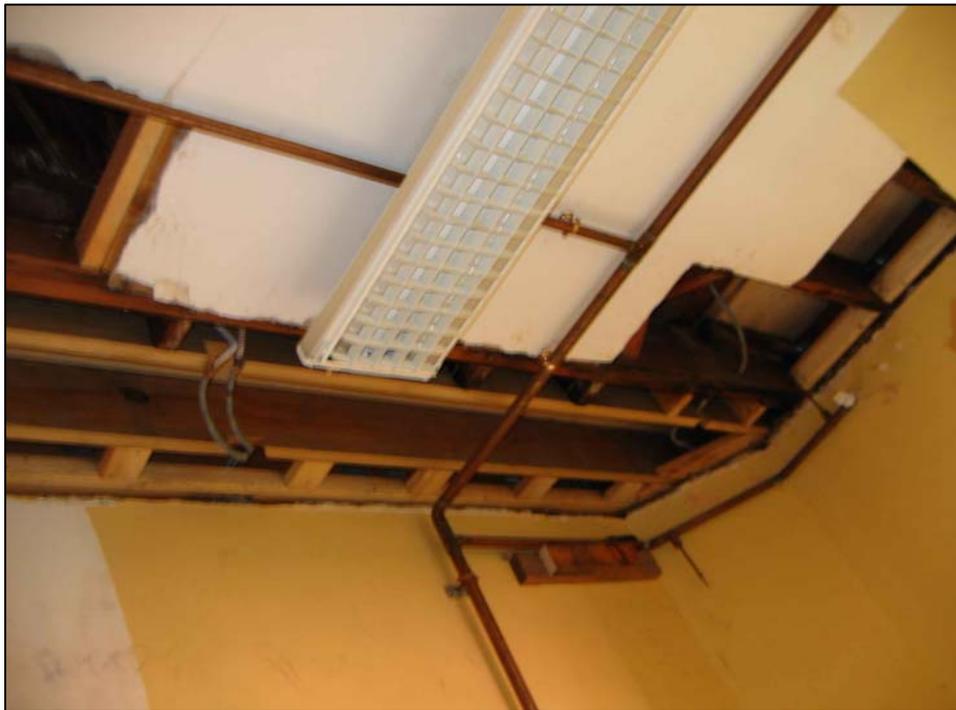
**Figure 4.113.** Room 301 (loft stair hall), ceiling damage at southwest corner.
