Cape Hatteras National Seashore  
Bodie Island Life- Saving Station & Boat House  
**Historic Structure Report**

2005

Joseph K. Oppermann - Architect, P.A.

2005  
Historic Structure Report  
Bodie Island Life- Saving Station & Boat House  
Cape Hatteras National Seashore  
Manteo, NC  
LCS#: Life- Saving Station #07243  
Boat House #091897

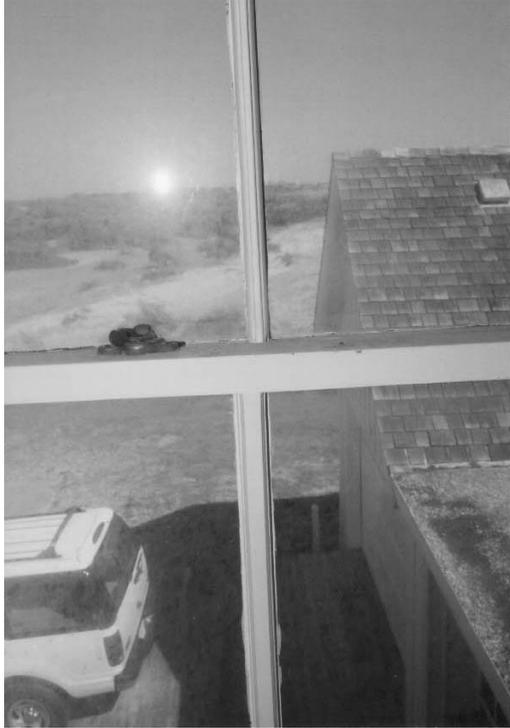
Figure C-16 Window muntins in Room 201

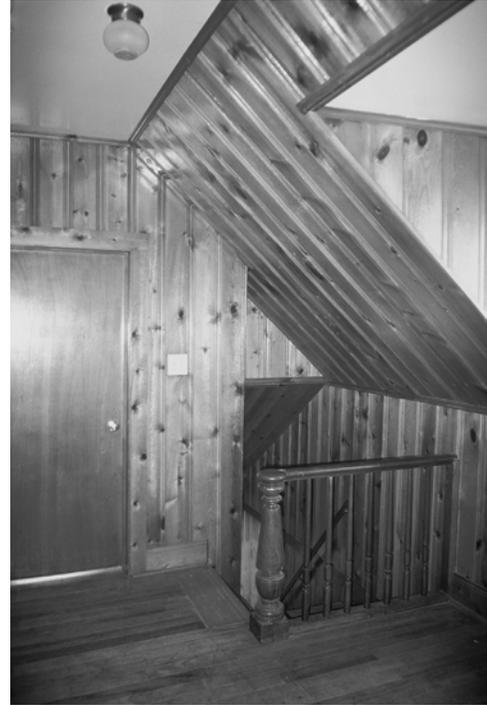
*Figure C-17 Room 202*

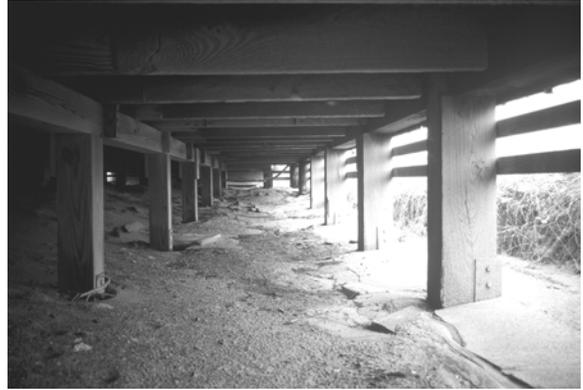
*Figure C-22 Foundation and floor structure of the boat house, looking west*

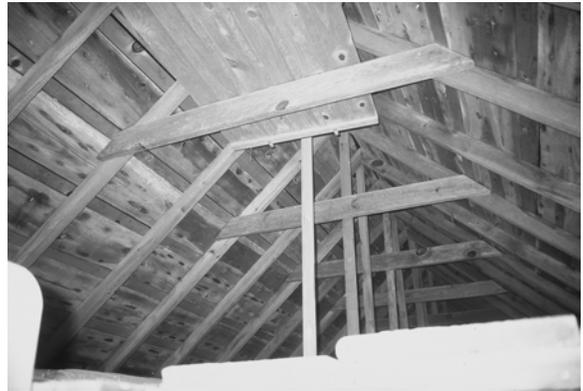
*Figure C-23 Attic of boat house*
