ASSATEAGUE BEACH COAST GUARD STATION

STATION HOUSE, GARAGE, AND BOATHOUSE

Historic Structure Report

2007

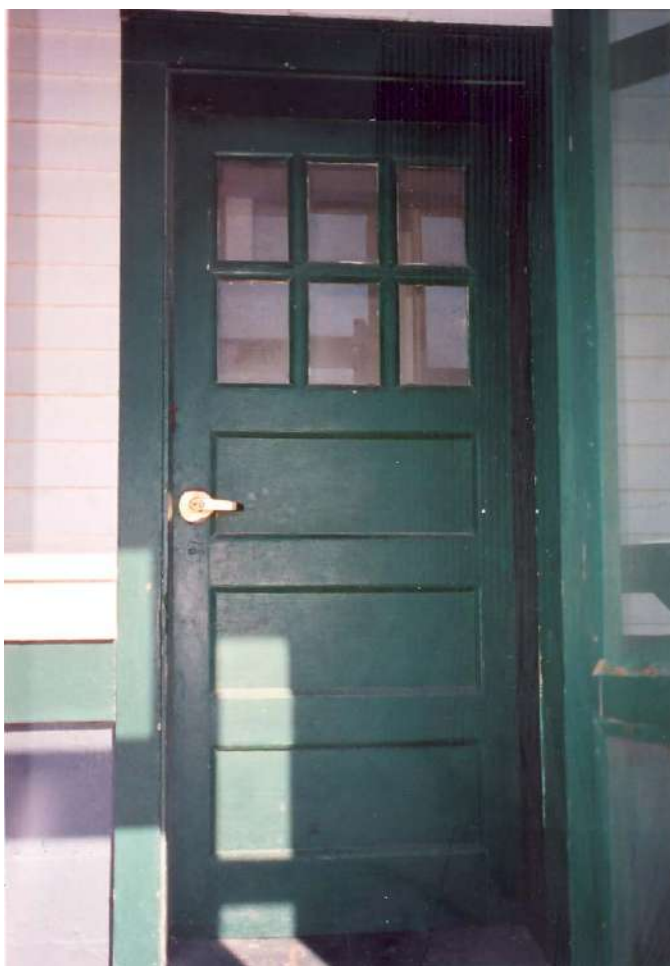
Figure 38.
Station House:
South façade,
doorway D101
(1999).

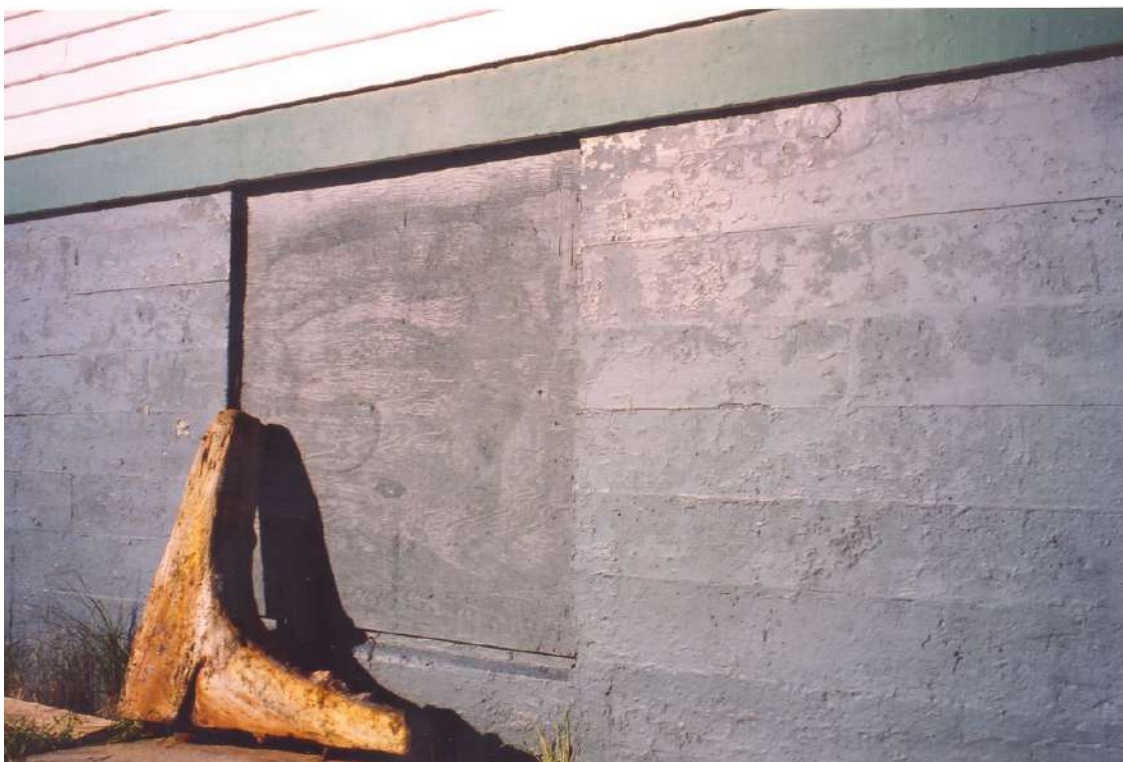
Figure 43. Station House: East elevation, doorway D001 blocked with plywood (1999).

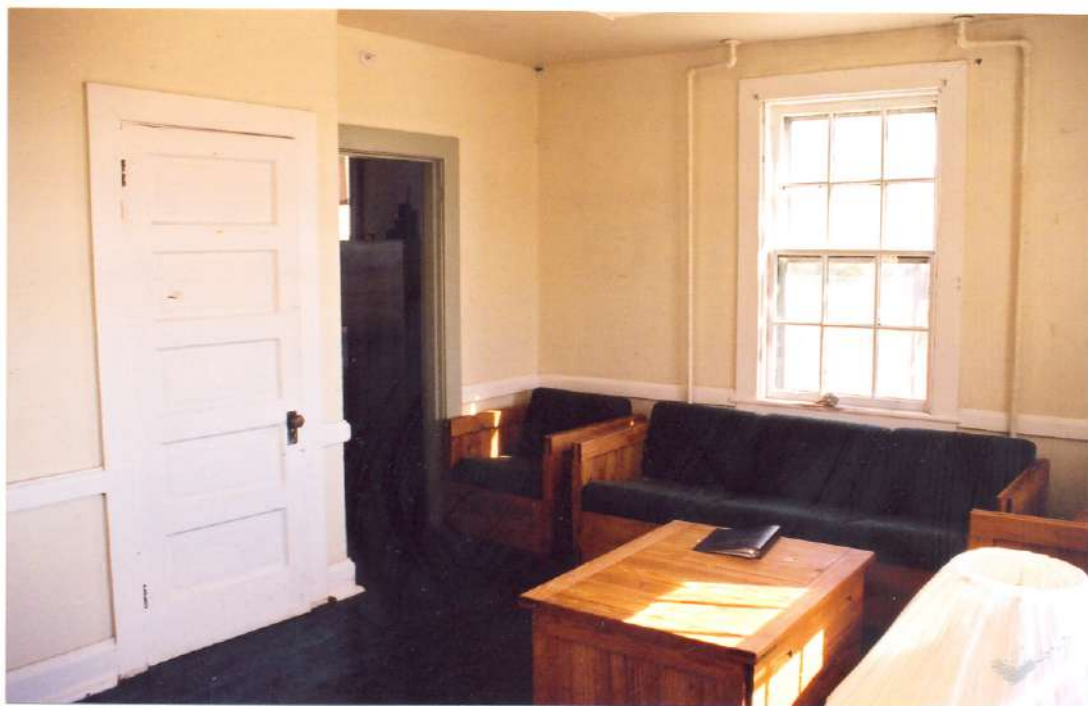
The mess room (fig. 65) is located in the southeast corner of the first story. The room measures approximately 17 feet 6 inches wide by 12 feet 6 inches deep. A doorway on the west wall leads from the stair hall (Room 101), and another doorway at the east end of the north wall leads to the kitchen (Room 103). The mess room has three windows – two on the south wall and one on the east wall – and a shallow closet on the north wall.

Figure 65. Station House: Mess room (Room 102), looking east/northeast (1999).

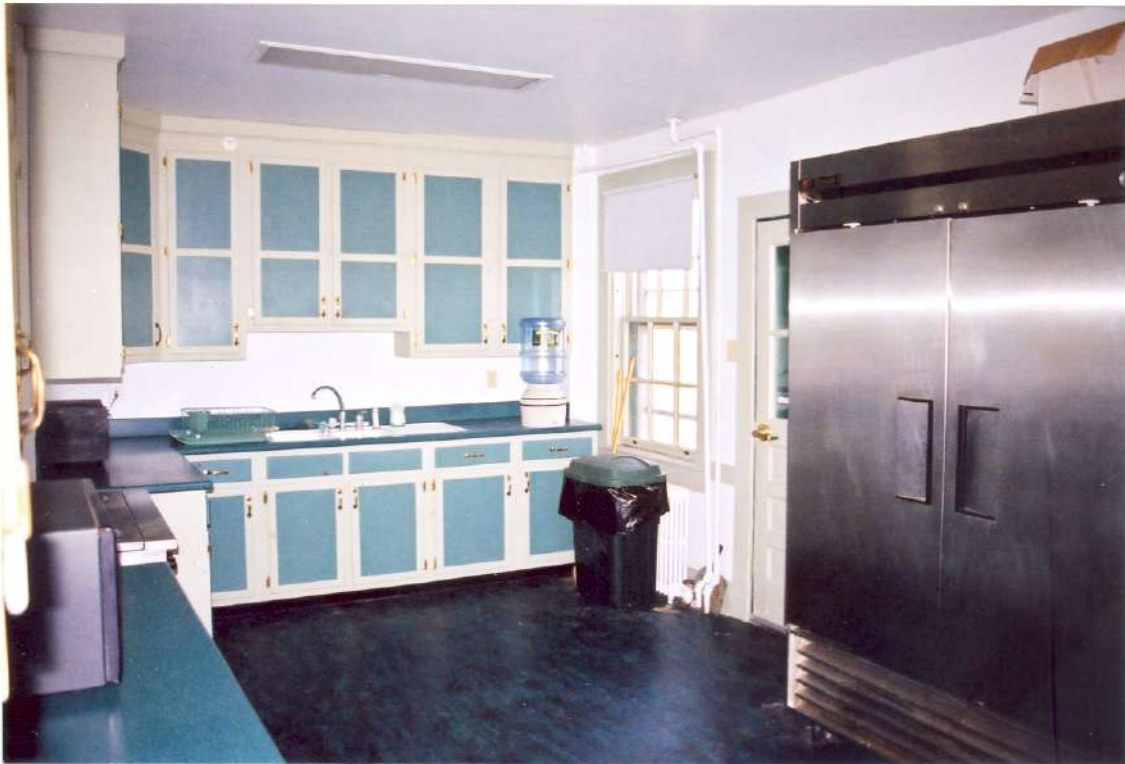
The kitchen (fig. 66) is located in the northeast corner of the first story. The kitchen was originally two rooms – a large kitchen/cooking area in the northeast corner of the first story, and a pantry with cupboards and a sink west of the kitchen. At some point, probably after World War II, the partitions between the two areas were removed, resulting in one large room with the west end (the old pantry area) a few feet narrower than the main area. The room was remodeled again in the early 1990s.

Figure 66. Station House: Kitchen (Room 103), looking west/northwest (1999).

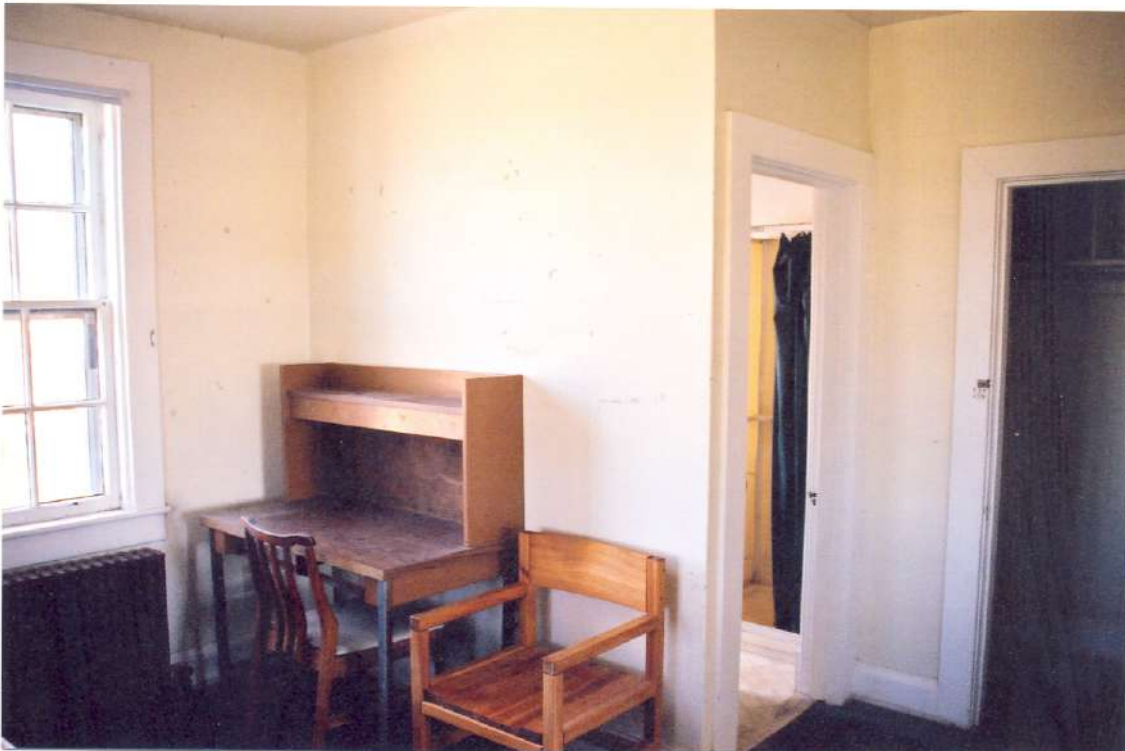
The keeper's room (fig. 67) is located in the northwest corner of the first story. The room is "L"- shaped and measures approximately 12 feet 6 inches at its widest point by 12 feet 6 inches at its deepest point. The keeper's room is entered from the office (Room106) via a doorway on its south wall. In the southeast corner of the room (the foot of the "L"), a doorway on the north wall leads to a bathroom (Room 105); a closet is located on the east wall. There is one window on each of the north and west walls in the main part of the room

Figure 67. Station House: Keeper's room (Room 104), looking northeast (1999).

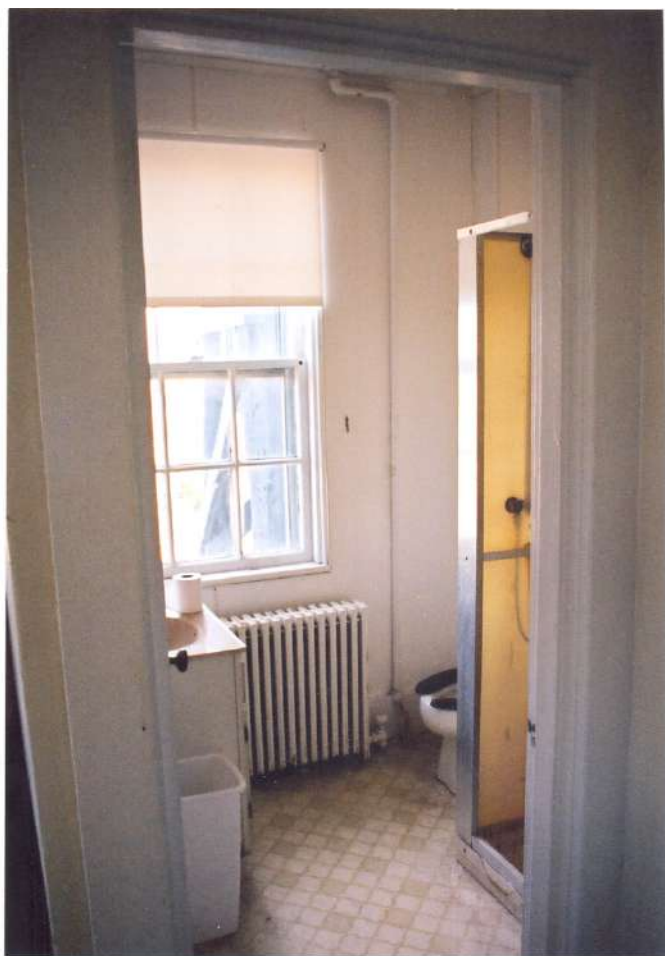
The keeper’s toilet (fig. 68) is located to the north of the foot of the “L” of the keeper’s room (Room 104). The room measures approximately 6 feet 6 inches wide by 6 feet deep, and is accessed via a doorway on the south wall. A window is located on the north wall of the room.

Figure 68. Station House: Keeper's toilet (Room 105), looking north/northeast (1999).

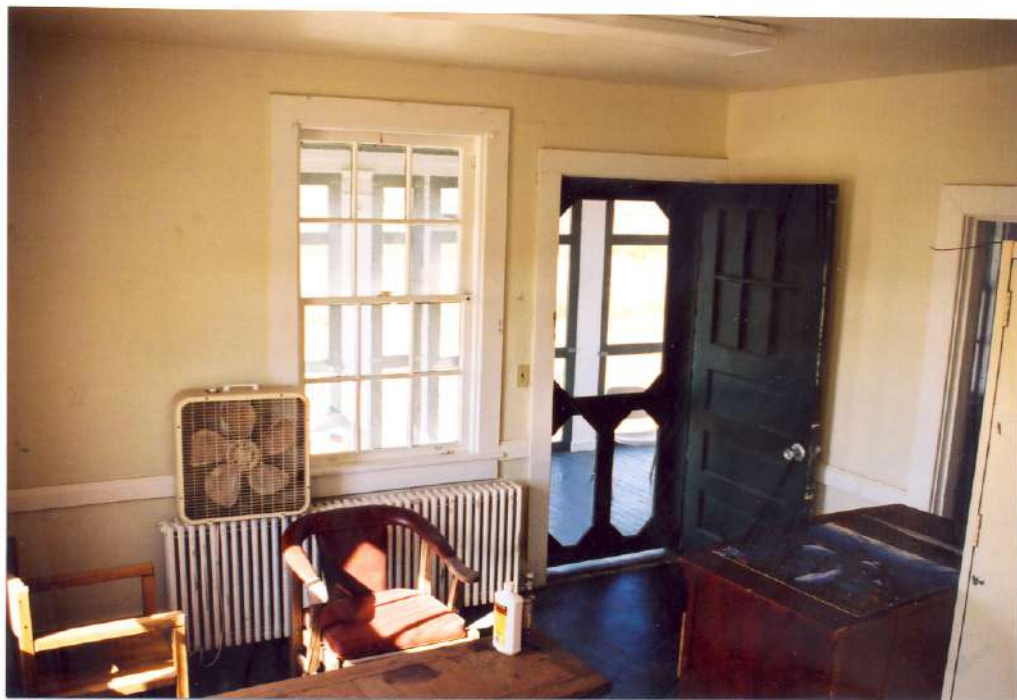
The office (fig. 69) is located in the southwest corner of the first story of the station house. The room measures approximately 14 feet 9 inches wide by 12 feet 6 inches deep, and has three doorways and three windows. A doorway on the east wall leads from the stair hall (Room 101), one on the north wall opens into the keeper's bedroom (Room 104), and an exterior doorway on the west wall opens to the west porch. One window is located on the west wall, and two are located on the south wall.

Figure 69. Station House: Office (Room 106), looking west/northwest (1999).

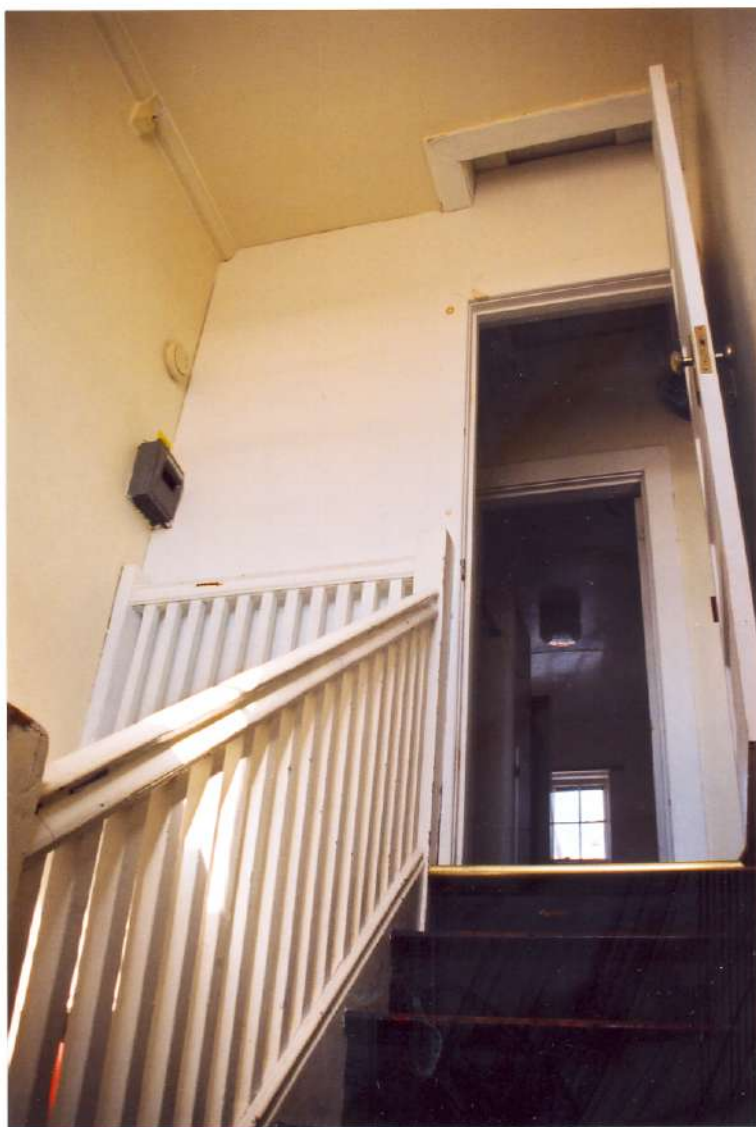
The stairwell (fig. 70) in the station house is located slightly to the west of center on the south side of the building. The stairwell contains a dogleg staircase that connects the first and second stories. The room measures approximately 6 feet 6 inches wide by 8 feet deep. Seven steps lead south along the west stair wall from the first- story stair hall to a landing, and six steps lead north along the east stair wall from the landing to the second- story hall. The stairwell has one window on the south wall at the second- story level, and one doorway at the top of the staircase that leads to the second- story hall.

Figure 70. Station House: Stairwell (Room 201), looking north (1999).

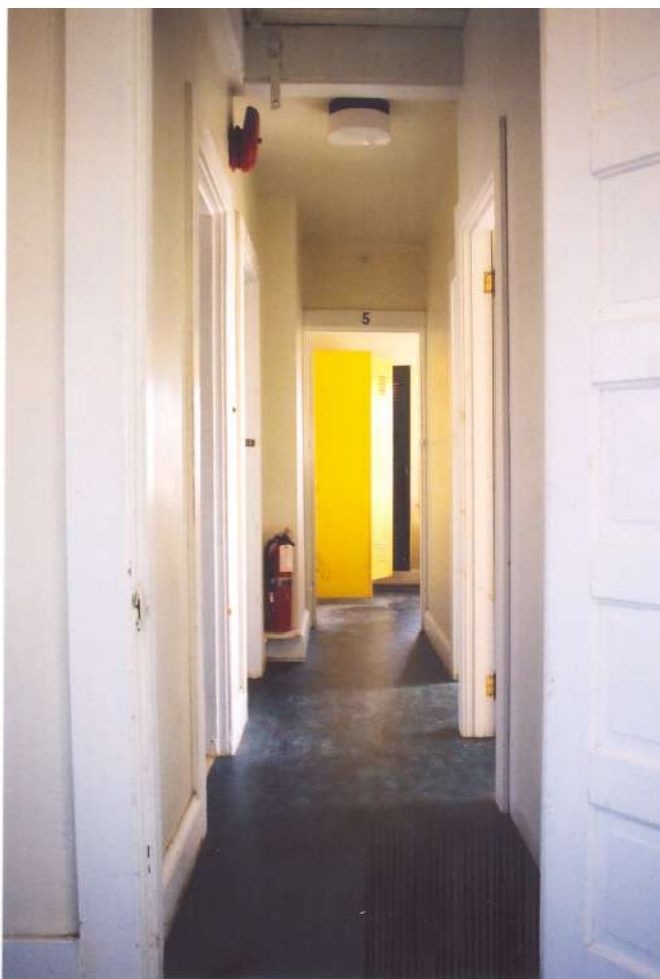
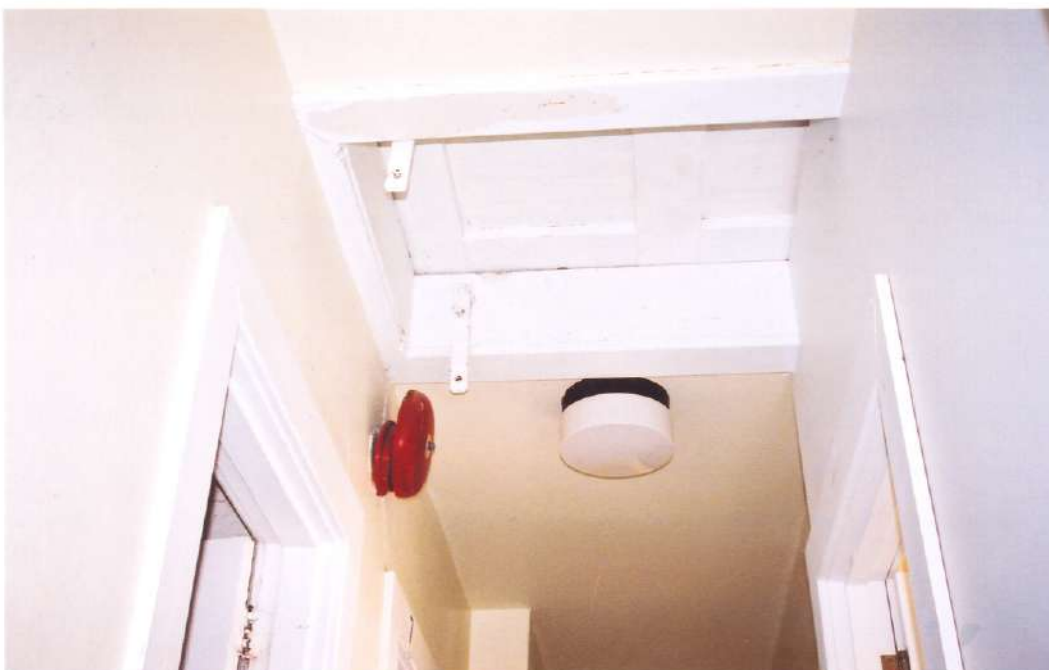
The second- story hall (figs. 71- 72) is located to the north of the stairwell (Room 201) and accesses all rooms on the second story. The room has six doorways: one opening from the stairwell, one leading to a bathroom, and four leading to bedrooms. There are no windows in the room.

Figure 71. Station House:
Second- story hall (Room
202), looking east (1999).

Figure 72. Station House: Second- story hall (Room 202), ceiling hatch (1999).

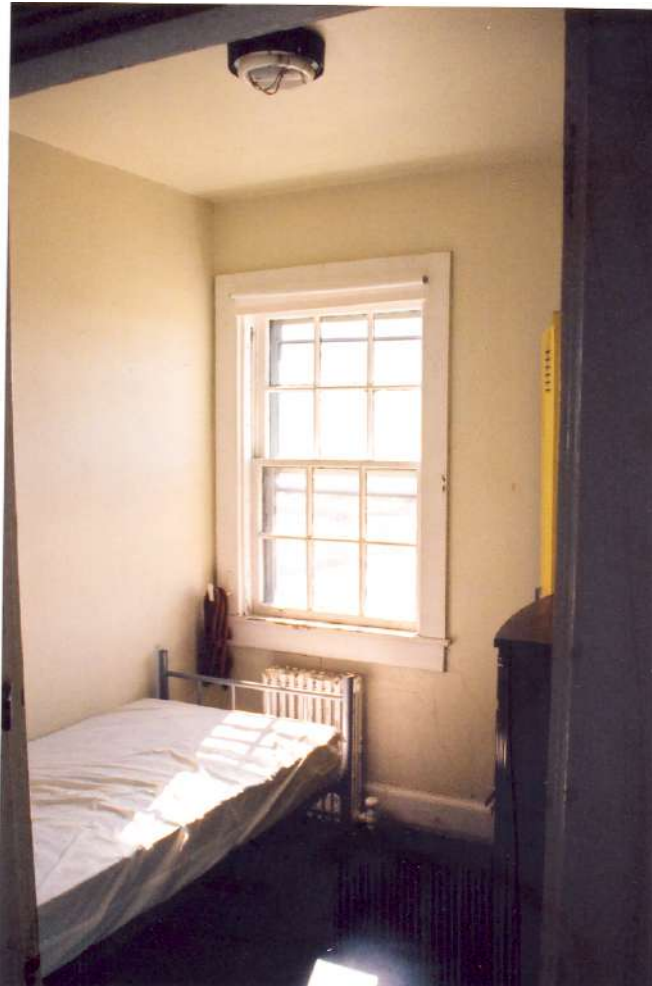
The spare room (fig. 73) is located on the south side of the second story, to the east of the stairwell (Room 201). The room measures approximately 7 feet 6 inches wide by 8 feet inches deep. A doorway from the hall (Room 202) is located on the north wall, and a window is located on the south wall.

Figure 73. Station House: Spare room (Room 203), looking south/southeast (1999).

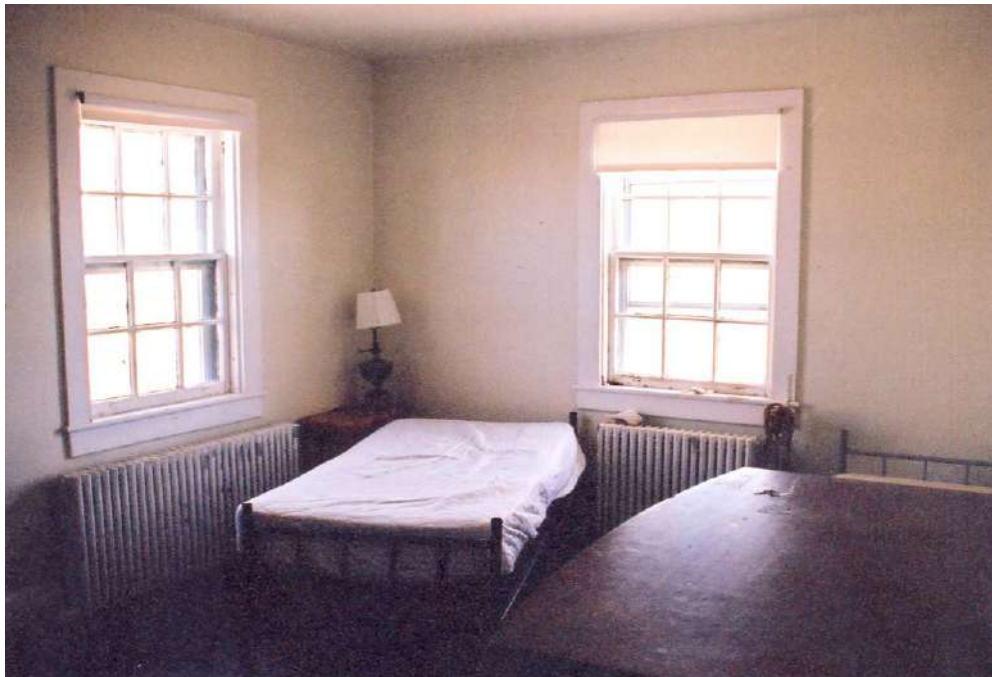
The northeast bedroom (fig. 74) is located in the northeast corner of the second story and was originally known as “Sleeping Room B.” The room measures approximately 17 feet wide by 12 feet 6 inches deep, and has a doorway from the hall (Room 202) located on the south wall. Two windows are located on north wall, with another window on the east wall.

Figure 74. Station House: Northeast bedroom (Room 205), looking east/northeast (1999).

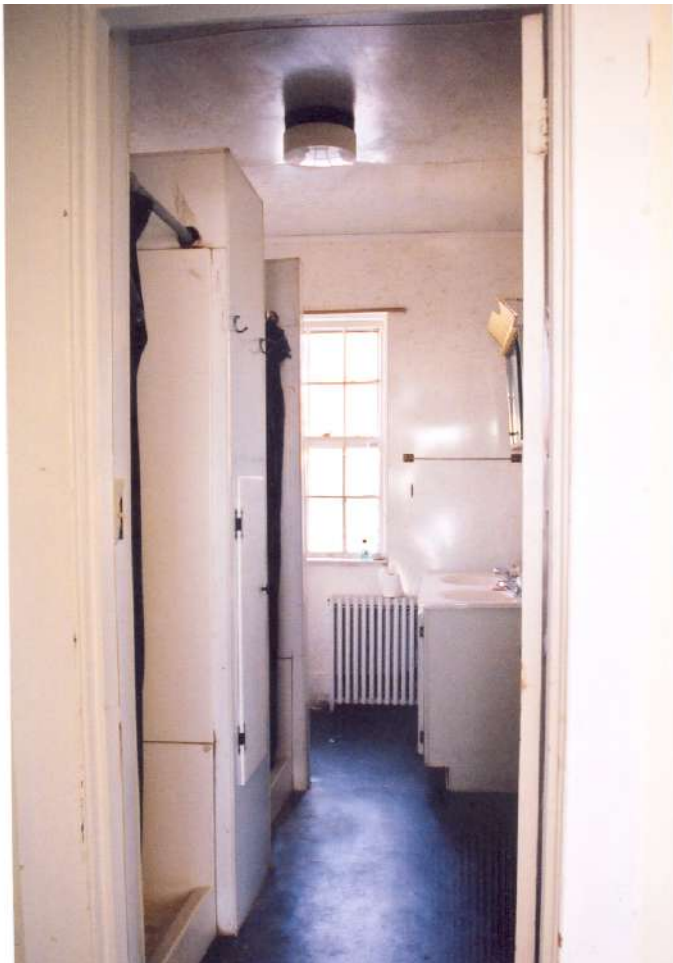
The bathroom (fig. 75) is located on the north side of the second story, across the hall from the stairwell to the south. The room measures approximately 6 feet wide by 12 feet deep. A doorway is located on the room's south wall, and a window on the north wall.

Figure 75. Station House: Bathroom (Room 206), looking north (1999).

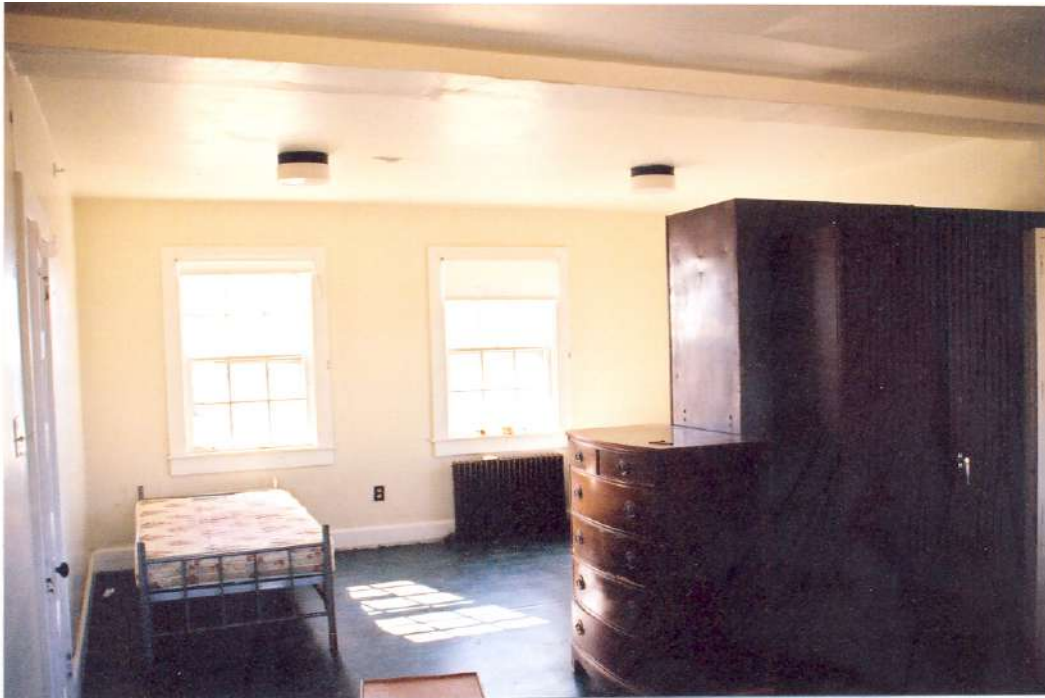
The west bedroom (fig. 76) occupies the west end of the second story, and was originally known as “Sleeping Room A.” The rectangular room measures approximately 14 feet 6 inches wide by 12 feet deep, and has one doorway opening from the hall located on the north wall. The room has six windows – two located on each of the north, west, and south walls.

Figure 76. Station House: West bedroom (Room 207), looking north (1999).

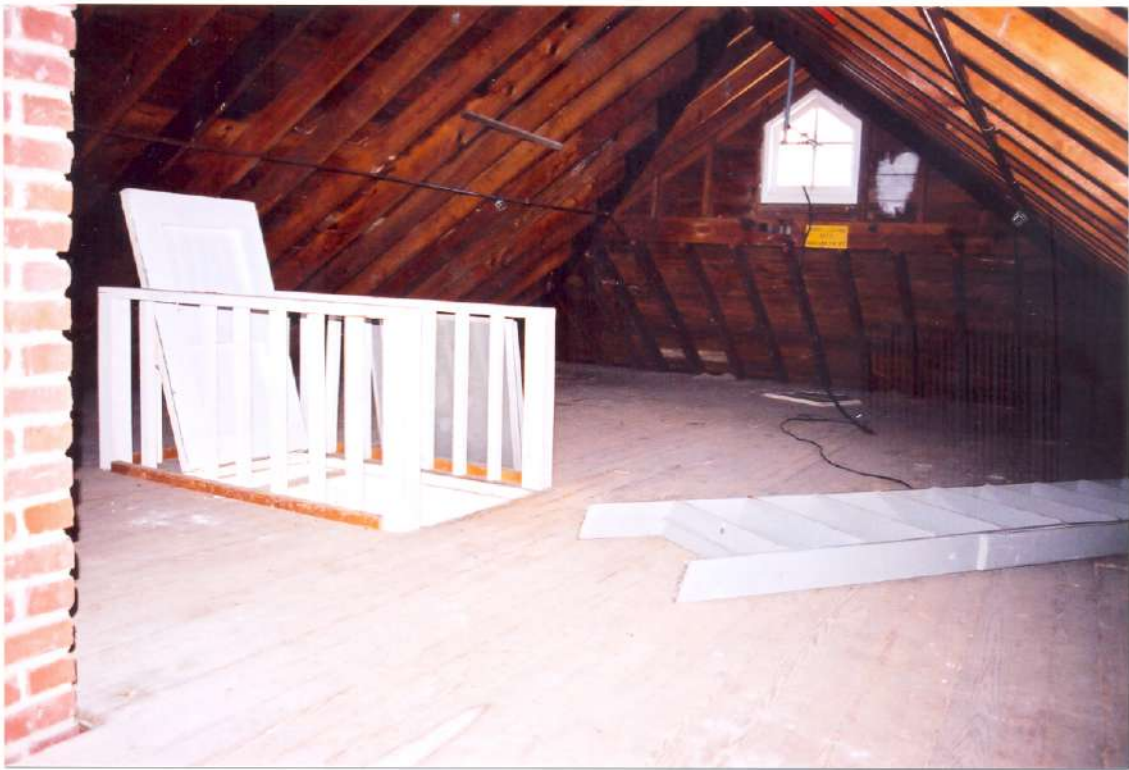
Room 301 (fig. 77) is an unfinished space that occupies the entire attic level of the station house. The floor is composed of tongue- and- groove boards 7 ½ inches wide, and the walls and ceiling are the exposed sheathing of the exterior walls and roof. The room has one casement window in each of the gables of the gable- on- hip roof. A hatchway with a hinged door is located in the center of the room; it opens from the second- story hall (Room 202) below. A balustrade constructed of dimensional 2- by 4- inch lumber protects three sides of the opening.

Figure 77. Station House: Attic (Room 301), looking west/southwest (1999).

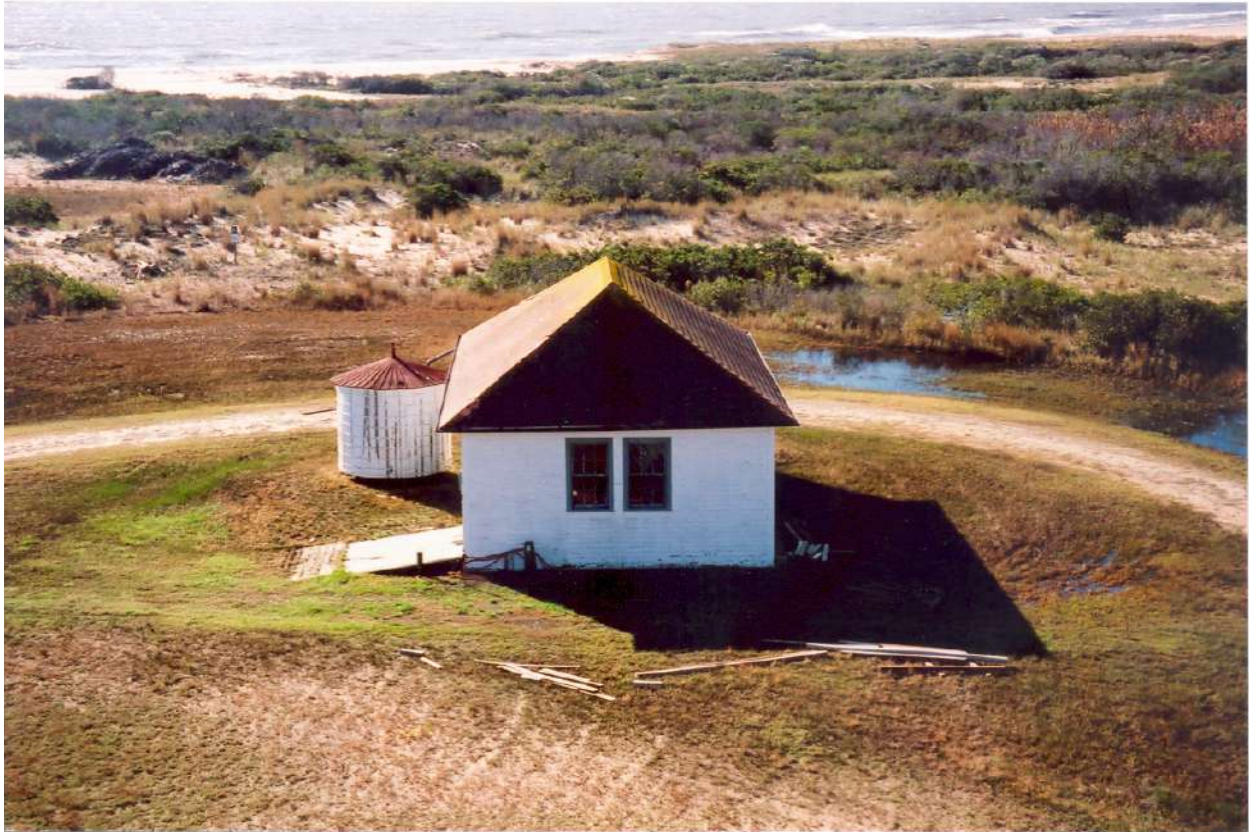
Figure 78. Assateague Beach Coast Guard Station Garage: View from lookout tower to the south, with Atlantic Ocean in background (1999).

The Assateague Coast Guard Station garage (fig. 78) was the original boathouse for the station. The building is a rectangular hip- roof structure that is situated approximately 100 yards south of the station house. The plainly detailed building is 1 ½ stories tall, and measures 23 feet deep by 39 feet 6 inches wide. The garage has two facades. The south façade with two double-wide doorways was the main boat entrance and is oriented to the Atlantic Ocean to the south (fig. 86). The east façade, labeled a “cart” entry on the 1922 construction drawings, is also the main pedestrian entrance, and is oriented toward the access road to the east (fig. 79). A large cylindrical water tank stands on pilings at the southeast corner of the garage. The water tank measures 10 feet in diameter and approximately 11 feet high, and has a conical roof topped with a decorative finial.

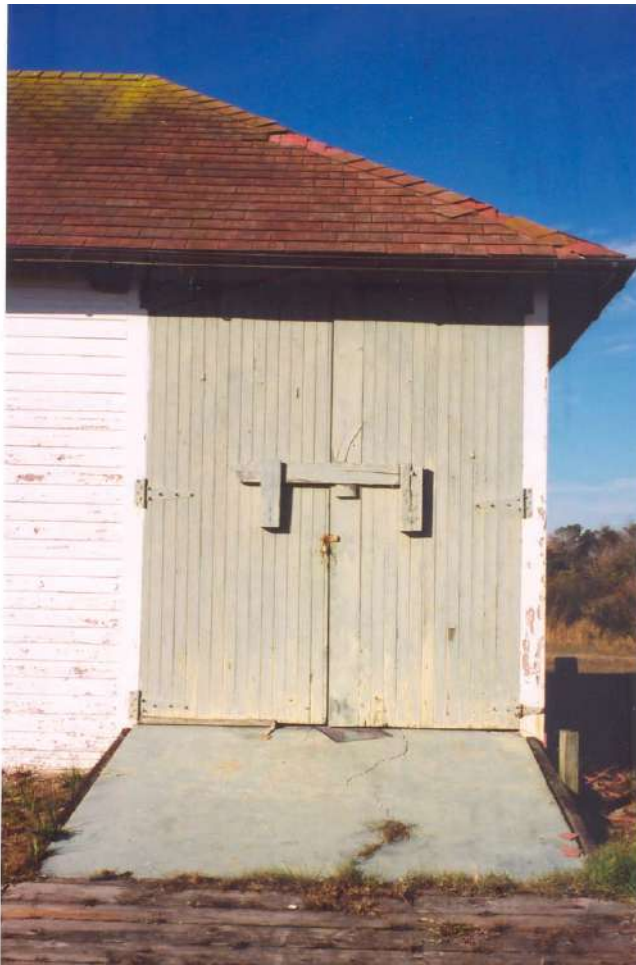
Figure 81. Garage:
East facade, doorway
D101 (1999).

East Façade – Doorway D101 (fig. 81)

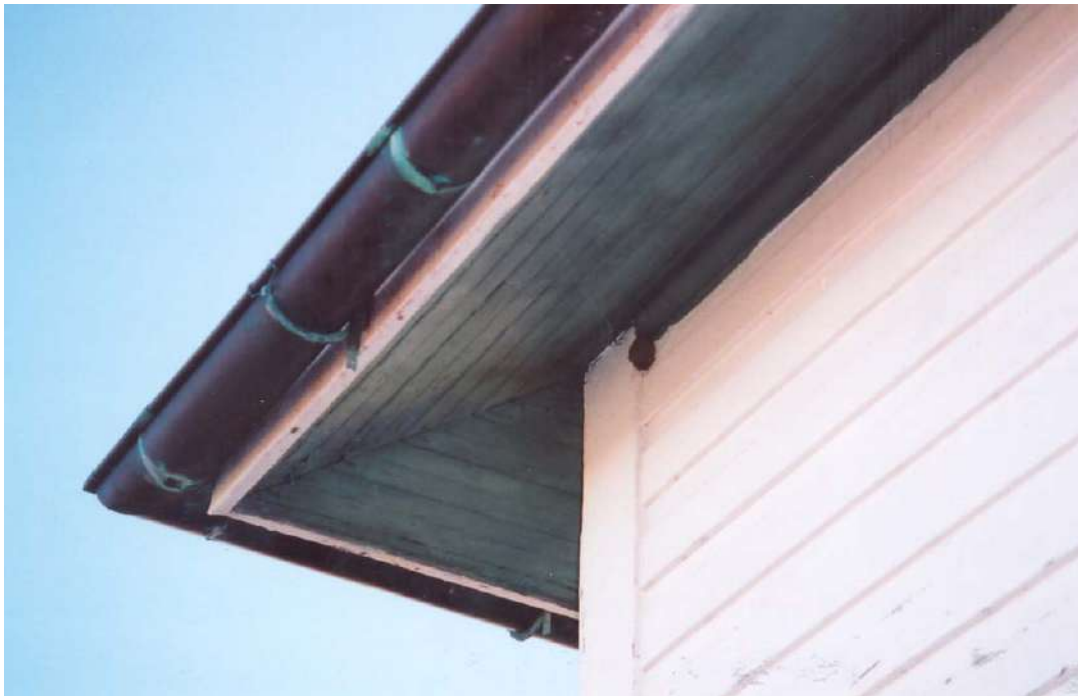
Figure 82. Garage: Northwest corner, detail of eaves soffits and gutters (1999).

Gutters	Half- round copper gutters mounted using copper hangers on all four eaves of hip roof (fig. 82)
Leader/Downspout	Copper leader connected to a round downspout that leads from east- eave gutter to water tank

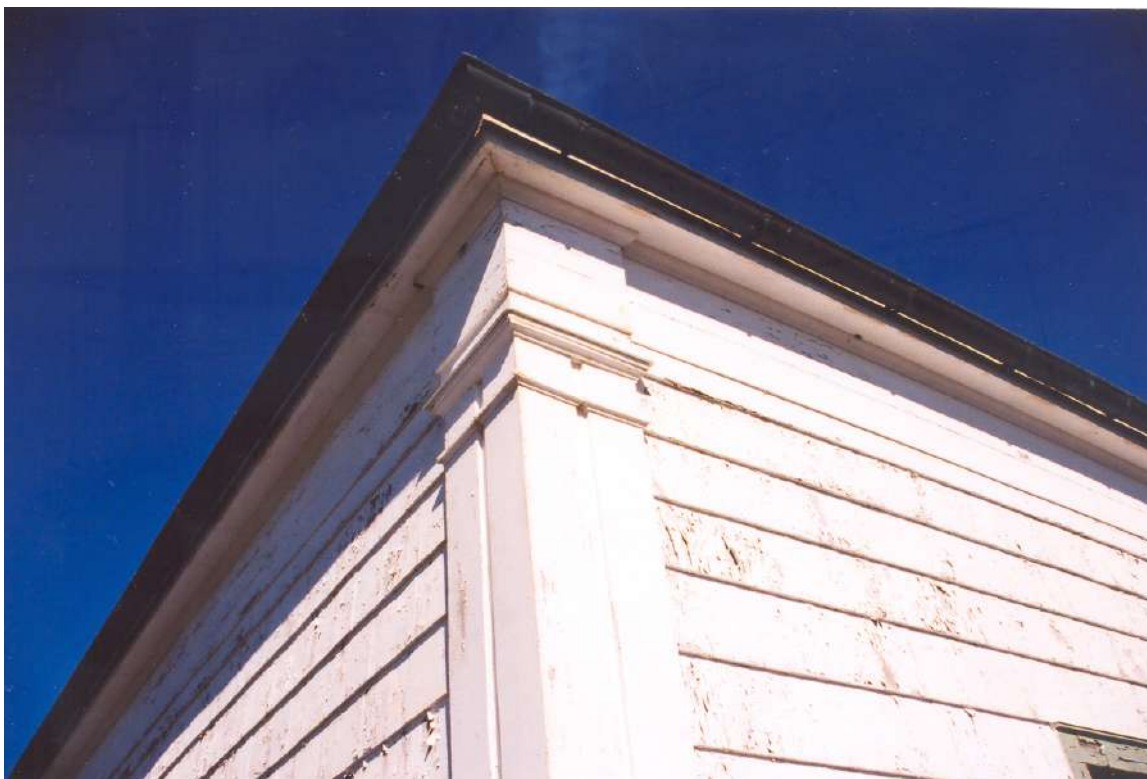
Figure 100. Boathouse: Southeast corner, architrave and pilaster detail (1999).

Half- round copper gutters mounted with copper hangers on all four eaves of building's hip roof (see fig. 100).

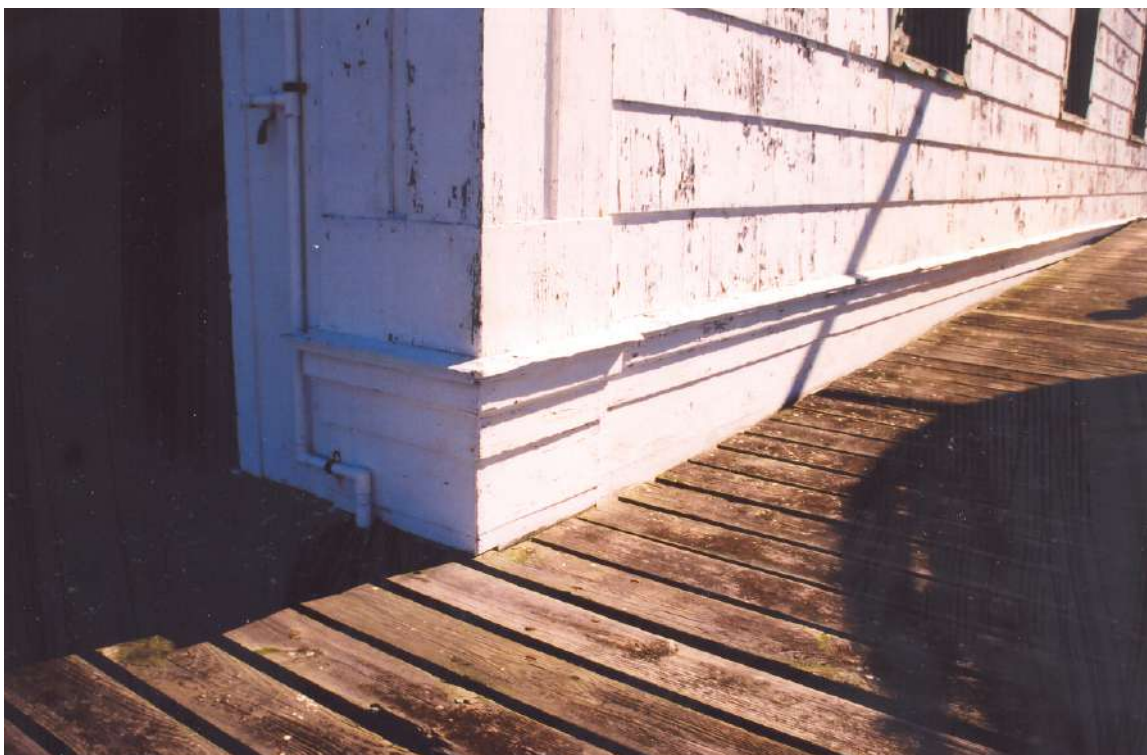
Figure 101. Boathouse: Northwest corner, water table detail (1999).

water table	composed of three stepped vertical boards; capped by a rounded drip edge covered with lead flashing; mostly visible toward north end of building where catwalk slopes down toward water line (fig. 101)
	other	original 1939 wood sign over center doorway on north façade; faded letters state “U.S. Coast Guard, Assateague Beach Station”

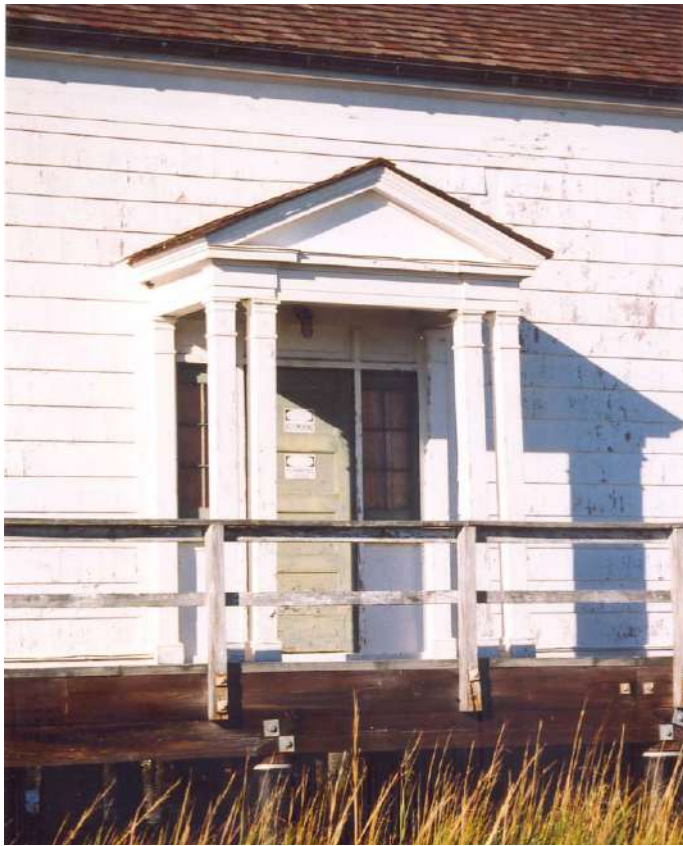
Figure 102. Boathouse:
South façade, doorway
D101 and porch (1999).

South Façade – Main Pedestrian Entrance (D101 – figs. 102 & 104)

Location	centered on the building’s south façade
Opening Size	not recorded
Door	door has four horizontal, recessed panels trimmed with quarter- round molding
Hardware	padlock; five- knuckle butt hinges with ball finials
Sidelights	6- light wood sashes with glazing removed (blocked with plywood from interior) over vertical recessed panel
Panels	three, “transom style” over door and sidelights, trimmed with square molding
Trim	engaged columns of porch (see “Porch – Columns”)
Other	original 1939 glazed door replaced with extant door before 1976; 1939 sidelights replaced with extant sidelights sometime after 1976

Porch (figs. 102 & 103)

Location	south façade, centered over main entrance D101
Size	not recorded
Foundation	catwalk on pilings
Balustrade	none
Decking	pressure- treated wide boards running north/south
Roof	pedimented gable with wood shingles; simple Colonial Revival entablature composed of stepped plain boards with stepped square- edge strip applied as molding (may be replacement)
Columns	double columns 6 inches square on each outer corner, single engaged column at wall on either side of doorway D101 and sidelights; simple capital
Ceiling	2 1/2 inch- wide tongue- and- groove boards installed in north/south direction (fig. 104)
Other	may be original 1939 porch; not known if/what details have been replaced

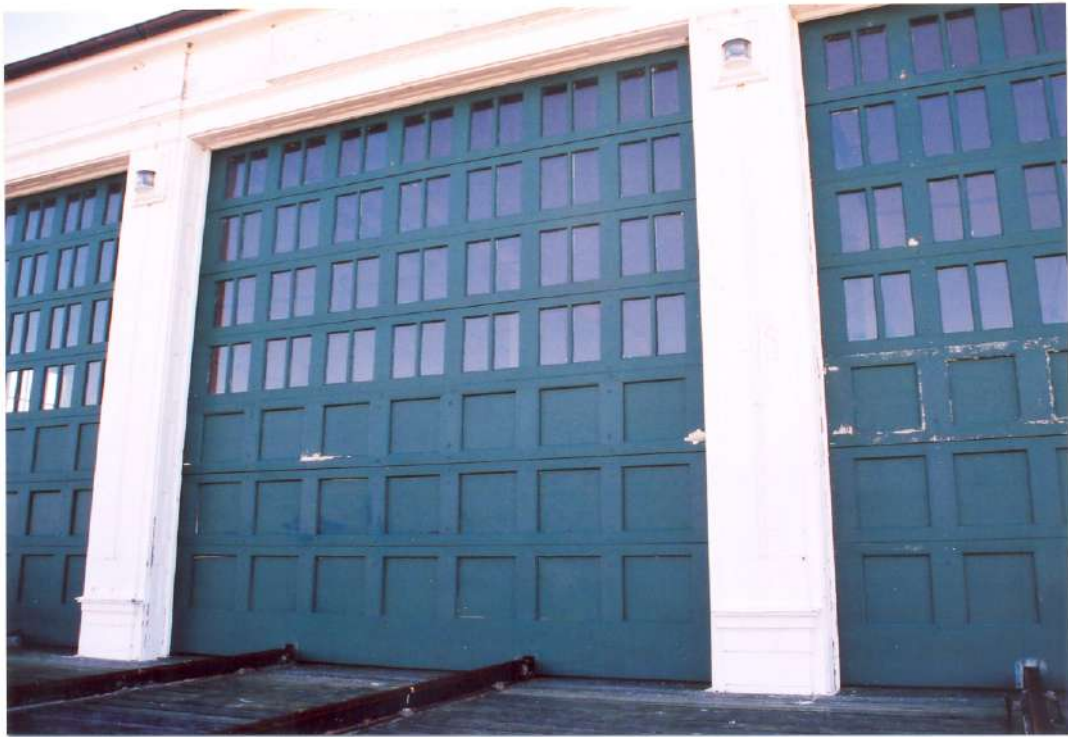
Figure 105.
Boathouse:
North elevation,
doorway D103
(1999).

North Façade – Boat Doorways (D102, D103, & D104 – figs. 98 & 105)

Locations	D002	east end
	D003	center
	D004	west end
Opening Sizes	each	approximately 12 feet wide by 12 feet 10 inches high
Doors	each	overhang door composed of seven rows of seven panels each; on the top four rows, each panel is composed of two vertical lights; each panel on the bottom three rows is a recessed wood (masonite?) panel
Hardware		none visible; in each doorway a pair of metal tracks lead up from the launchway and through the bottom of the door
Surrounds		pilasters at each corner and between the doors (see “Walls: Trim – Pilasters”)
Reveals		at east and west ends, each composed of seven recessed, vertical panels, one over the other (fig. 106)
Other		original 1939 doorways and doors; some panels replaced in kind in 1992

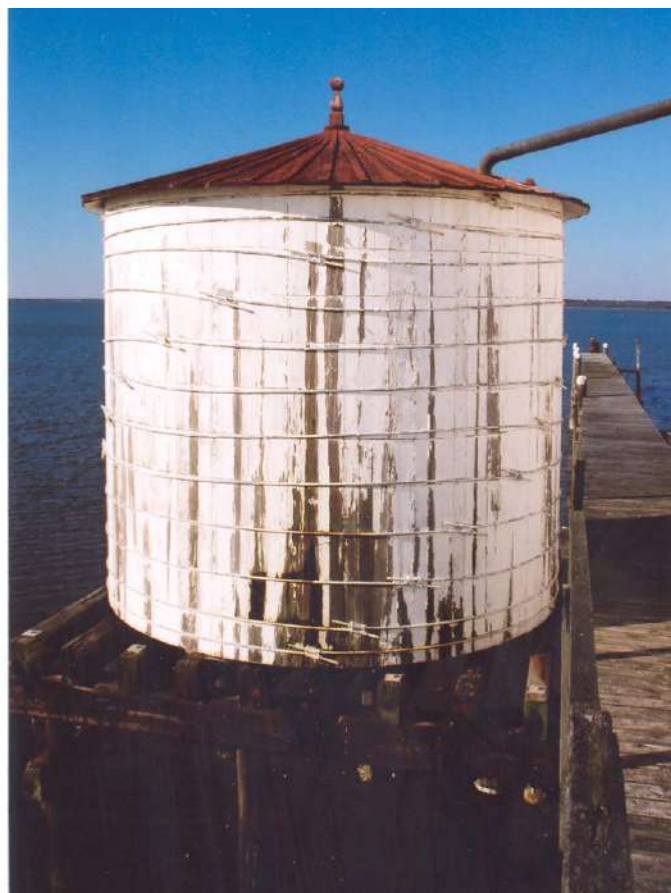
Figure 110.
Boathouse: Water
tank off northwest
corner (1999).

Cladding	building & dormers (cheek walls)	Wood shingles half an inch thick and of varying widths (7 to 14 inches), laid with a 10- inch exposure and fastened using wire nails
	water tank	Vertical boards with rod compression rings (reconstructed circa 1992 – fig. 110)
Sheathing		5 ½ inch- wide tongue- and- groove boards laid diagonally
Trim	architrave	Colonial Revival style reminiscent of classical architrave, except not “supported” by the corner pilasters; composed of four boards laid horizontally and trimmed at the top with a quarter-round molding – each of the top three boards are approximately 3 ½ inches wide and are on the same plane; top boards are stepped over lowest board, which is approximately 2 ½ inches wide (fig. 100)
	pilasters	Colonial Revival style reminiscent of a classical capital; at each corner; 1 foot 5 inches wide, composed of two vertical boards each 7 ½ inches wide with a 2- inch recess between; top is decorated with a protruding continuation of wall frieze detail, below which are two bands of molding; bottom is a continuation of the water table (fig. 100)

Water Tank (fig. 110)

Round copper leader and downspout runs from gutter on west eave of building to water tank (see fig. 110).
