**OLD HARBOR LIFE-SAVING STATION
Provincetown, Massachusetts**

HISTORIC STRUCTURE REPORT

**Cape Cod National Seashore
South Wellfleet, Massachusetts**

June 1988

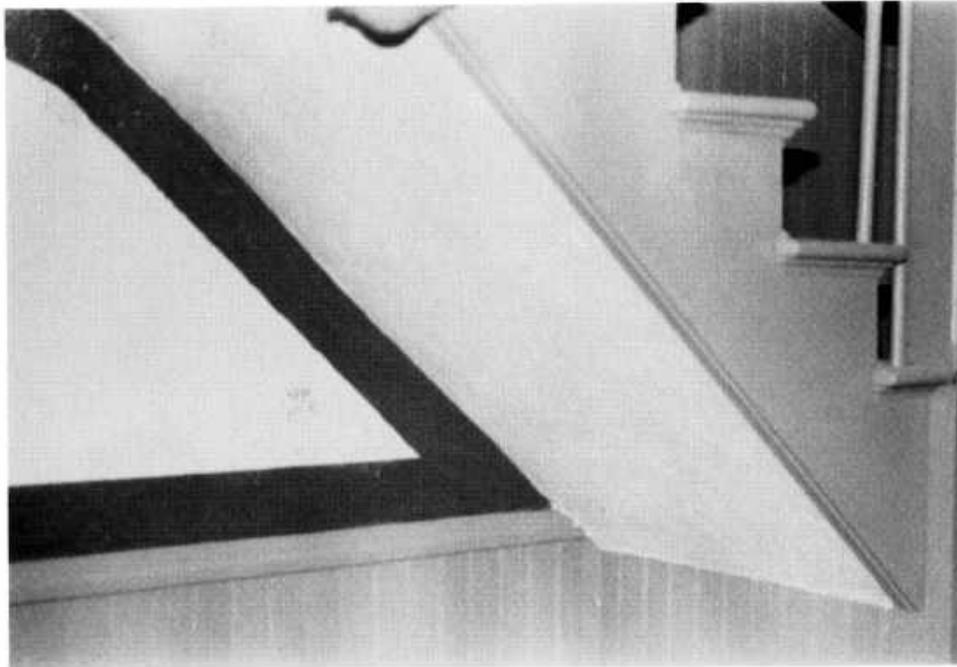
Illustration 45. First-Floor Stair Hall:
Soffit of Stair.

Woodwork. Single-beaded matchboard wainscot wraps around all lower walls and follows the angle of the stair up to the second floor. All sections of the wainscot and its cap molding are historic and painted olive green. The paint on the west-wall wainscot is worn, due to the wedging of a large timber between the wainscot and D113, to keep the door securely shut. The wainscot displays a paint line approximately 1 inch above the floor, indicating the former presence of a shoe molding. Wainscot without a cap exists on the short north wall under the soffit of the stair (fig. 45).

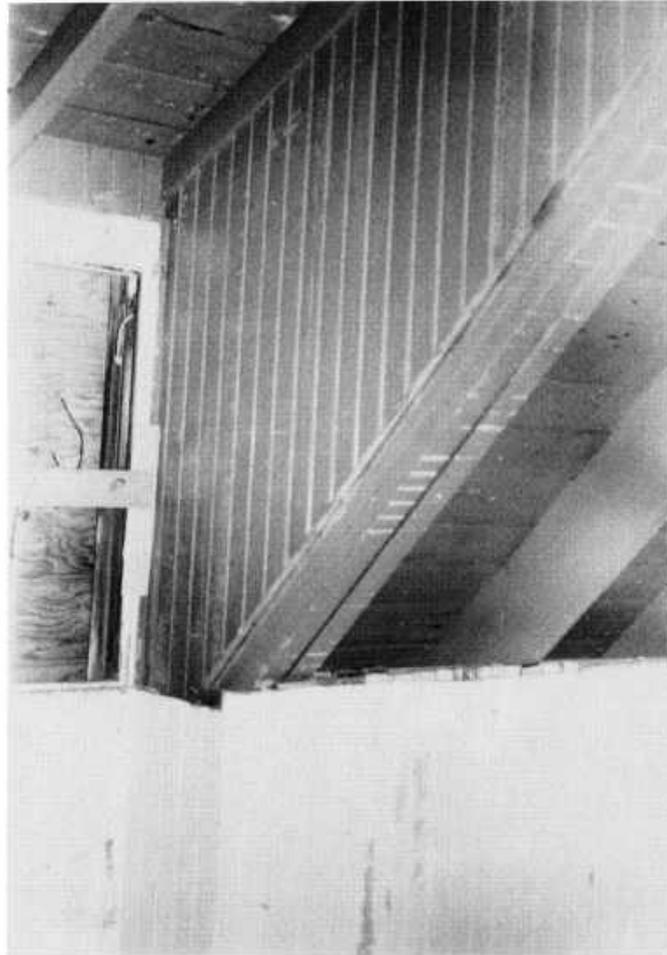
Illustration 49. Quarters: Side of
South Dormer.

Woodwork. Double-beaded, matchboard wainscot was used historically on the lower sections of all four walls, including the alcoves created by the south and north dormers (fig. 49). Most of this wainscot is extant, but it is missing from the east and west walls of the north-dormer alcove.

The top edge of the wainscot apparently was trimmed historically with a molded cap. One type of wainscot cap is extant on the east and west walls. A cap with a different profile is found where the wainscot abuts the windows in the south and north dormer alcoves. It is probable that the first type of cap molding also was used historically on the south and north walls:

fewer paint layers above a paint line at the top of the wainscot here suggest the former presence of such a molding.

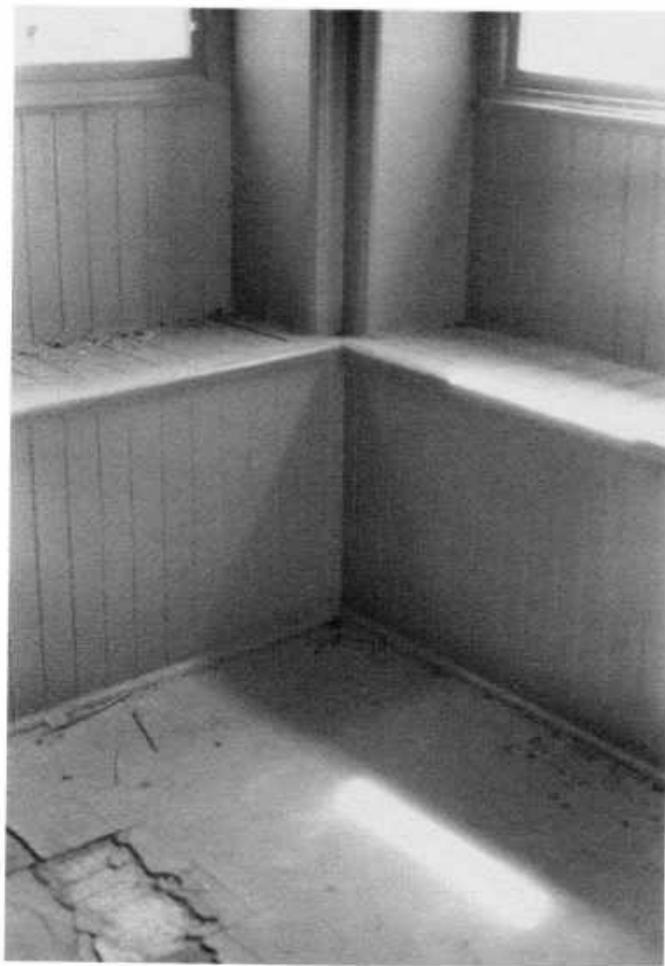
Illustration 57. Lookout: Lower
and Middle Wall Tiers.

Most of the original matchboarding and smooth lumber is intact. It is missing in two places, which have been patched with wide pine boards. These places are part of one bench seat, and the east half of the middle tier of the north wall.
