# U.S. COAST GUARD NAUSET STATION DWELLING AND BOATHOUSE

Cape Cod National Seashore  
Eastham, Massachusetts

**HISTORIC STRUCTURE REPORT**

January 2008

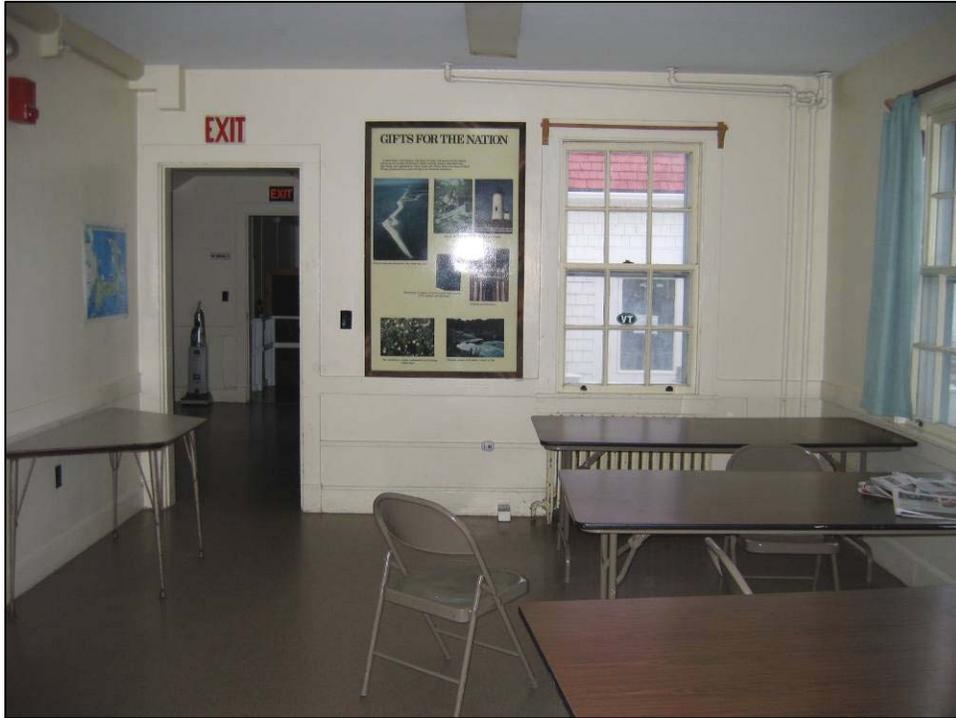
Figure 4.56. Room 102 (mess room), north wall and doorway #1K.

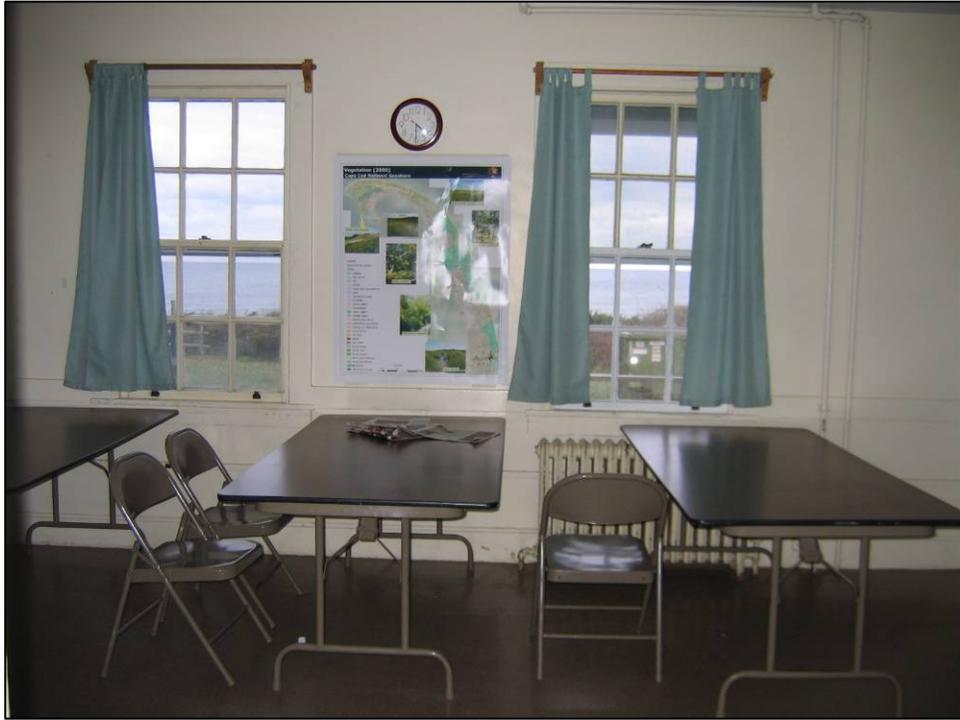
The frame and casing were altered at unknown date, and the original door is missing. (See Fig. 4.58.) As indicated on the original drawings, the opening had a wood door with four solid raised panels and six lights with “obscured glass.”

Figure 4.58. Room 102 (mess room), east wall.

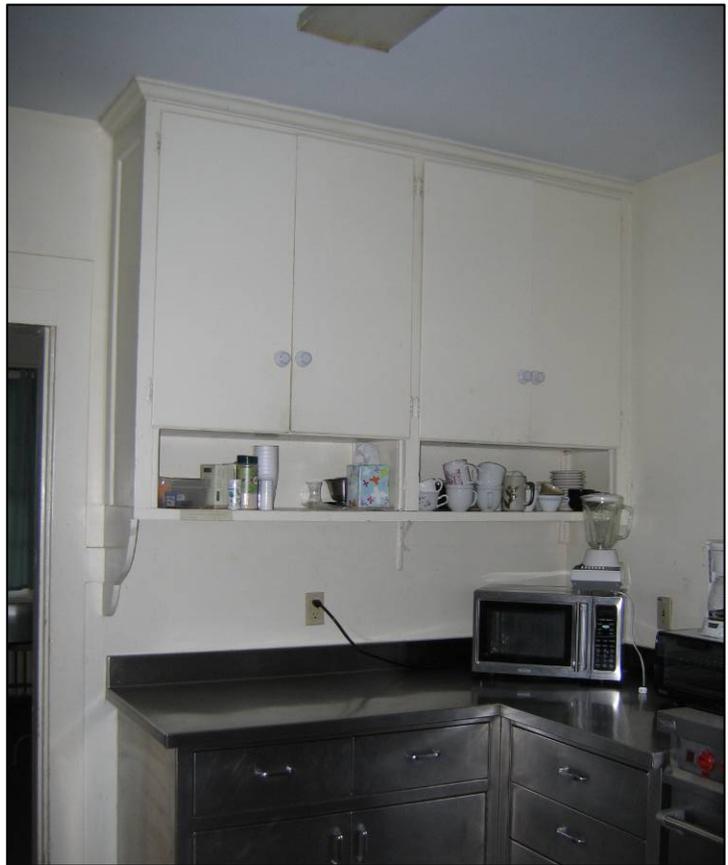
The lower portion of the original floor- to- ceiling wood cabinet on the east wall is missing, and a wood bracket is scabbed onto the left side panel. The original doors to the upper cabinet have also been replaced. The date of these alterations is unknown. Complete cabinet details are shown on the original drawings. A modern stainless- steel counter stands in the location of the missing lower cabinet. (See Figs.4.60 and 4.61.)

**Figure 4.60.** Room 103 (kitchen), east wall and altered kitchen cabinet.

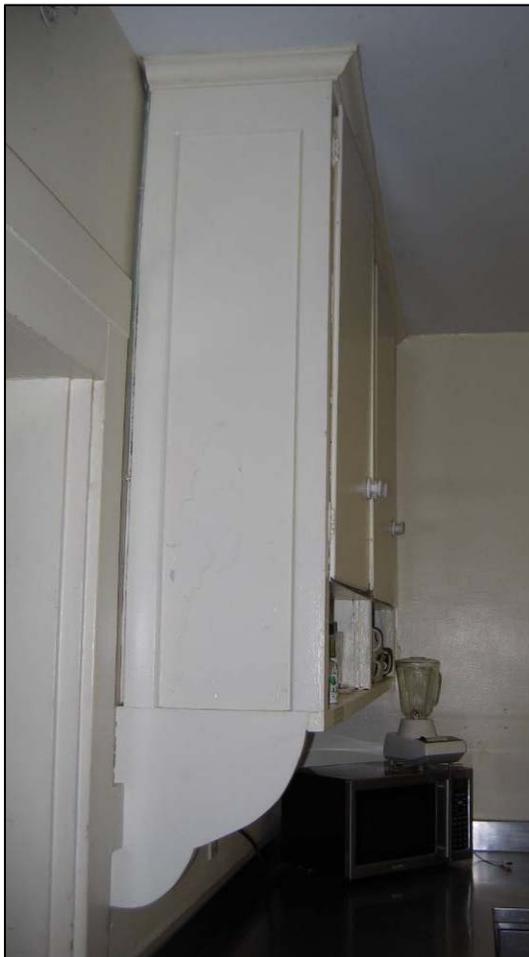
**Figure 4.61.** Room 103 (kitchen), altered kitchen- cabinet detail.

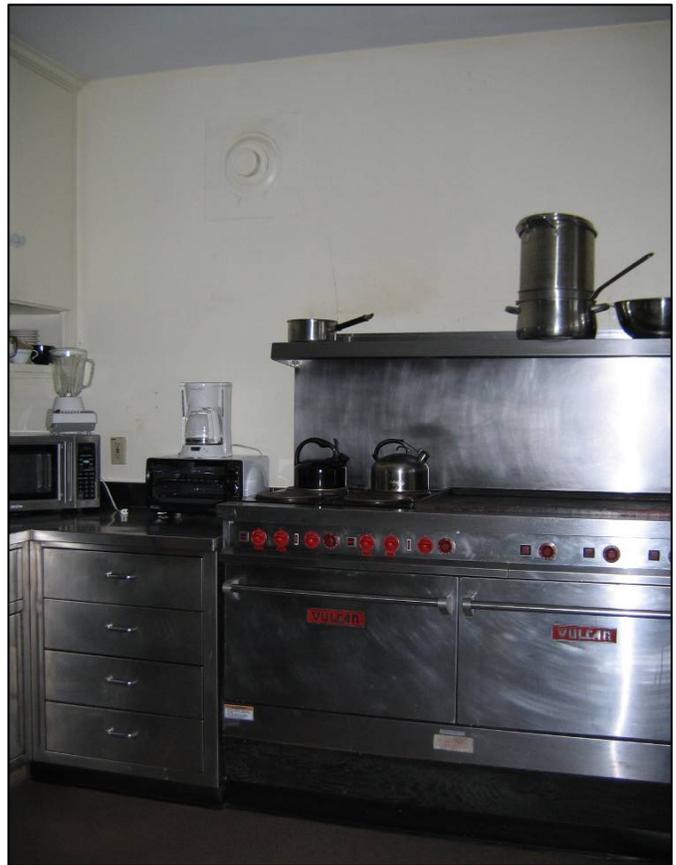
Original built- in counters and a sink have been replaced by modern stainless- steel counters. The thimble for the original range's stove- pipe connection is located near the southeast corner. (See Fig. 4.62.) The present through- wall exhaust fan was installed between 1958 and circa 1974.

**Figure 4.62.** Room 103 (kitchen), east wall.

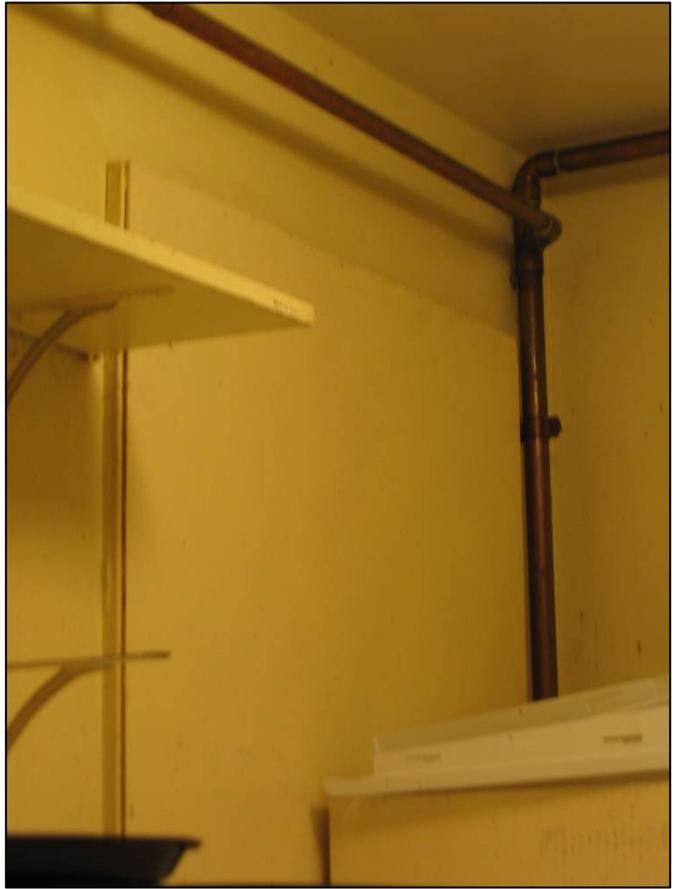
The original borrowed- light window with “obscured glazing” is boarded over. Two tiers of original wood shelving partially remain with all of its original wood ledgers and metal brackets. An original built- in cabinet below the borrowed- light window was removed at unknown date. (See Fig. 4.64.)

**Figure 4.64.** Room 104 (pantry), west wall and blocked borrowed- light window opening.

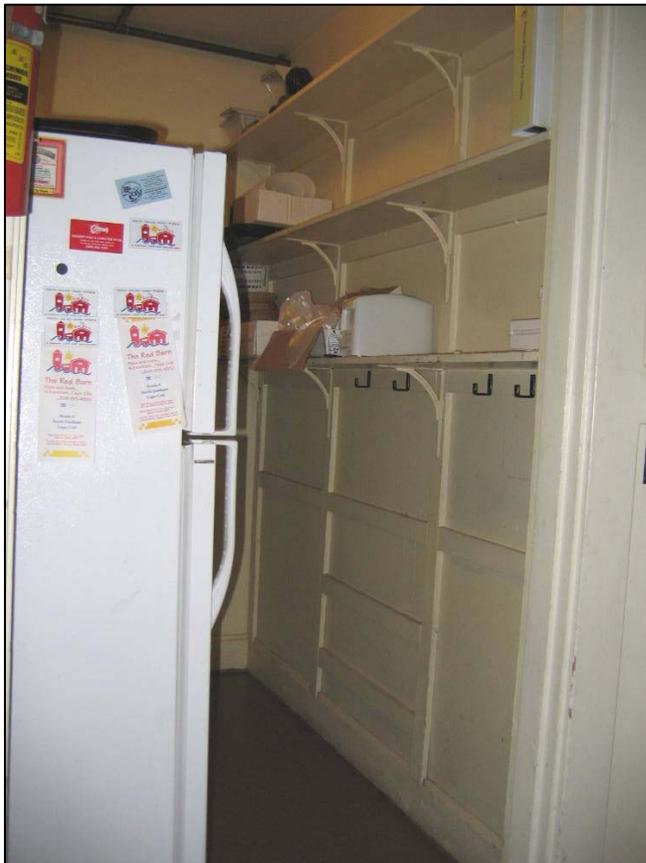
Three of four tiers of original wall- mounted wood shelving remain, as do all original wood ledgers and metal brackets. (See Fig. 4.65.)

**Figure 4.65.** Room 104 (pantry), east wall.

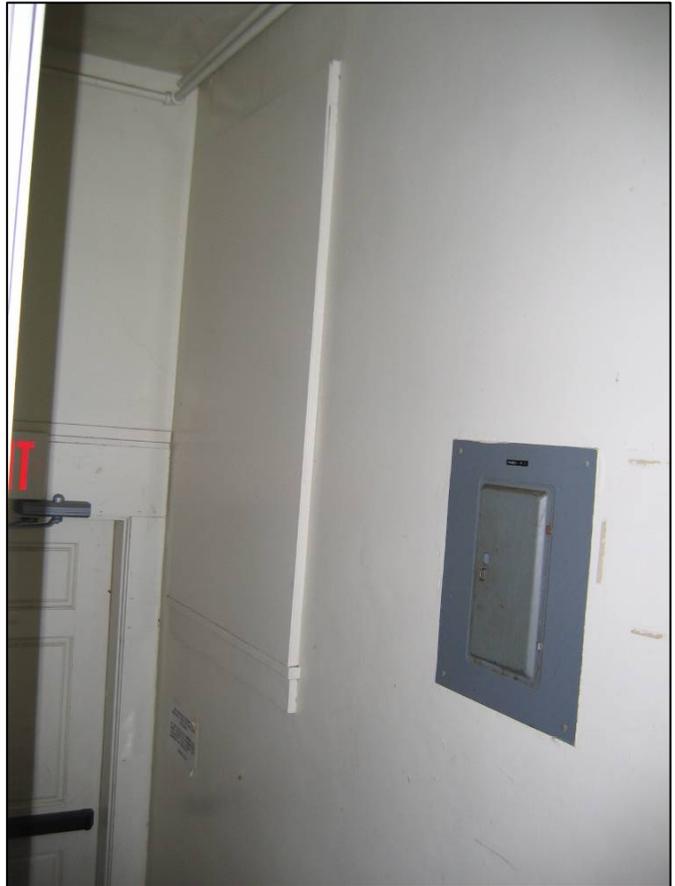
The original borrowed- light window opening to the pantry (room 104) is boarded over, but the original frame and casings remain. (See Fig. 4.66.) A later electrical panel is recessed into the wall to the right of the borrowed- light window.

**Figure 4.66.** Room 105  
(rear stair hall), east wall,  
northeast corner.

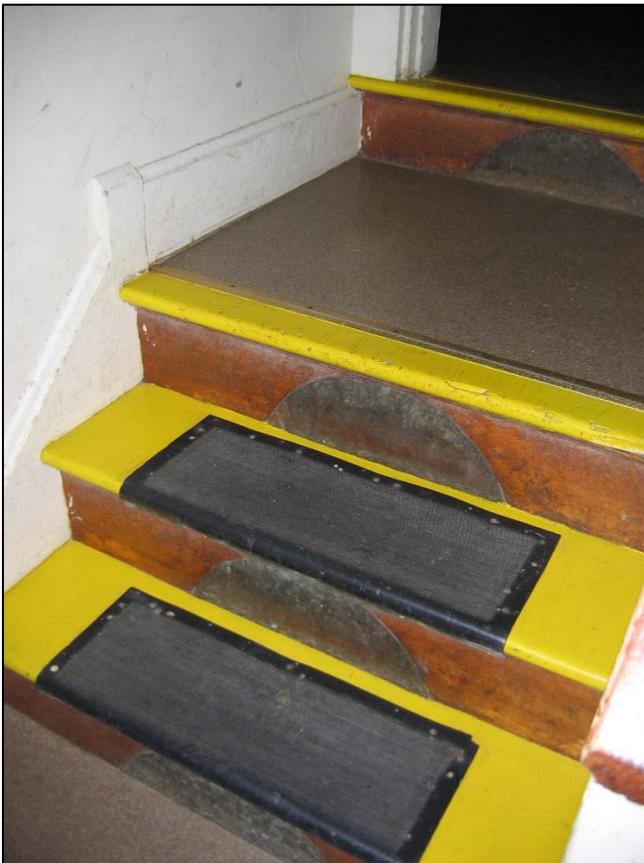
The rear stairway remains as indicated on the original drawings. The steps have semicircular sheet- copper kick plates applied to the risers. These are of unknown date, but may be original. (See Fig. 4.67.)

**Figure 4.67.** Room 105  
(rear stair hall), stairway.

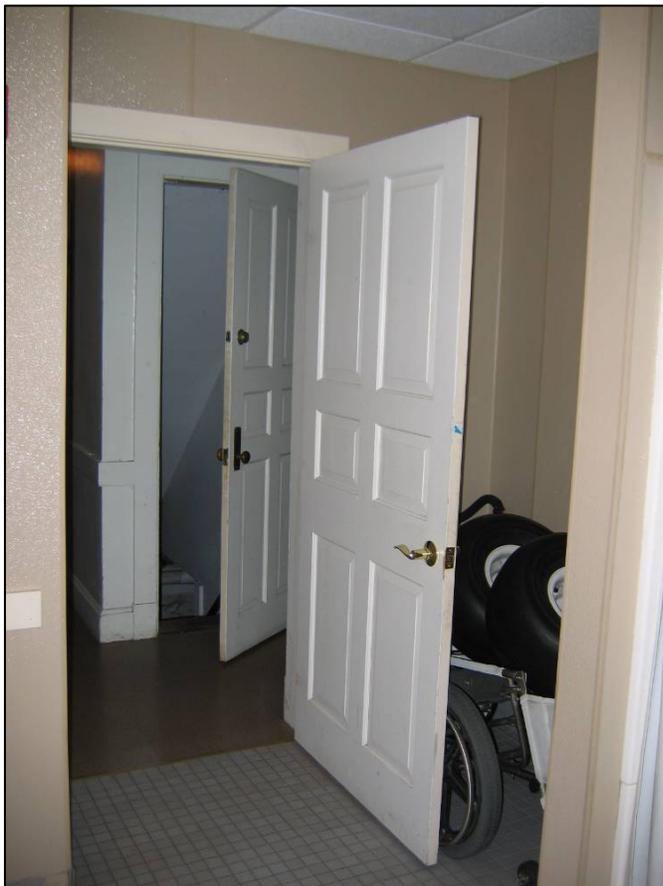
The present 3- foot- wide wood door with six solid raised panels replaced the original six- panel wood door – which was 2 feet, 8 inches wide – when the room was converted to the accessible bathroom. (See Figs. 4.52 and 4.69.)

**Figure 4.69.** Room 106 (former bedroom), east wall and doorway #1D.

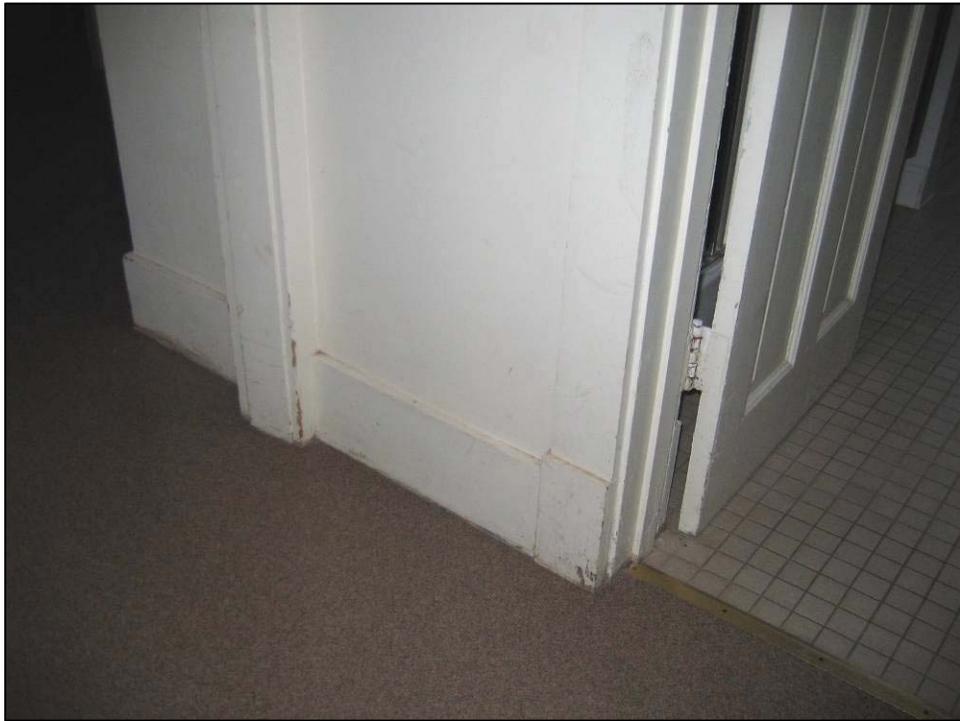
The present east wall is a later frame partition of unknown date. As indicated on the original drawings, there was no partition in this location; the floor and ceiling of the present room were continuous with those of the adjacent office (room 08). (See Figs. 4.70- 4.71.)

The present south wall is either a later frame partition of unknown date or the altered original partition. The date of the alteration is unknown. As indicated on the original drawings, the wall had a typical molded baseboard and chair rail, but no openings. The present wall has a plain baseboard and no chair rail. (See Fig. 4.70.)

Figure 4.70. Room 107 (passageway), south wall, southeast corner.

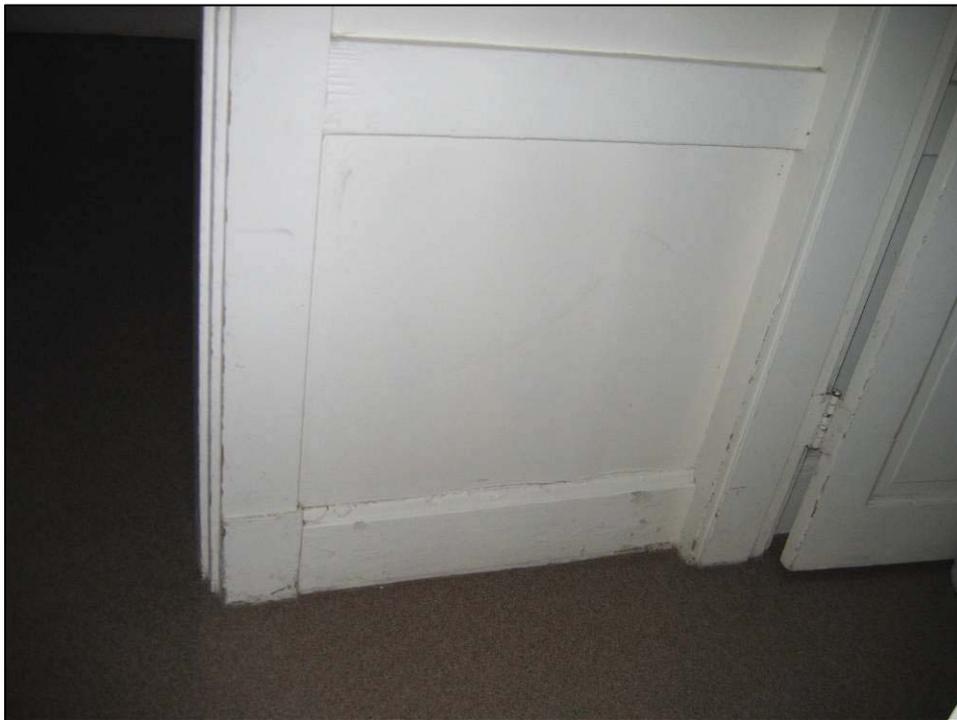
Figure 4.71. Room 107 (passageway), north wall, northeast corner.

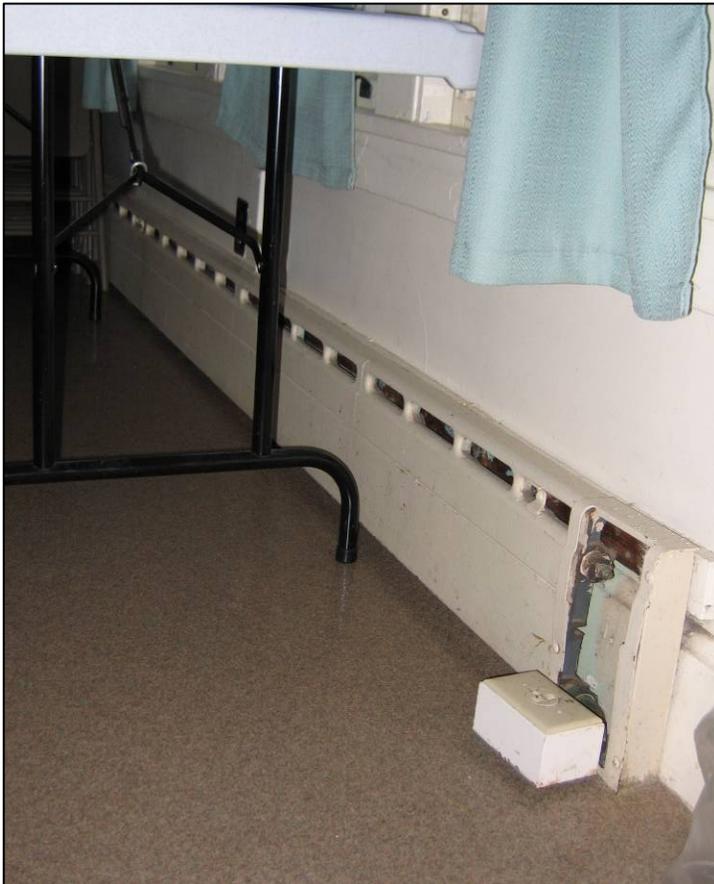
**Figure 4.79.** Room 111 (day room), east wall, later radiator.

A later baseboard radiator of unknown date was added on the east wall. (See fig. 4.79.)

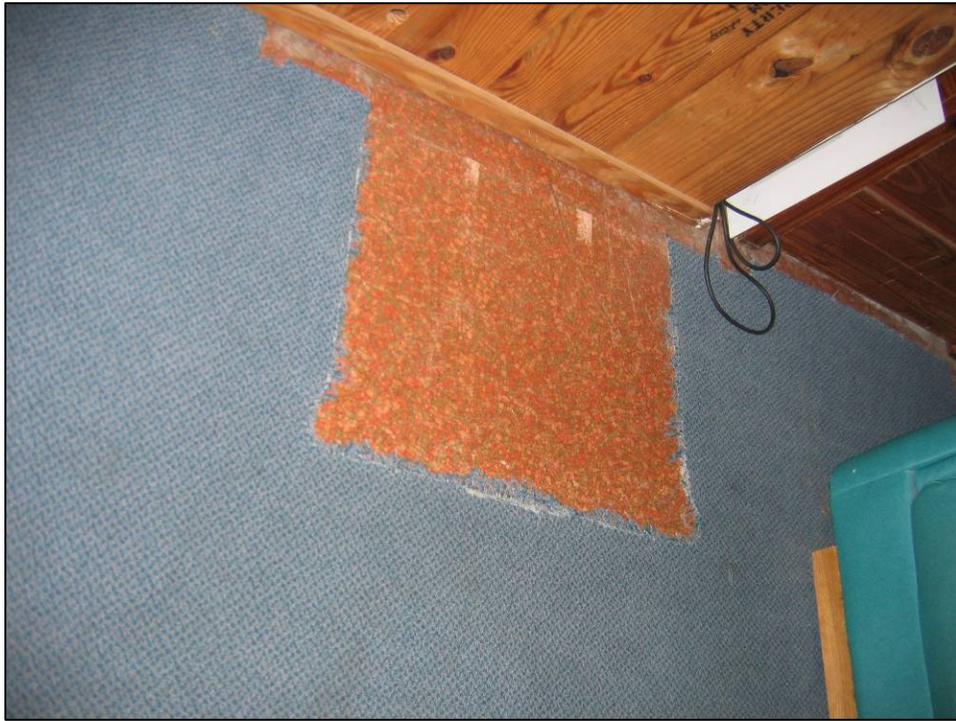
Figure 4.82. Room 112 (part of former boat room), floor at northwest corner.

The present floor is 1962 wood framing constructed over the original concrete floor slab, with wall- to- wall carpet over earlier sheet vinyl flooring. (See Fig. 4.82.)

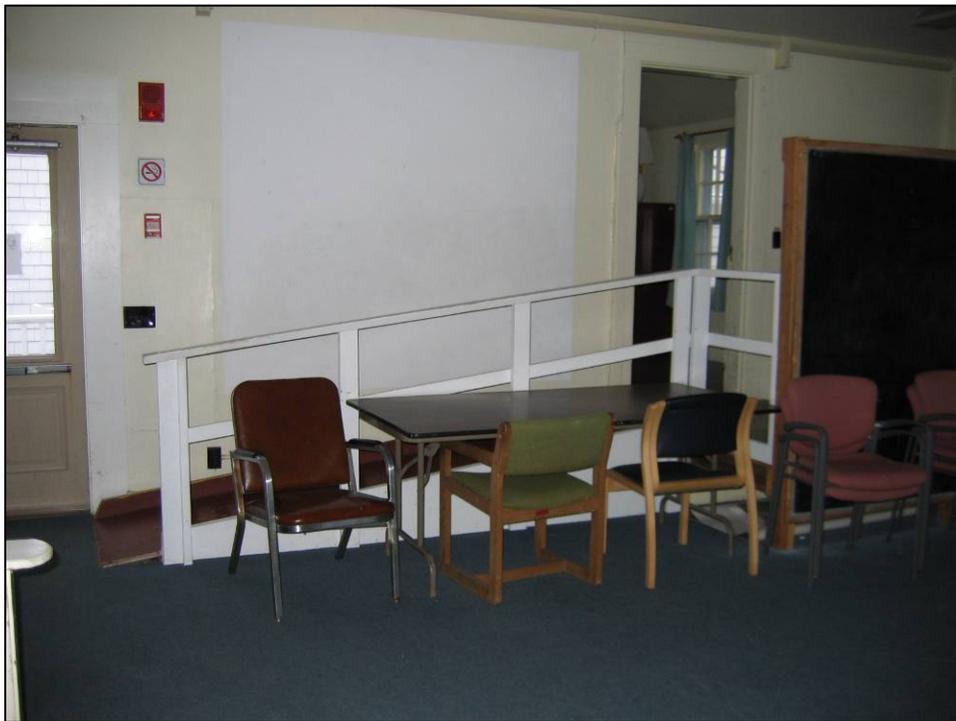
Figure 4.85. Room 112 (part of former boat room), south wall and nonhistoric ramp.

The present stairway and ramp with wood handrails on the south wall replaced a stairway and pipe handrail depicted on the original drawings. (See Fig. 4.85.)

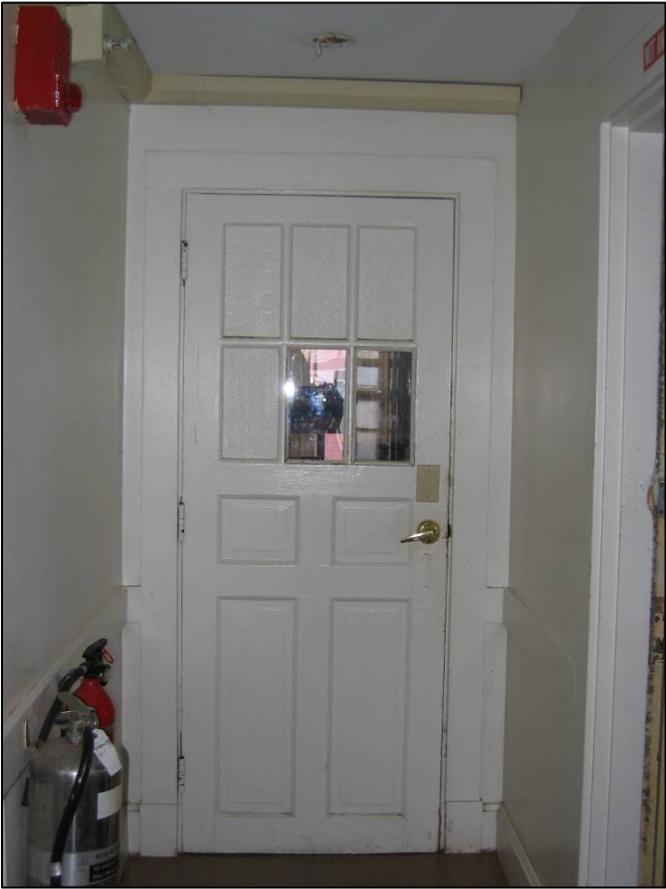
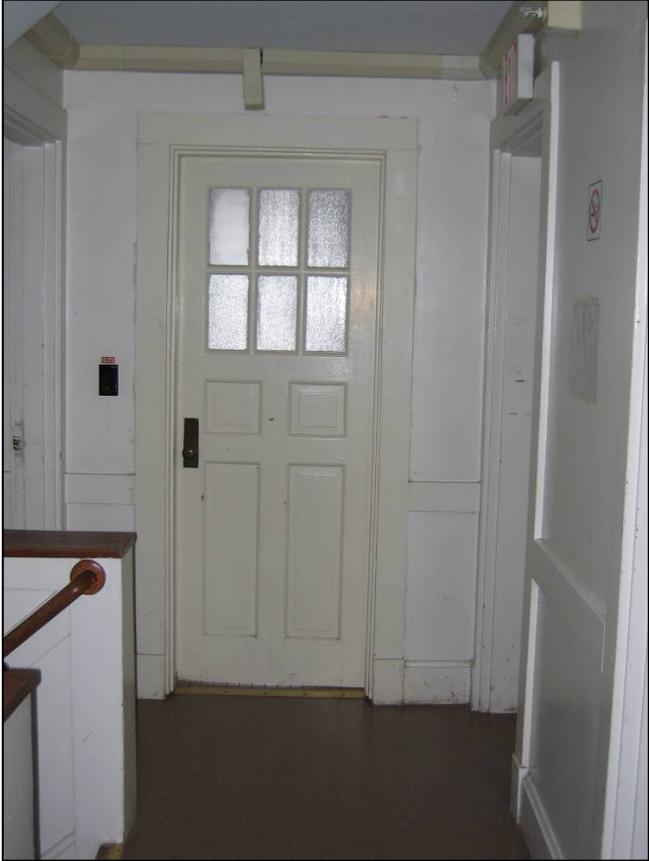
All three doorways have typical casings and wood doors with four solid raised panels and six lights, as indicated on the original drawings. The lights on doors #2D and 2K had obscured glass, while door #2L had clear glass. Some of the obscured glass has been replaced with alternate materials. (See Figs. 4.89 and 4.90.)

**Figure 4.89.** Room 201 (hall), north wall and doorway # 2K.

**Figure 4.90.** Room 201 (hall), south wall and doorway #2D.

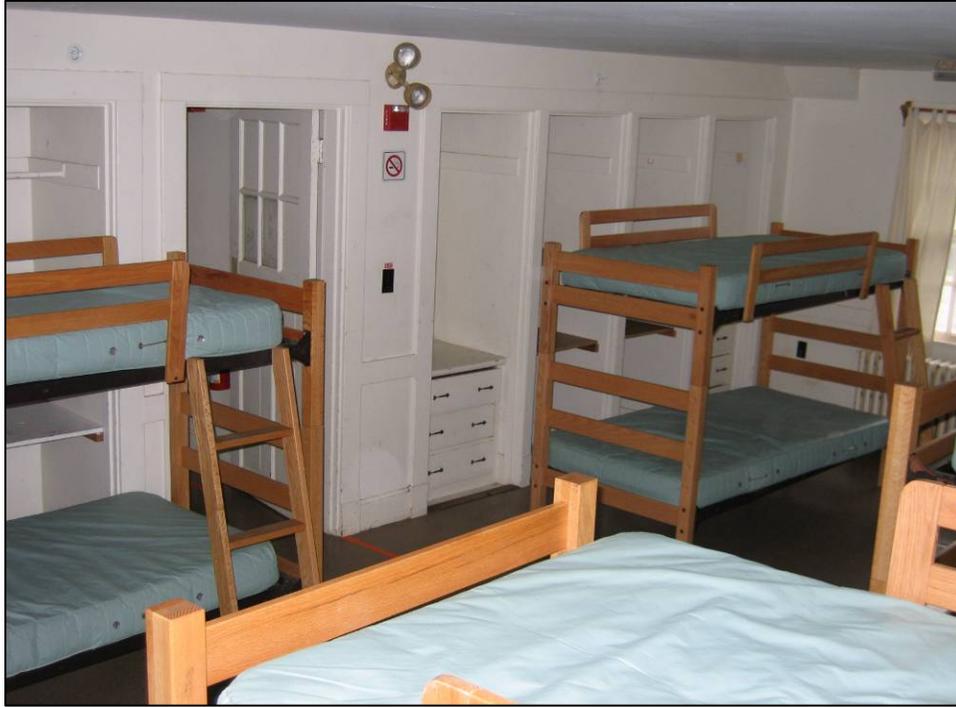
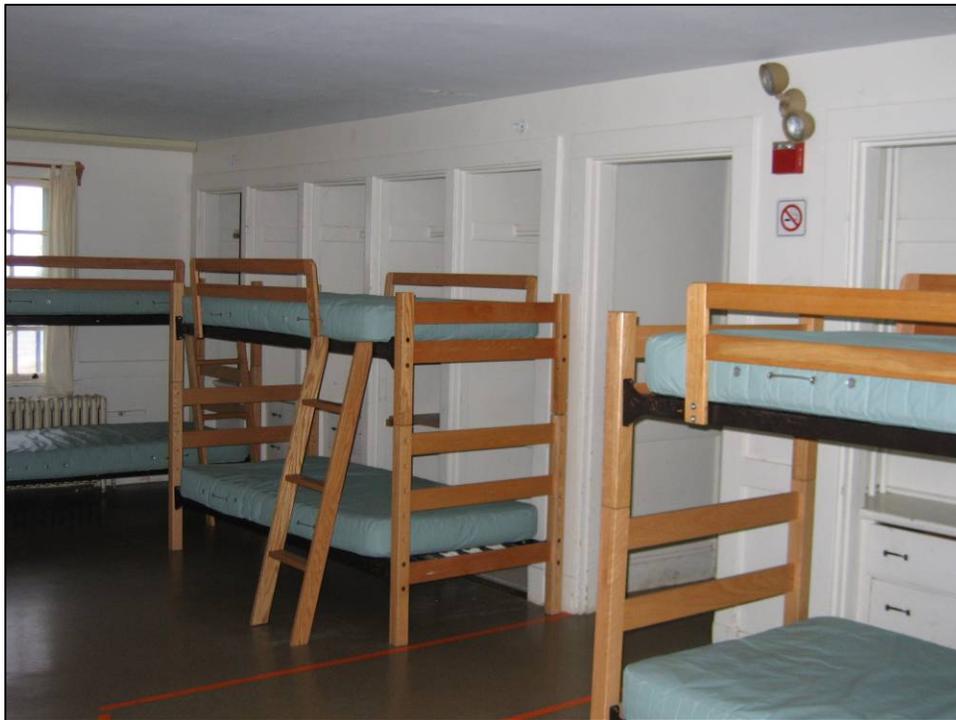
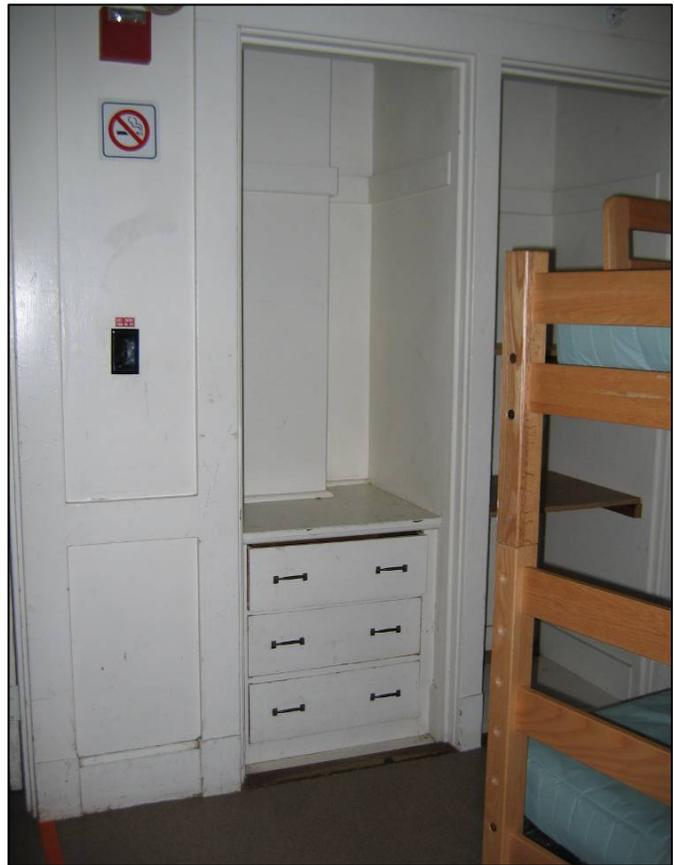
As indicated on the original drawings, the interiors of lockers 202 a - i were each plastered and fitted with a built- in wood cabinet with three drawers, a closet pole, and an upper shelf supported on wood ledgers. Presently lockers 202 d, e, g, and h are lacking cabinets. All of the lockers retain their upper- shelf ledgers, but many are missing the shelf and closet pole. Doorways #2N - 2V and their hinges are presently missing. As indicated on the original drawings, each of these was a wood door with six solid raised panels. Closer inspection of locker interiors and doorway frames is necessary to determine whether the locker doors and interior cabinets were actually constructed as designed and later altered, or if the lockers were constructed without doors and with variations in cabinetry. (See Figs. 4.91 - 4.93.)

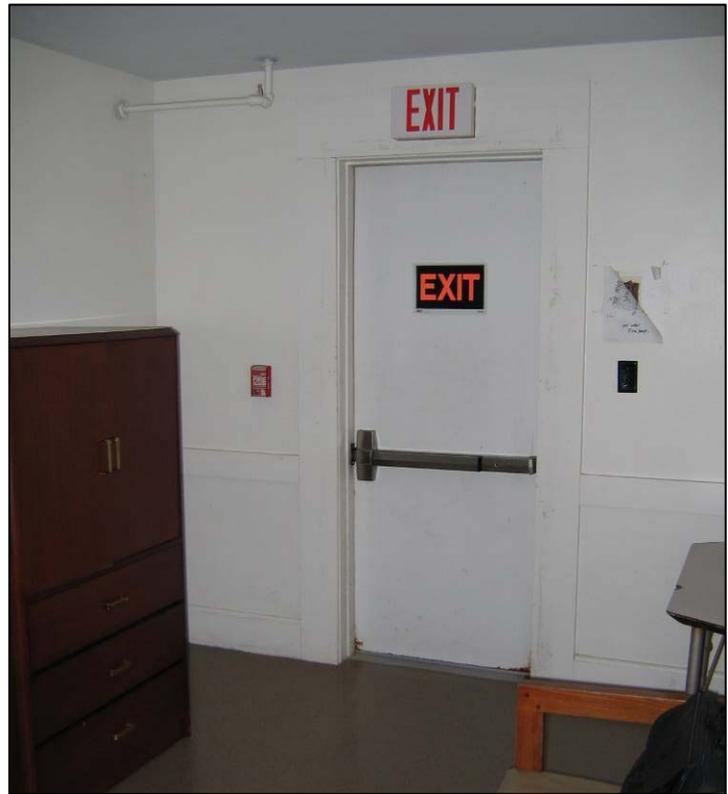
**Figure 4.100.** Room 205 (crew's bath) and doorway #2D.

Room 205 retains the configuration shown on the original drawings, but with extensive alterations of unknown date. (See Fig. 4.100.)

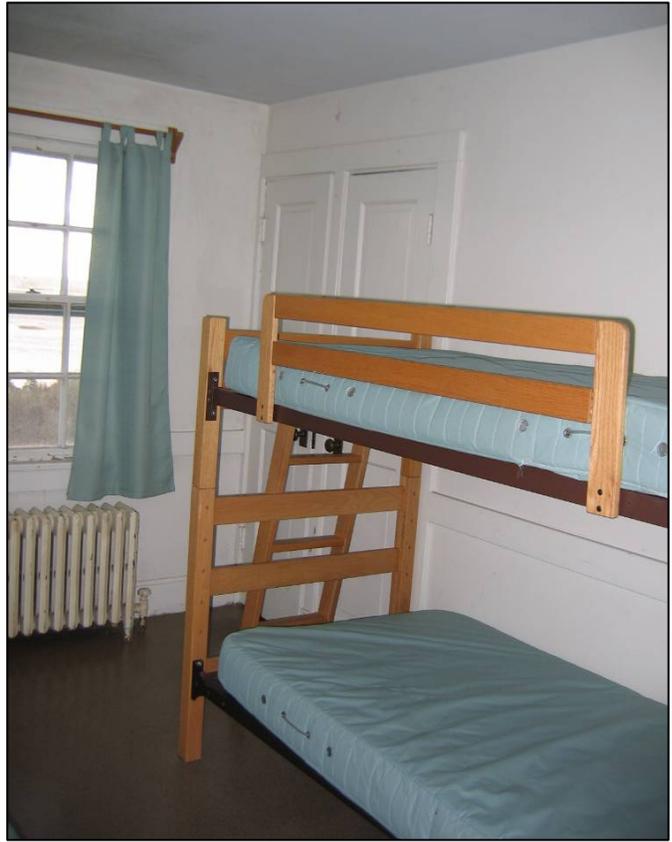
**Figure 4.102.** Room 206 (bedroom 1), closets 206a and 206b.

The typical closet cabinet and shelf are missing from this space. (See Fig. 4.102.)

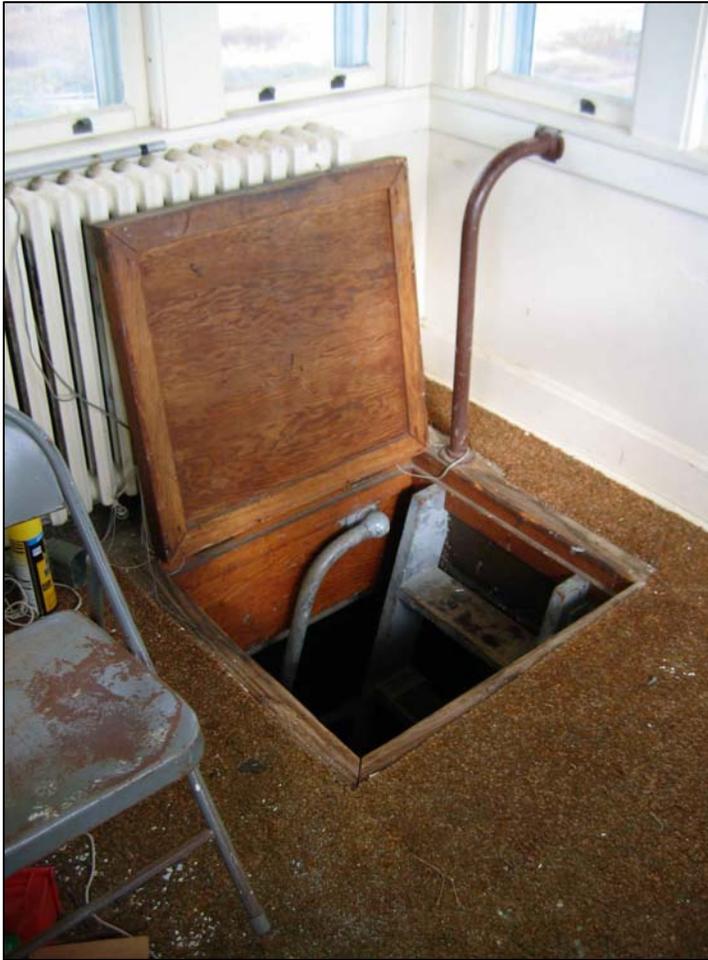
Original linoleum flooring is presently concealed under nonhistoric wall- to- wall carpet. The hinged scuttle doorway in the northeast corner of the room has a steel pipe rail extending from the floor to the east wall. (See Fig. 4.120.)

**Figure 4.120.** Room 401 (watch room), scuttle at northeast corner.

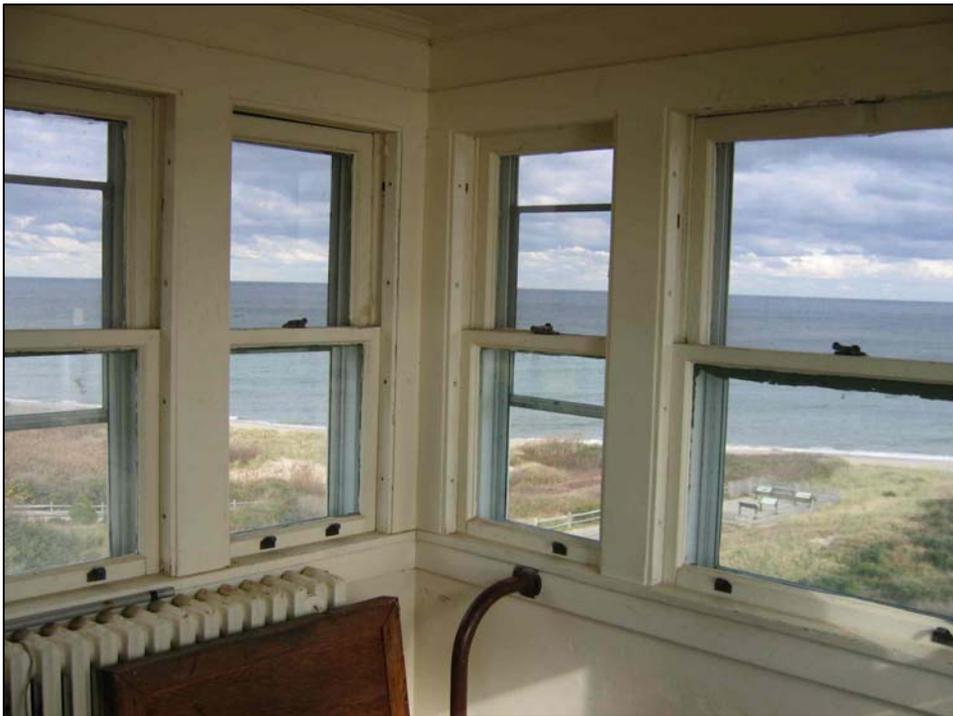
See the discussion “Current Physical Description: Exterior, Building Elevations, Watch Tower.” The chimney projects from the west wall and is plastered. The upper half of the north, south, and east walls are entirely occupied by double- hung windows with one- over- one wood sashes glazed with plate glass. (See Fig. 4.121.)

**Figure 4.121.** Room 401 (watch room), northeast corner.

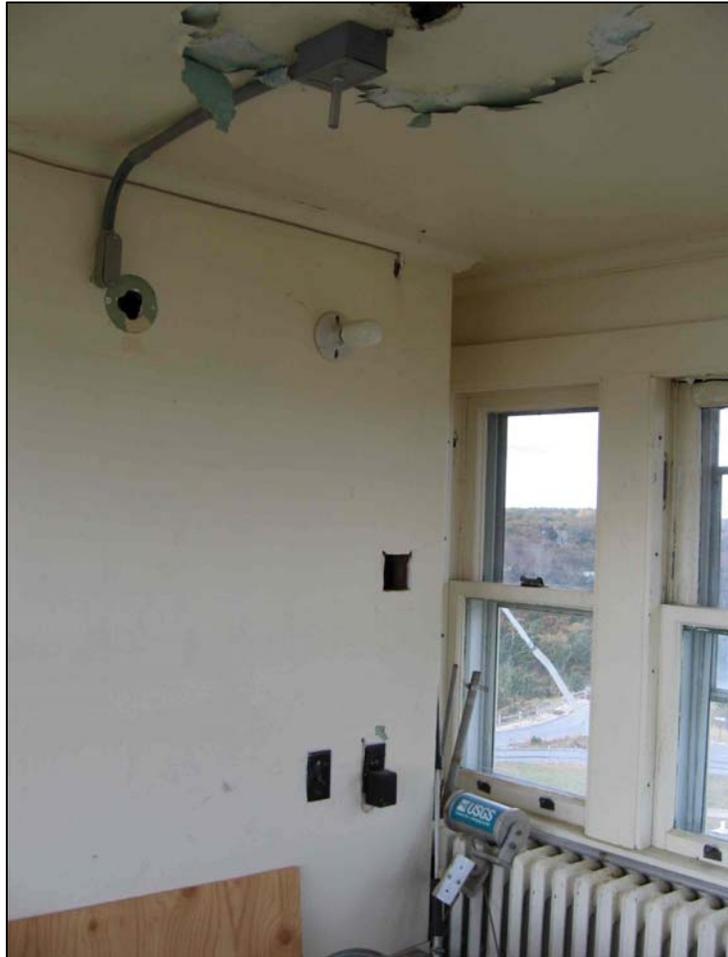
A molded wood cornice encircles the ceiling. The original wind dial on the ceiling is missing; however, the penetration of the center mast through the ceiling and evidence of the original dial is visible through the peeling ceiling paint. A later electrical junction box and rigid conduit runs from the north wall into the area of the dial. (See Fig. 4.122.)

Figure 4.122. Room 401 (watch room), northwest corner.
