# SPERMACETI COVE LIFE-SAVING STATION

Fort Hancock, New Jersey  
Sandy Hook Unit, Gateway National Recreation Area

## **HISTORIC STRUCTURE REPORT**

**James J. Lee III  
Architectural Conservator**

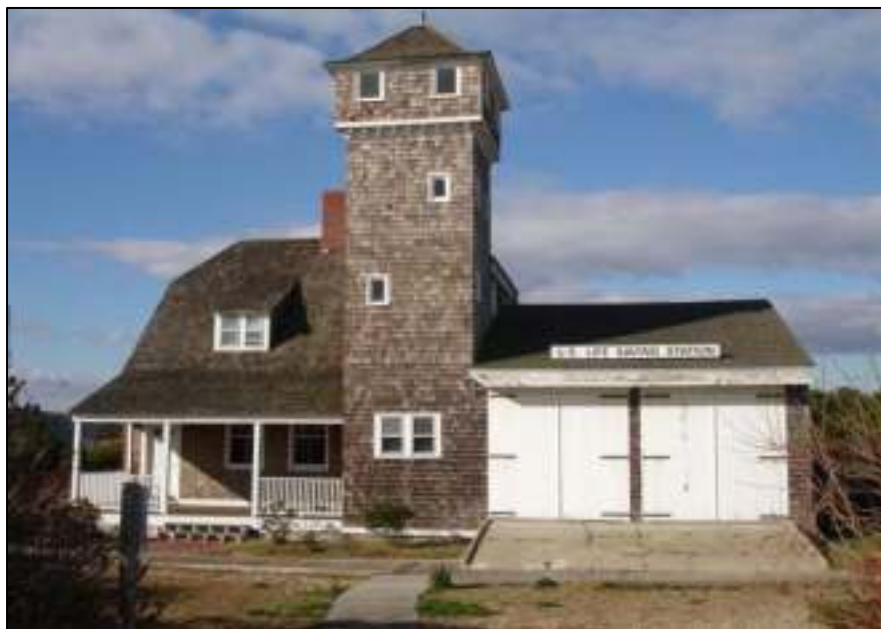
**Figure 3.** Spermaceti Cove Life-Saving Station east elevation.

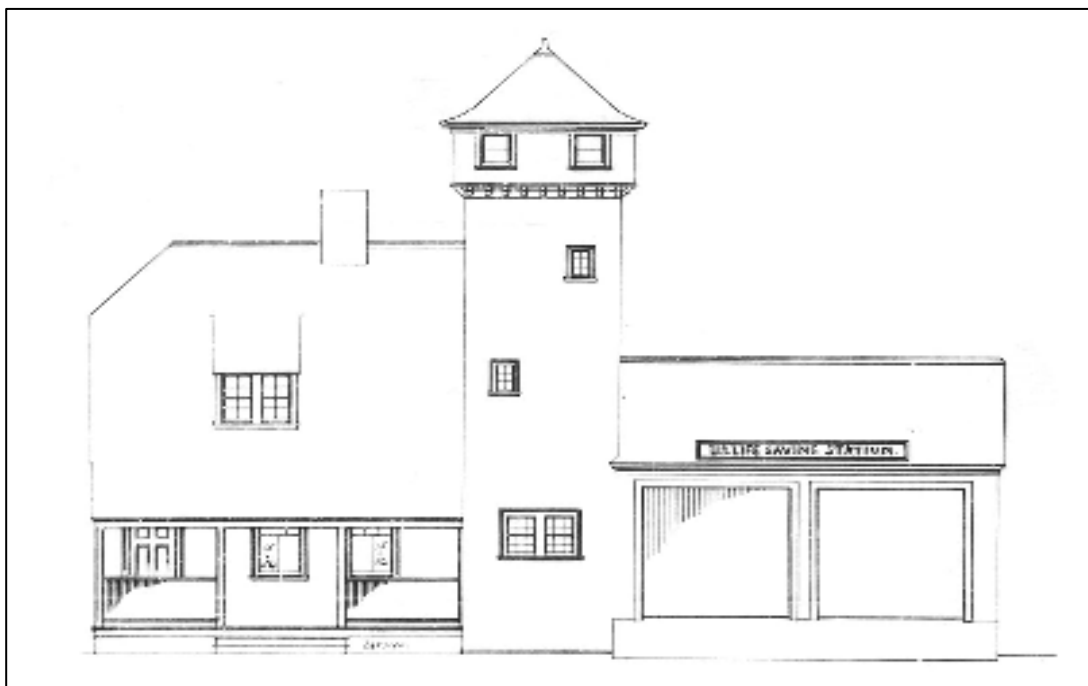
**Figure 9.** Front elevation of the Duluth-type life-saving station, designed by George R. Tolman (not to scale).

George Tolman designed two more station types for the U.S. Life-Saving Service and a one-of-a-kind station in Ashtabula, OH. The Niagara-type station was designed in ca. 1892 but only two such stations were constructed. The Ashtabula Life-Saving Station was designed and built around the same time but was not duplicated. Tolman's next design in 1893 was the Duluth-type station (fig. 9) that became the most prolific of his designs with at least twenty-

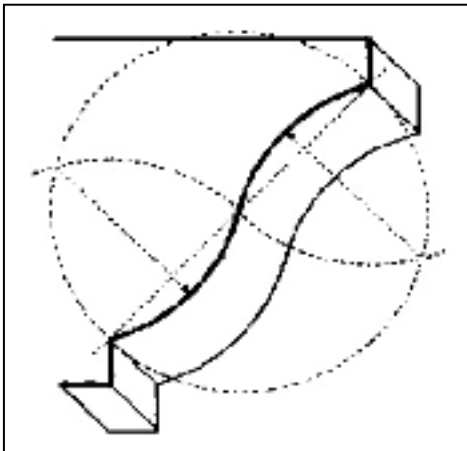
Figure 10. Cyma recta molding profile.

The Duluth-type station shared some characteristics of Tolman's previous designs. The exterior walls and roofs were usually covered with wood shingles and the overall massing was Shingle Style. However, aspects of the Duluth-type station incorporated Colonial Revival-style details that were gaining greater recognition at the time. This was reflected in the use of small paned sashes and a semi-circular window opening with a fanlight sash on the gable end of the Boat Room, as well as the use of cyma recta and cyma reversa trim on the exterior and interior elements (figs. 10 & 11).

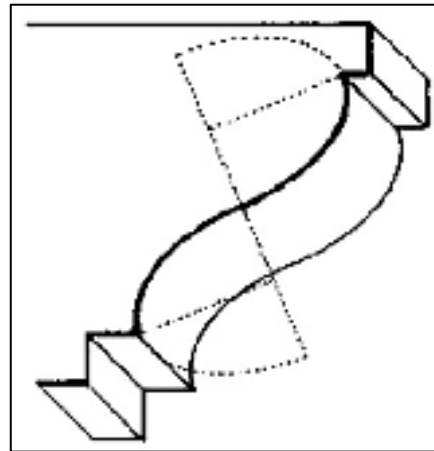
Figure 11. Cyma reversa molding profile.

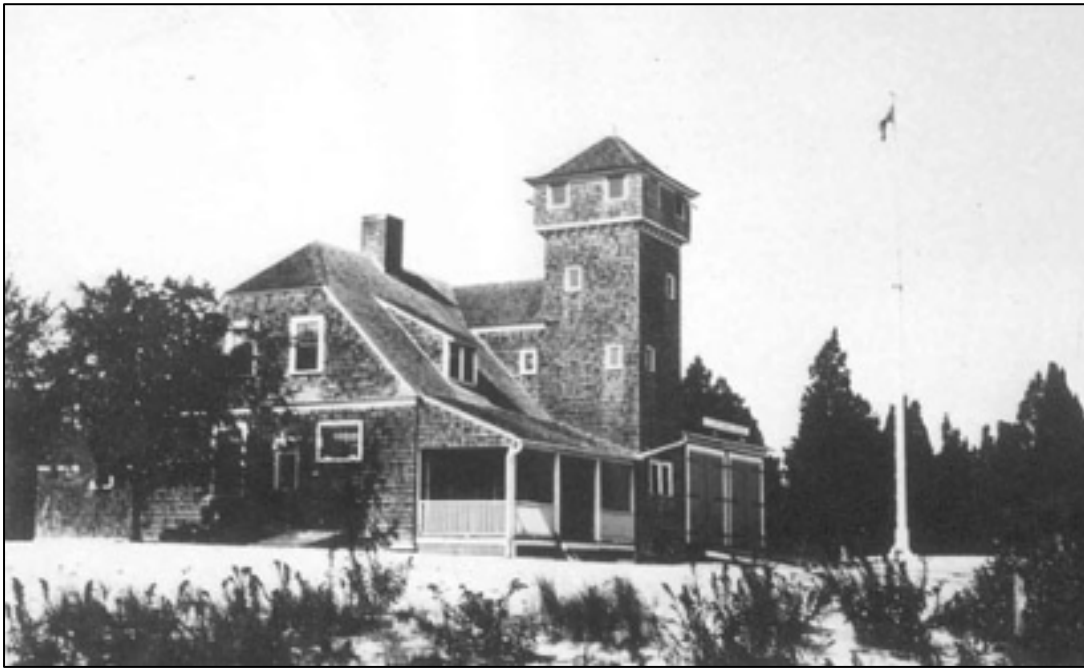
**Figure 13.** 4<sup>th</sup> District, Station No. 2, Spermaceti Cove, Sandy Hook, New Jersey; after 1909 alterations. Note outbuilding to the west of the station.

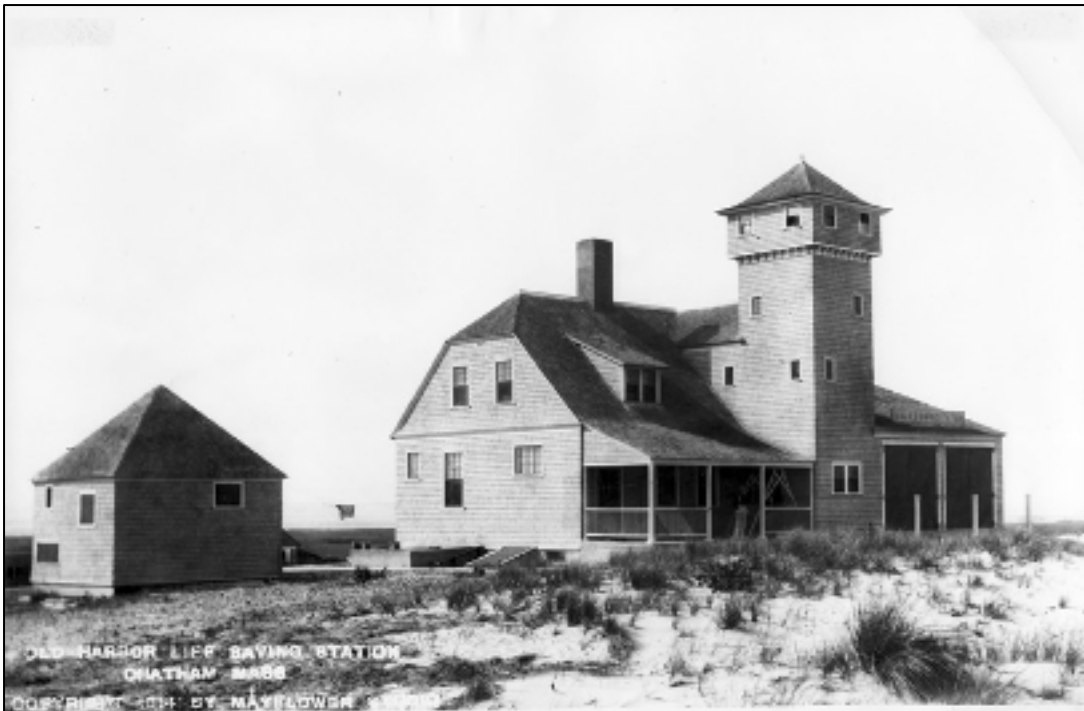
**Figure 14.** Old Harbor Life-Saving Station, Chatham, Massachusetts, depicting Duluth-type station and outbuilding, 1914.

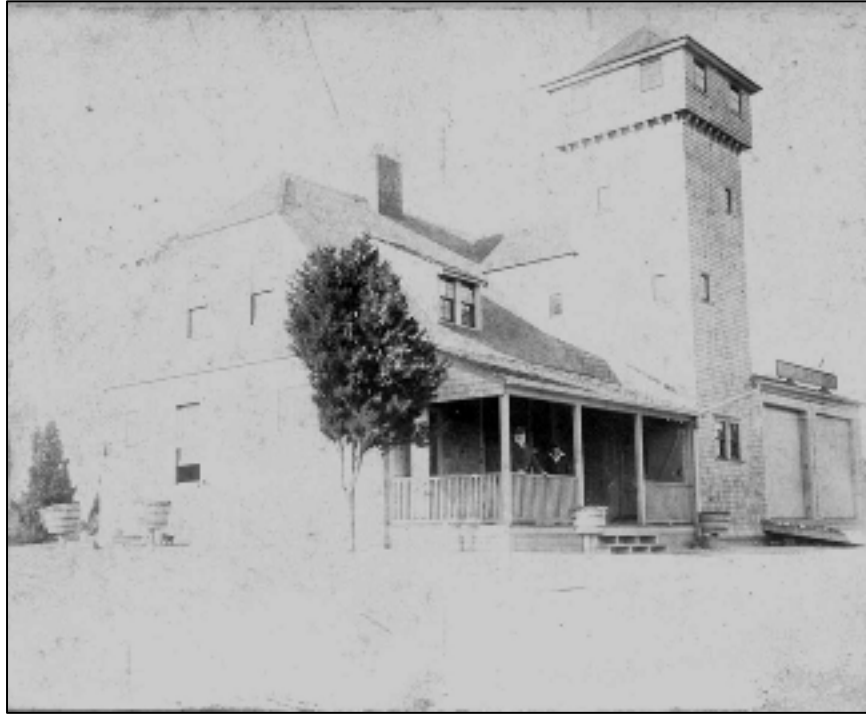
Figure 15. 1894 Spermaceti Cove Life-Saving Station. Earliest known photograph of the station ca. 1900.

The Boat Room was constructed with three wide doorways for access to the beach apparatus carts and surfboats. The drawings of the Duluth-type station depicted the doorways in plan and detail (Appendix A, drawing No. 7). On the west side of the north elevation of the Spermaceti Cove station was a doorway that is not extant; it was approximately 9 feet wide by 7 feet 4 inches high. On the east elevation of the Boat Room were two wide doorways side-by-side that were depicted in the earliest photograph of the 1894 Spermaceti Cove Life-Saving Station but were later altered (fig. 15). Both of those doorways were 9 feet 9 inches wide by 9 feet 7 inches high. All three of the Boat Room doorways were originally equipped with sliding doors “hung with extra heavy ‘The Modern Antifriction Hanger’ with 5-inch wheels, two to each door, hung at the top on a double-bracketed rail.”<sup>49</sup> At the bases of the doorways were “stay rolls” to prevent the door from blowing in. The doorways on the east elevation of the Boat Room were built so that the doors would slide by each other. In order for the north door to slide in front of the south door, the north jamb of the south door was hinged. This permitted a section of the jamb to swing open, allowing the north door to slide completely open. The hinged jamb was depicted in drawing No. 7 of Tolman’s plans and was barely discernable in the earliest photograph of the station (fig. 15).

On the south elevation of the Main Block were different types of window openings. On the first story the southeast window was a wide opening set high on the first story, which opened into the Storm Clothes Room. The window opening had a single awning sash with eighteen lights (figs. 15 & 17). The next window opening on the first story (W107) had double-hung sashes with twelve-over-two lights. A smaller window opening was built for the Pantry. It contained a single casement sash that was hinged on the side and had nine lights. The second story of the south elevation had two window openings with double-hung, twelve-over-two sashes that opened into the crew's quarters.

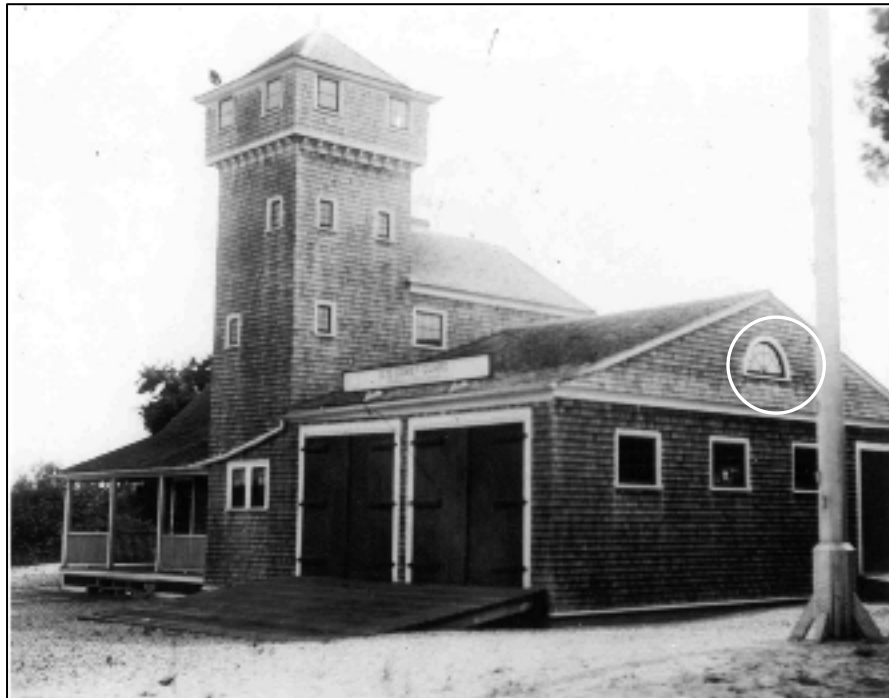
**Figure 16.** 1894 Spermaceti Cove Life-Saving Station, east and north elevations, circa 1916, depicting historic window openings including north elevation fanlight sash (circled). This photograph also depicts some post-1909 alterations to the station.

The north elevation of the Boat Room had three similar window openings with awning sashes on the first story and a half-round opening in the gable that contained a fanlight sash. The fan light sash was depicted in the plans and one historic photograph (fig. 16). It was divided into pie-shaped quarters that radiated from the center of the sash's base. Each quarter had four lights for a total of sixteen lights in the fan sash.

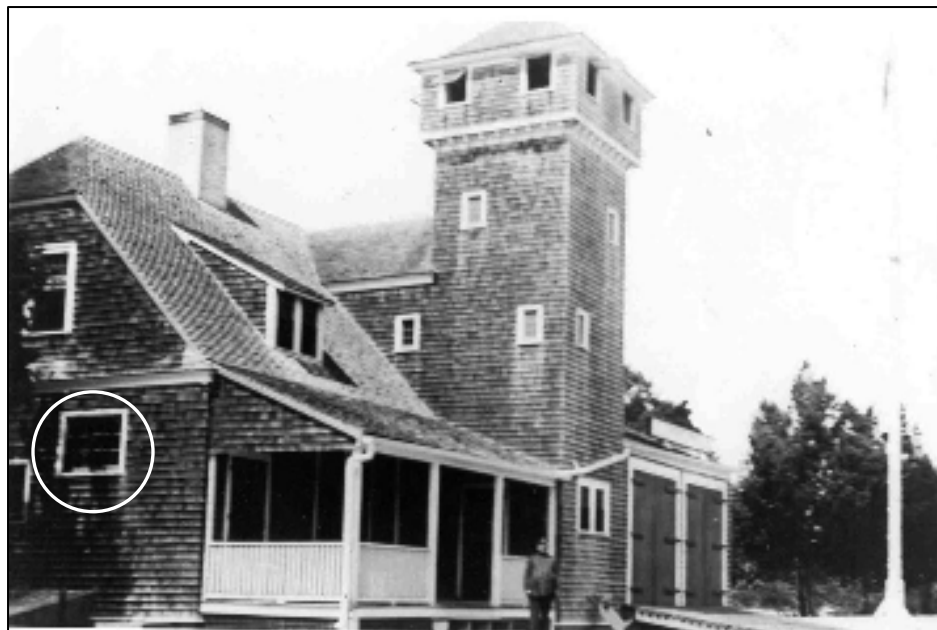
**Figure 17.** 1894 Spermaceti Cove Life-Saving Station, east and south elevations, circa 1916 depicting historic window openings including south elevation awning sash (circled). This photograph also depicts some post-1909 alterations to the station.

The 1894 Spermaceti Cove Life-Saving Station was constructed with two porches, which were labeled as piazzas in the Duluth-type plans by George Tolman. The front porch was on the east elevation of the Main Block and faced the ocean (fig. 17). From the porch there was access to the station through D101 on the south side of the Tower and D102, which lead into the Storm Clothes Room. The back entry porch was located on the west elevation and provided access to the back hallway through D103. Historic plans and photographs, as well as extant building evidence suggest that the porches were constructed in the same manner and with similar materials. The plans for the Duluth-type station included a section drawing of the porches for general reference (Appendix A, drawing No. 6).

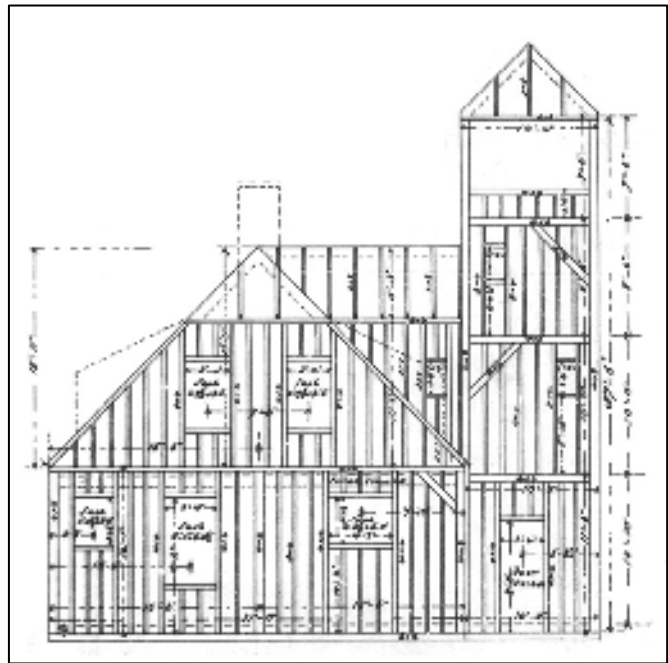
**Figure 19.** Duluth-type life-saving station, south elevation framing of Main Block and Tower.

Like the other sections of the station, the Tower was framed with 4-inch by 8-inch corner posts and 4-inch by 6-inch girts at each level, braced by 4-inch by 6-inch supports. The plans for the Duluth-type station depicted each corner post as 37-foot 6-inches long (fig. 19). The specifications noted that “long timbers (were) to be halved, lapped, and bolted, not more than two equal lengths to a piece,” which made up the Tower’s corner posts. As with the Main Block, the floors at each story of the Tower were framed with 3-inch by 10-inch joists with 2-inch by 10-inch joists spiked to the girts. The staircase opening at the second story was framed with a 4-inch by 10-inch joist to carry the load of the staircase. The trap doorway from the third to the fourth story was built in the center of the floor and was framed with 3-inch by 10-inch joists. The exterior walls of the Tower were generally framed with 3-inch by 10-inch studs. The first story entry doorway (D101) and double window opening (W101) were framed with 4-inch by 10-inch studs, sills and headers. The smaller window openings at the second and third stories were framed with 3-inch by 10-inch lumber.

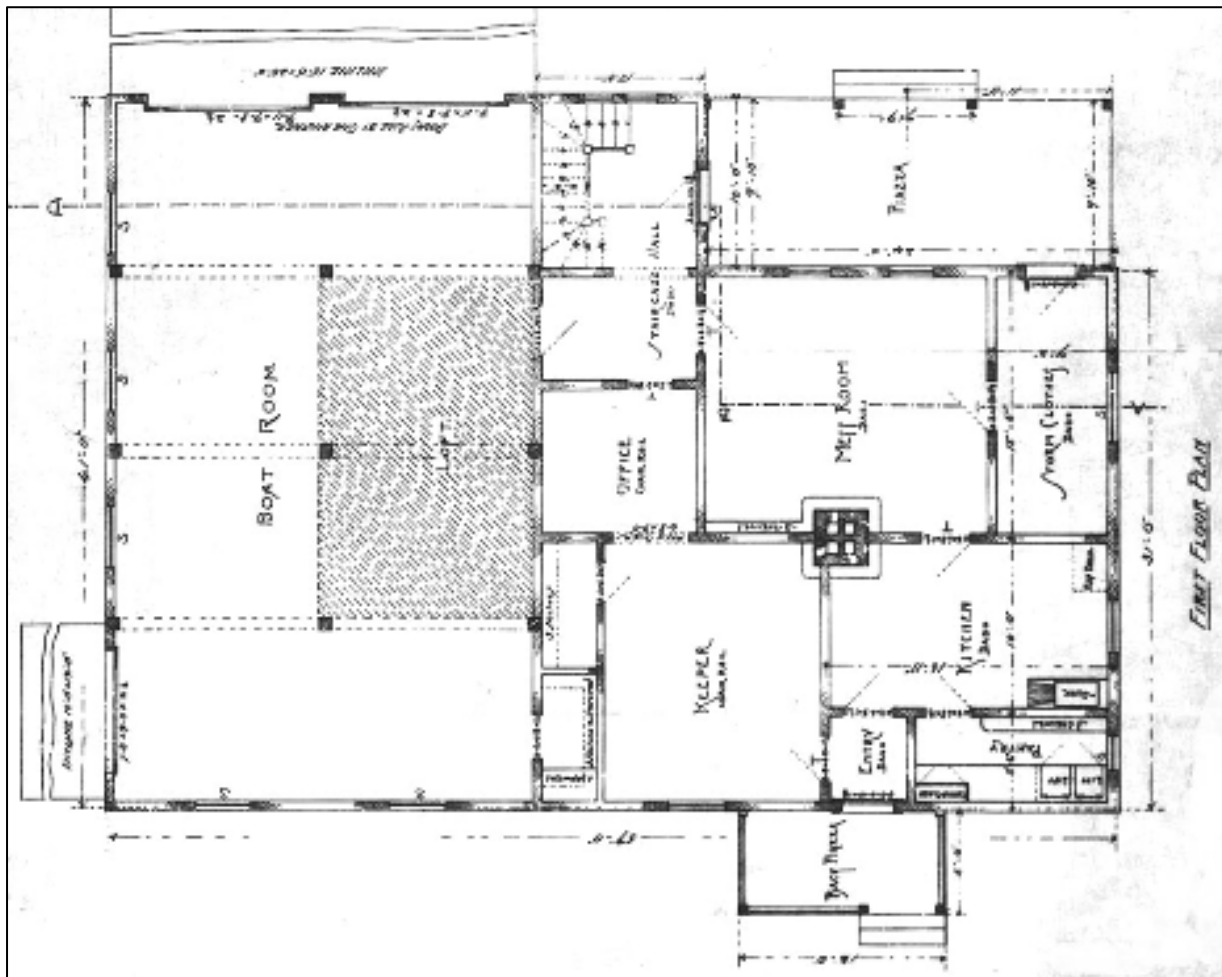
Figure 20. Duluth-type life-saving station first story plan copied from drawing No. 1.

The three sections of the 1894 Spermaceti Cove Life-Saving Station were not only different on the exterior of the building but served distinct purposes on the interior of the station. The Main Block served as the Keeper and Crews Quarters, Office, Kitchen, Pantry, Mess, and Storm Clothes Rooms; the Boat Room housed the surf boats, boat carts, beach carts and other life-saving apparatus; and the Tower held the staircase and the Watch Room where the surfmen would keep their vigil. George R. Tolman's plans for the Duluth-type station illustrated the floor plans in drawing No. 1 (fig. 20) and details of the interior elements in drawing No. 6 (Appendix A).

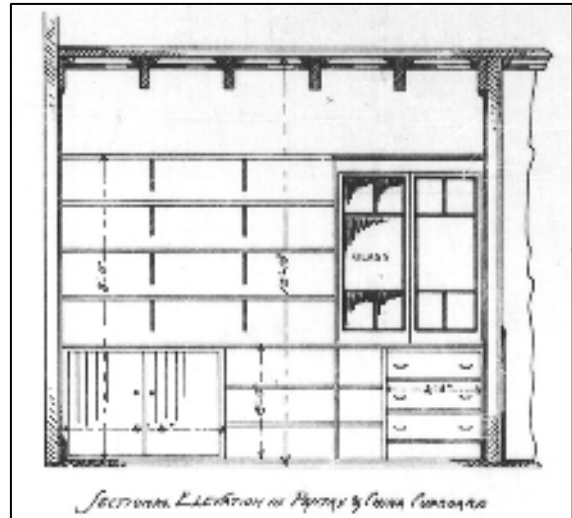
Figure 21. Detail drawing of Pantry china cupboard.

As noted in the specifications, the plans of the Duluth-type station did include a detail drawing of the china cupboard (fig. 21). These elements were not extant at Spermaceti Cove but were found at Old Harbor.<sup>58</sup> There is no doubt that the Pantry was fitted with some type of shelving and cupboards. Since the rest of the station was true to the specifications and plans it seems likely that the Pantry would have included the specified built-in elements.

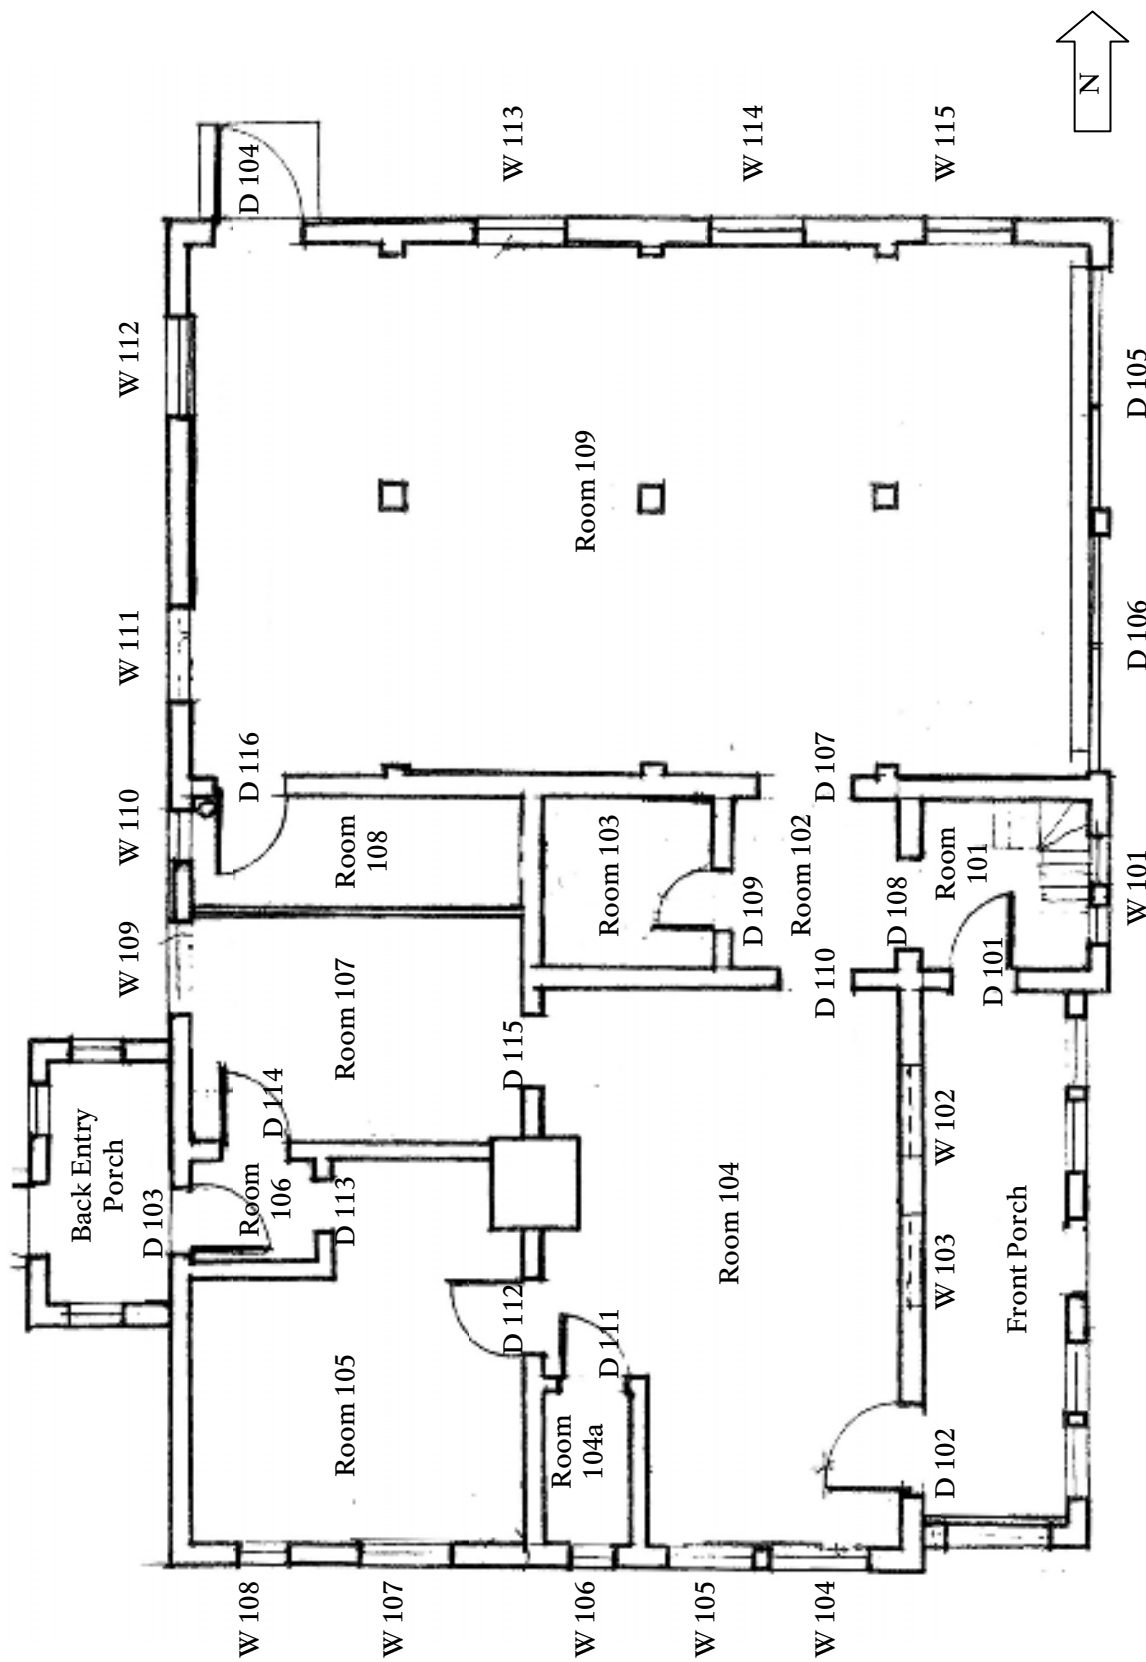
Figure 22. 1894 Spermaceti Cove Life-Saving Station, first story plan with room, doorway, and window opening numbers.

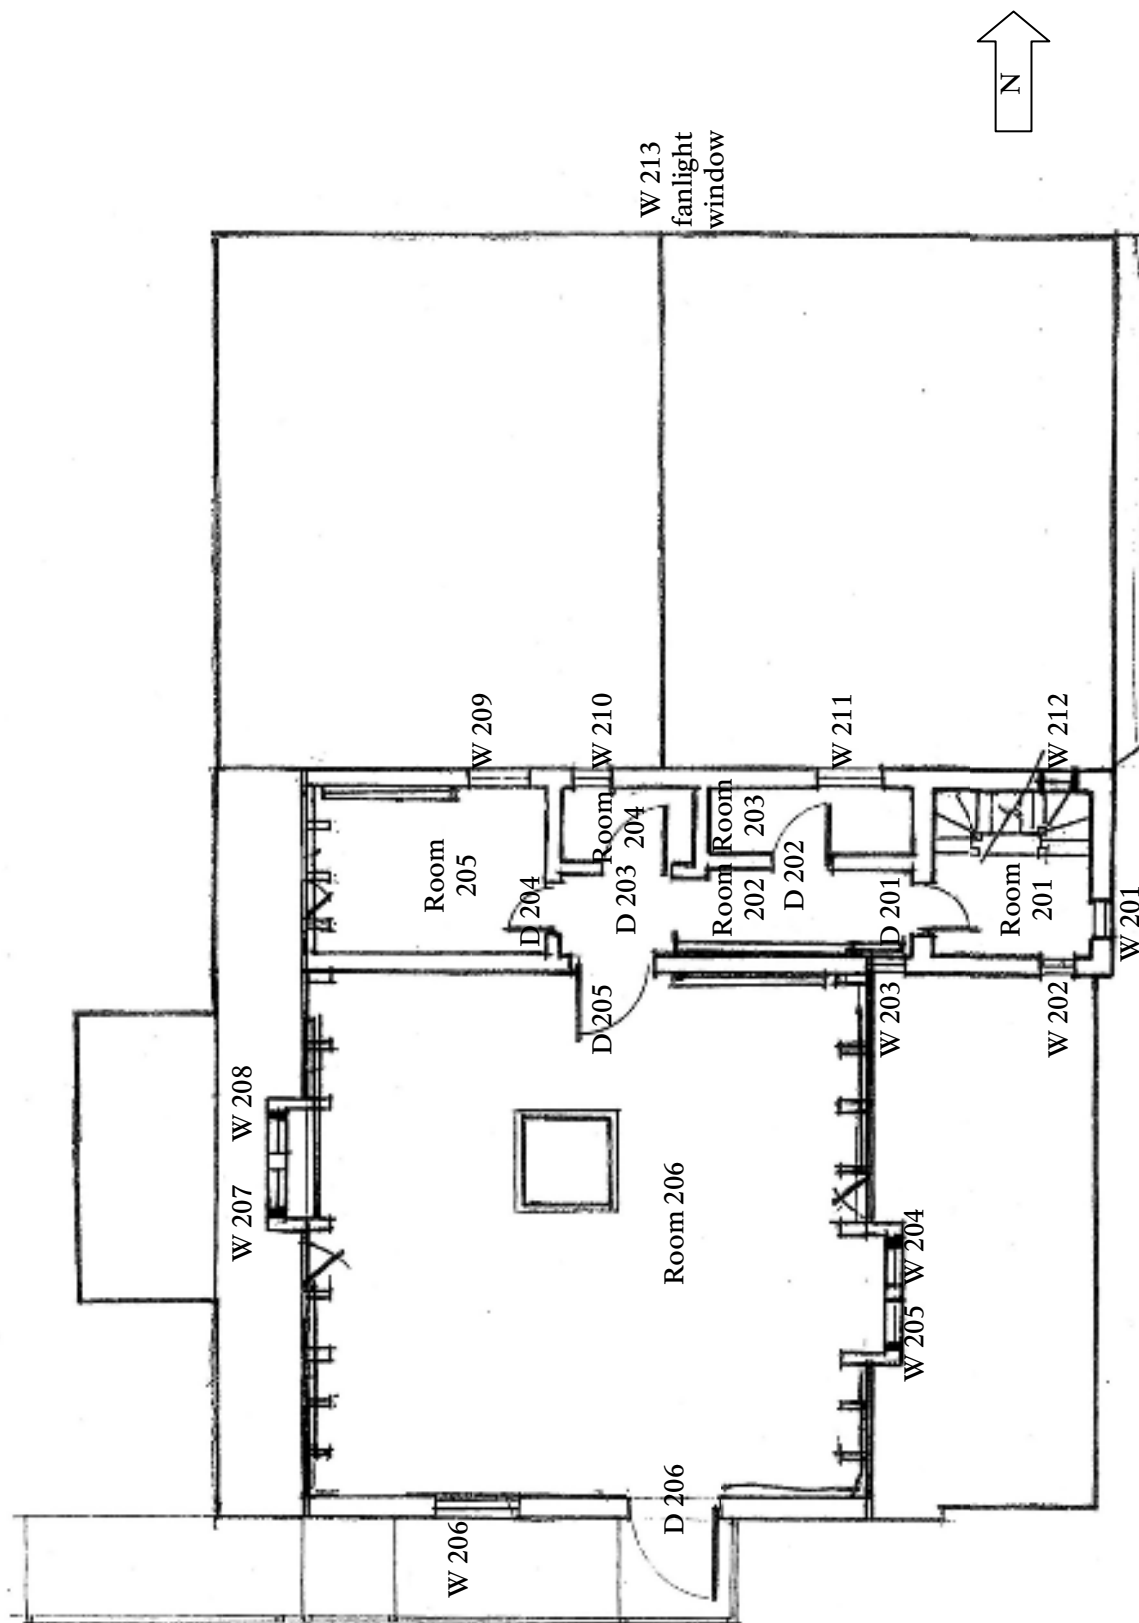
Figure 23. 1894 Spermaceti Cove Life-Saving Station, second story plan with room, doorway, and window opening numbers.

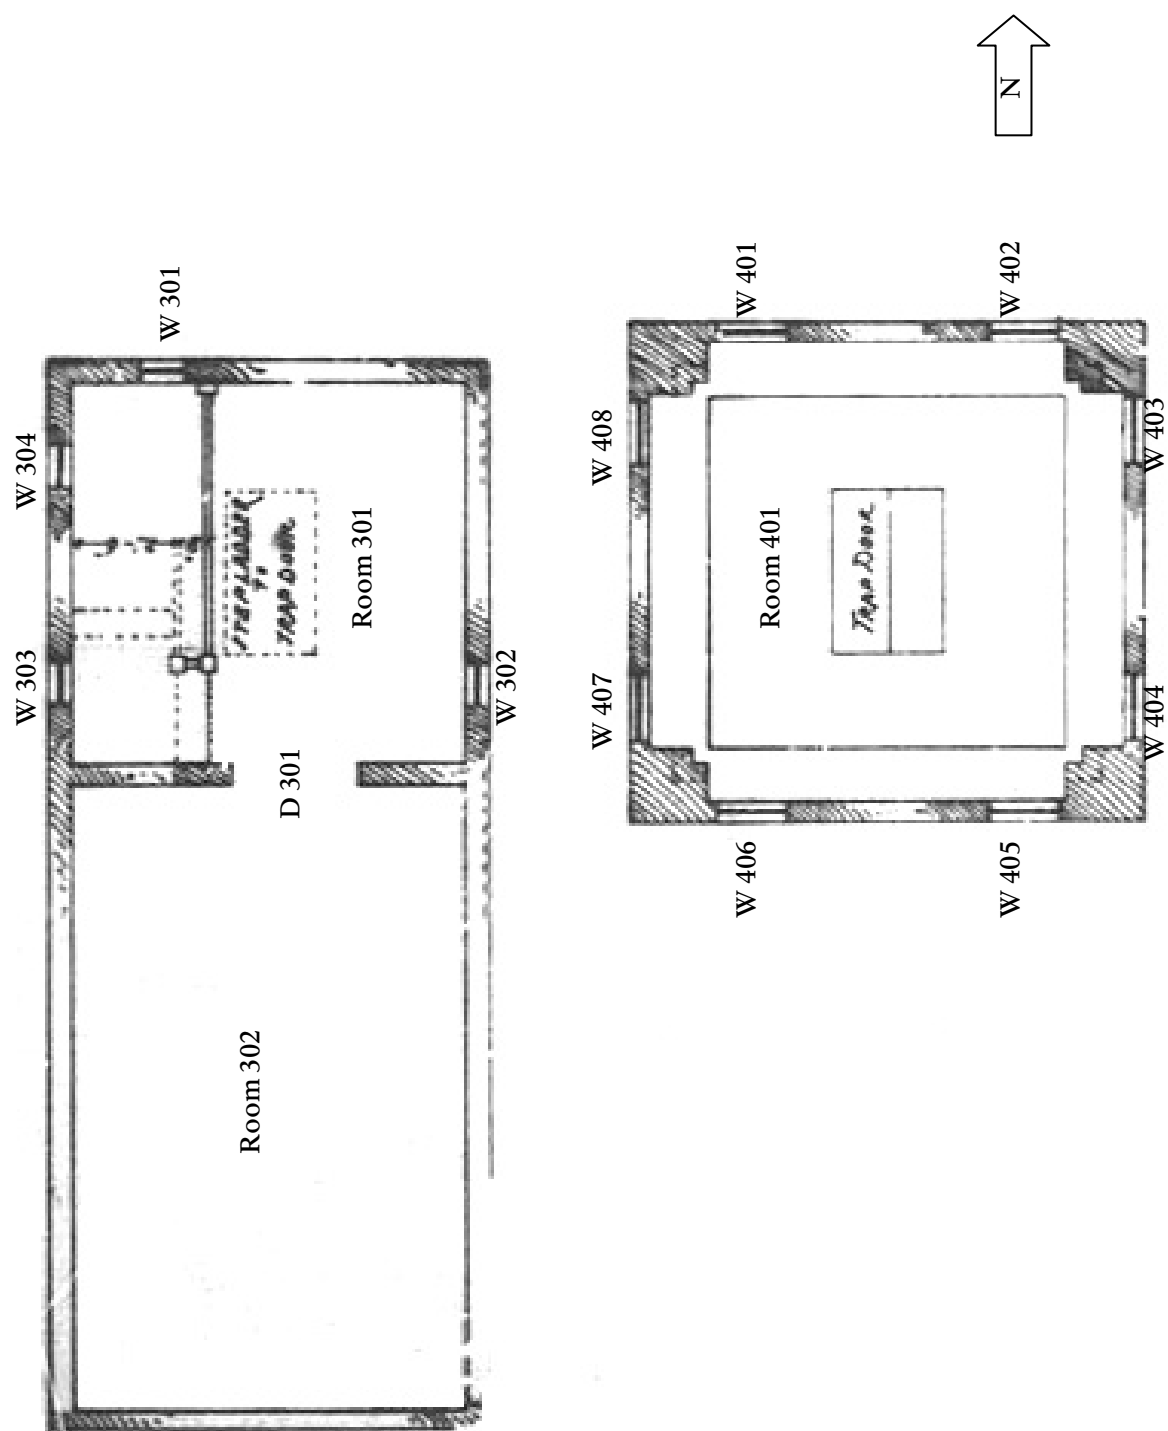
Figure 24. 1894 Spermaceti Cove Life-Saving Station, third and fourth story plans with room, doorway, and window opening numbers.

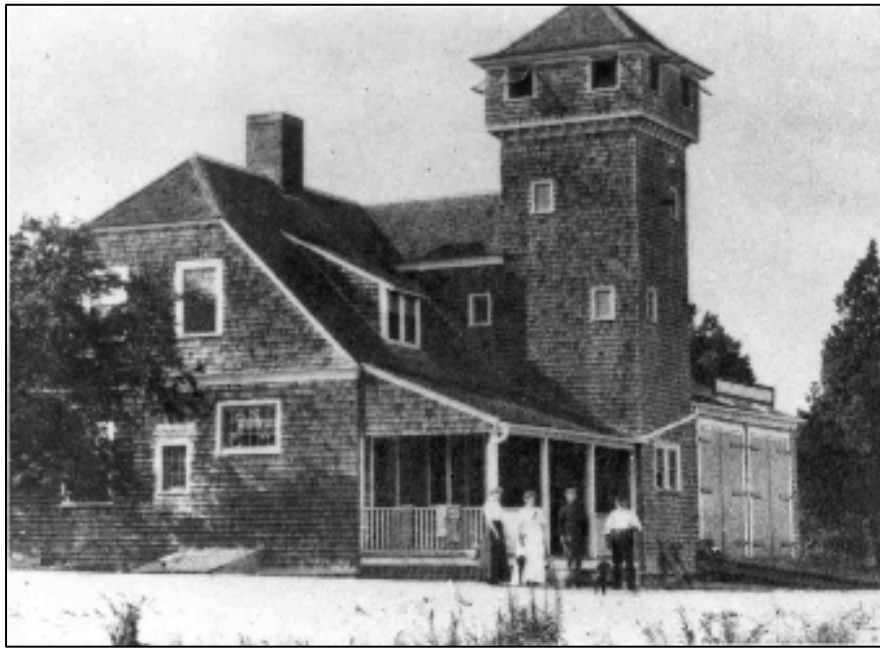
Figure 25. 1894 Spermaceti Cove Life-Saving Station circa 1910 after the basement was added and the Boat Room doors were altered.

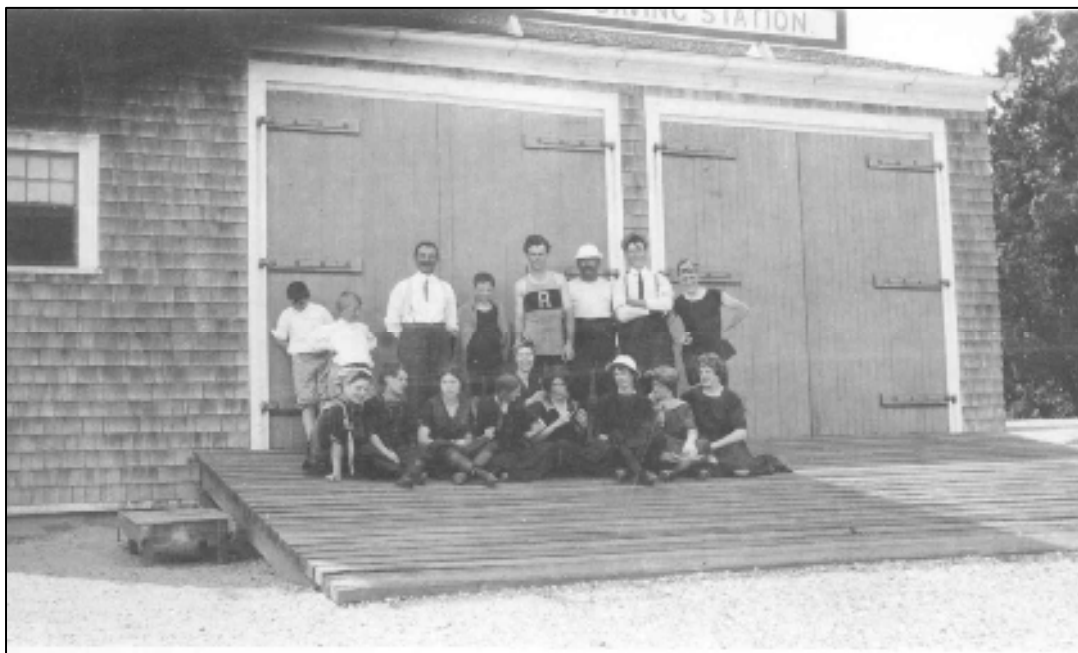
**Figure 27.** Spermaceti Cove Life-Saving Station, Capt. Joel Wolley and crew circa 1912, depicting east elevation post-1909 alterations to the Boat Room doorways.

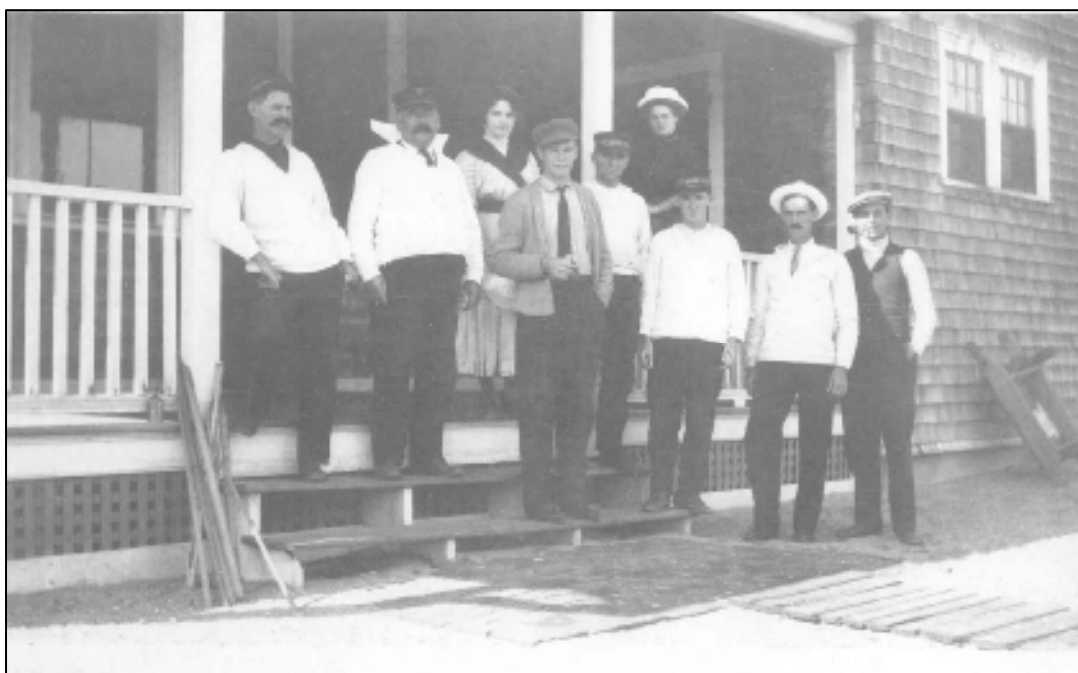
**Figure 28.** Spermaceti Cove Life-Saving Station, Capt. Joel Wolley (second from right) and crew circa 1912, depicting east elevation and historic porch elements.

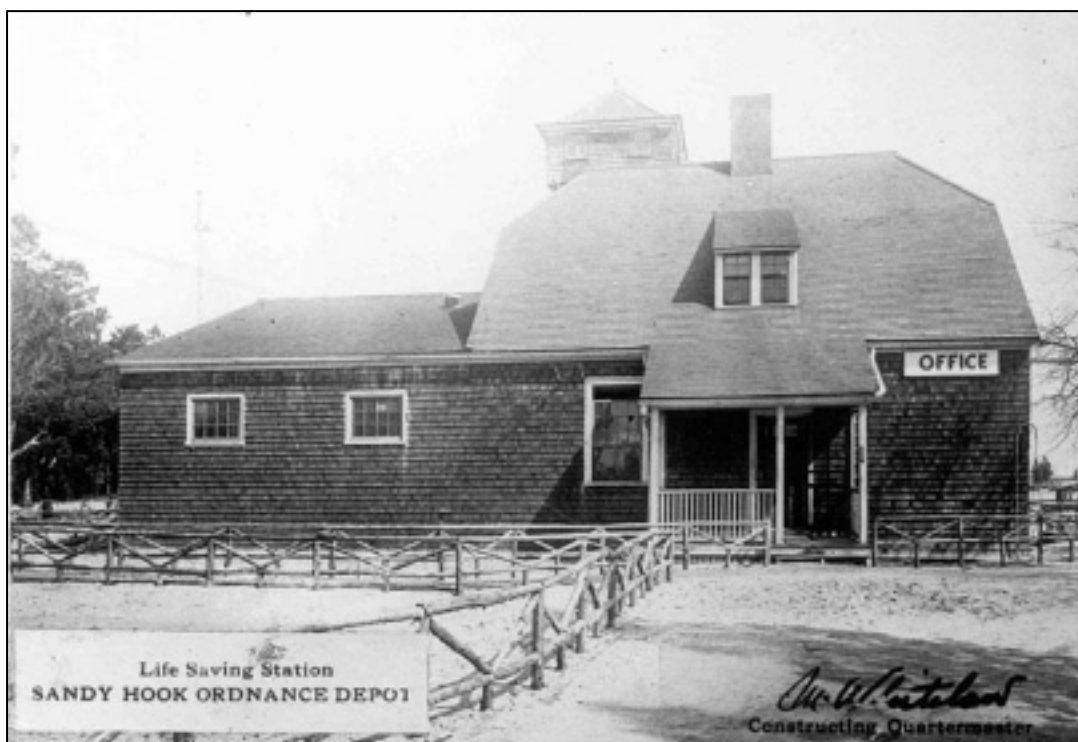
**Figure 29.** Spermaceti Cove Life-Saving Station, during use by U.S. Ordnance Dept. circa 1918, depicting west elevation.

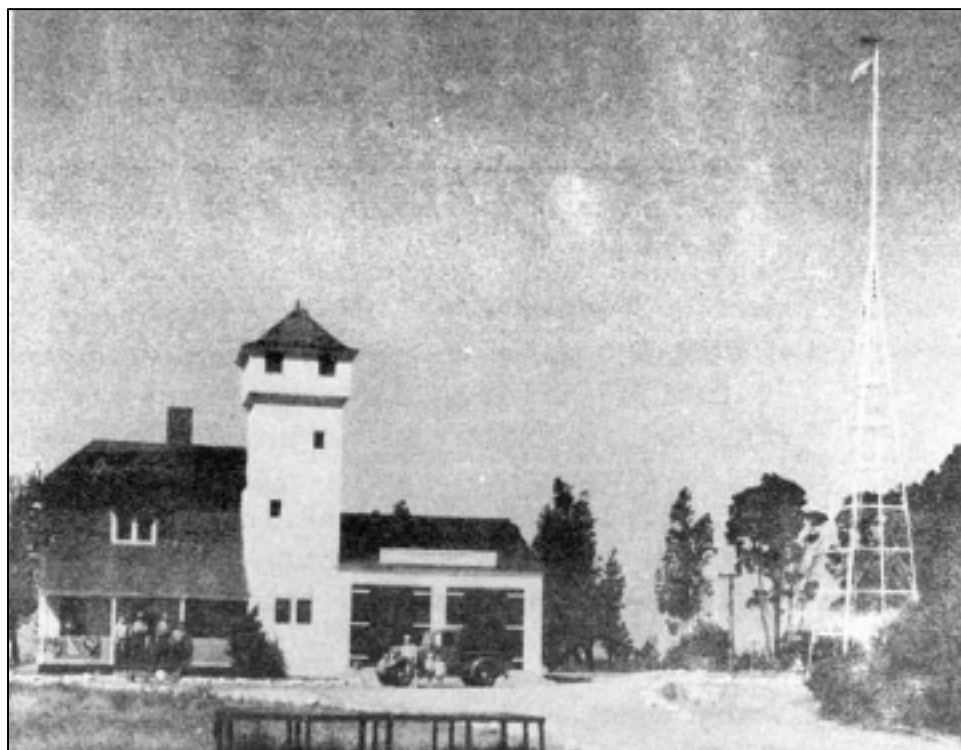
**Figure 30.** Spermaceti Cove Life-Saving Station, circa 1930, depicting east elevation exterior paint and steel tower north of station.

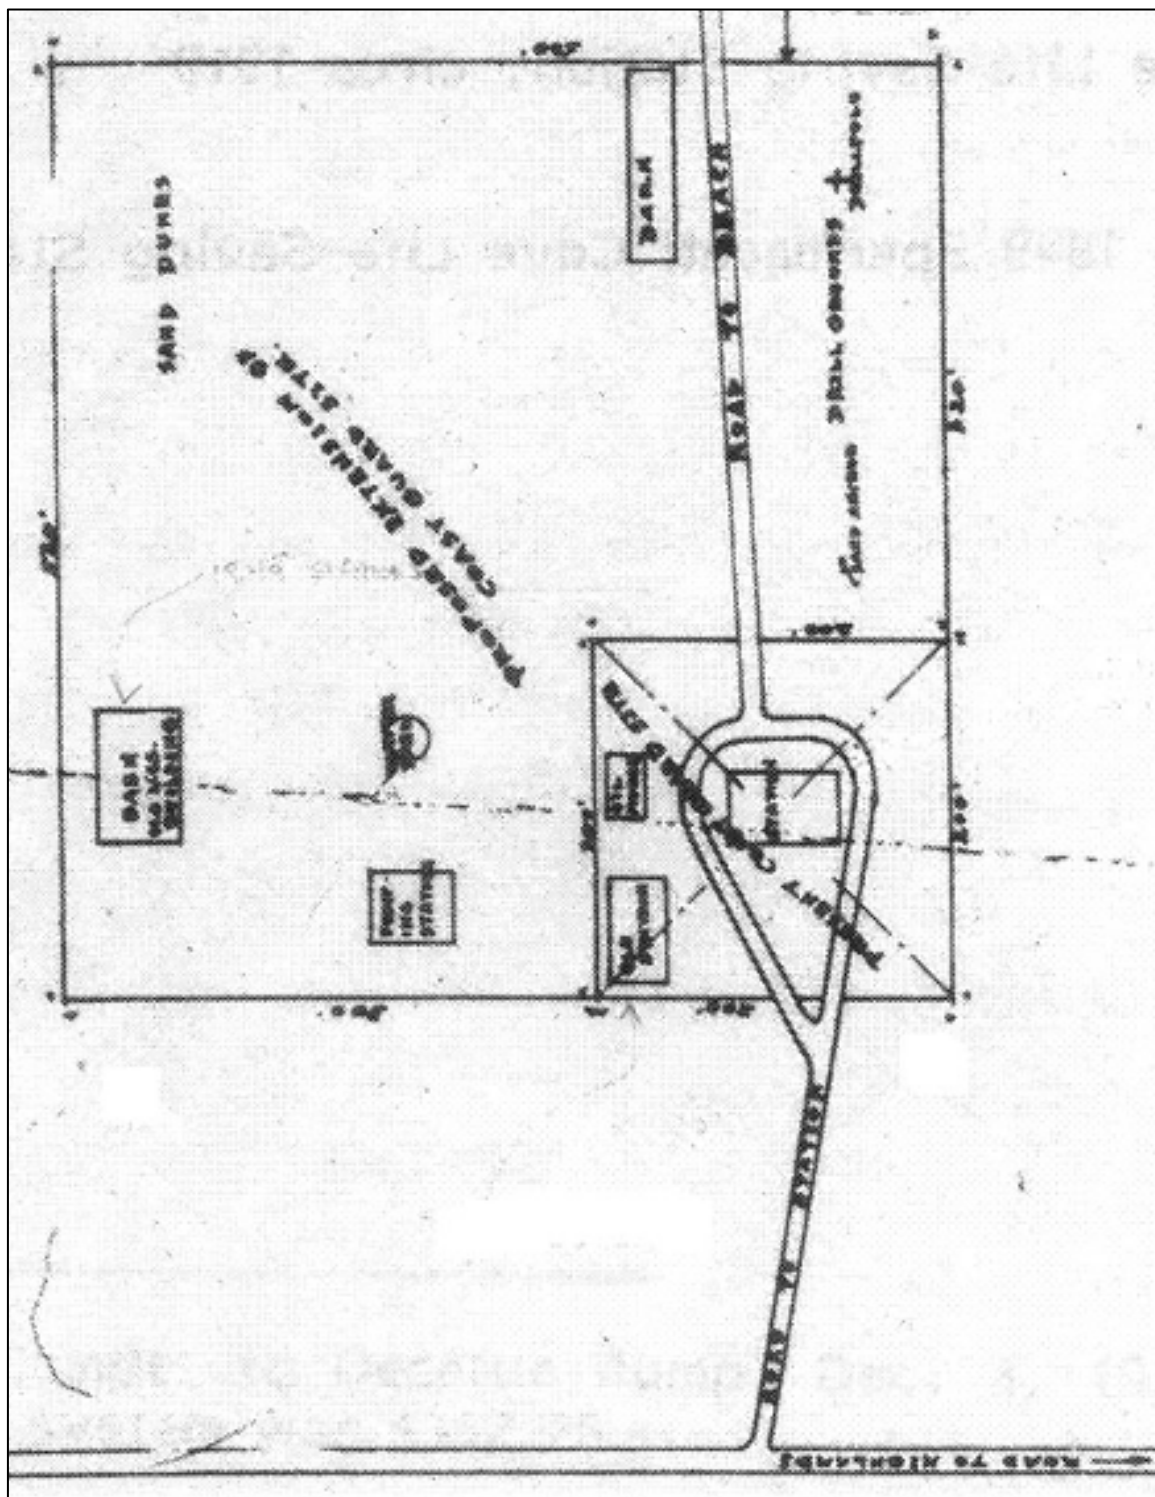
Figure 31. Plot plan of Spermaceti Cove, after 1920, depicting 500 by 520 foot lot and adjacent out buildings including the 1849 station northwest of the 1894 station (within the earlier 200 sq. ft. lot).

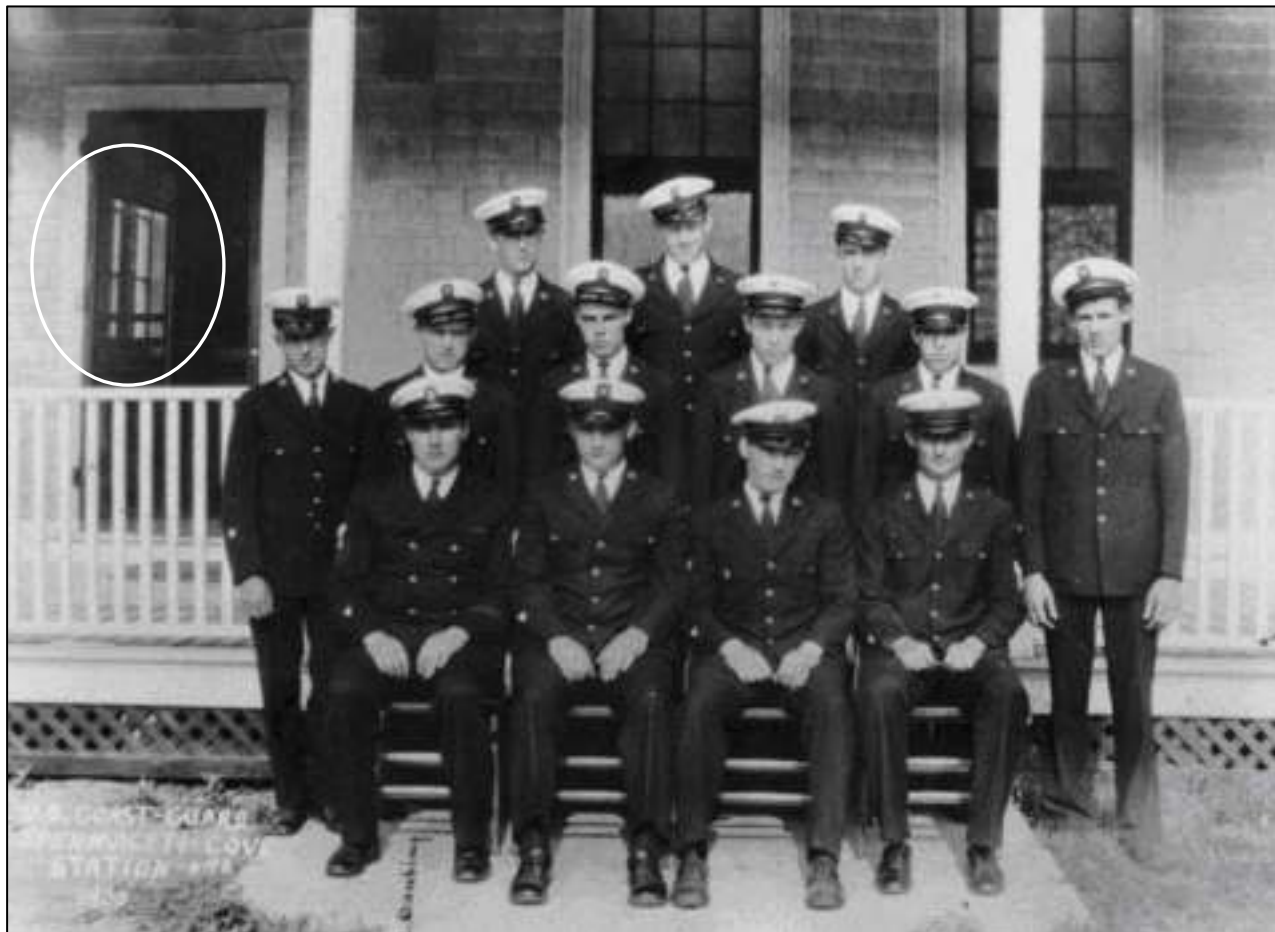
**Figure 32.** U.S. Coast Guard, Spermaceti Cove Station, 1930, depicting east elevation porch and interior window openings in Storm Clothes Room circled in the background.

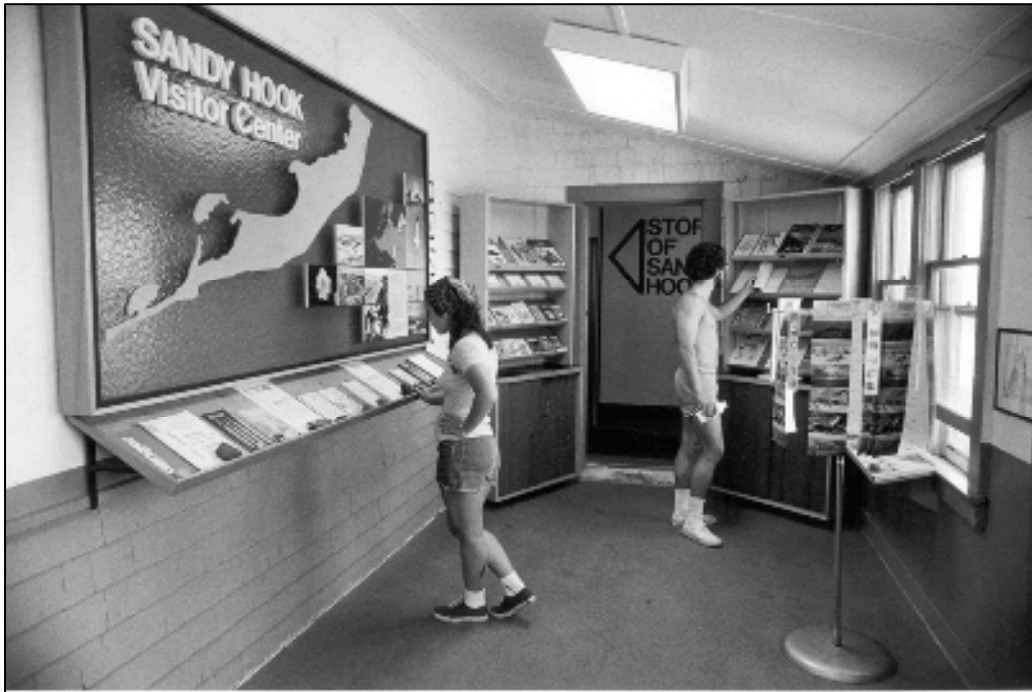
**Figure 34.** Spermaceti Cove Life-Saving Station, circa 1976, depicting interior of front porch after conversion to Sandy Hook Visitor Center.

December 16, 1992 (approved)	The project removed the homosote building board that was used to cover two original window openings (W102 and W103). The covers were removed and the existing aluminum sashes were replaced with double hung, nine-over-two sashes that were replicas of the original sashes. The project included removing masonite attached to the interior wall of the exhibit room (Room 104) and rehabilitating that wall.	Section 106 Assessment of Effect on Cultural Resources, compliance tracking # 92-1775-009 (fig. 34).
