# SPERMACETI COVE LIFE-SAVING STATION

Fort Hancock, New Jersey  
Sandy Hook Unit, Gateway National Recreation Area

## **HISTORIC STRUCTURE REPORT**

**James J. Lee III  
Architectural Conservator**

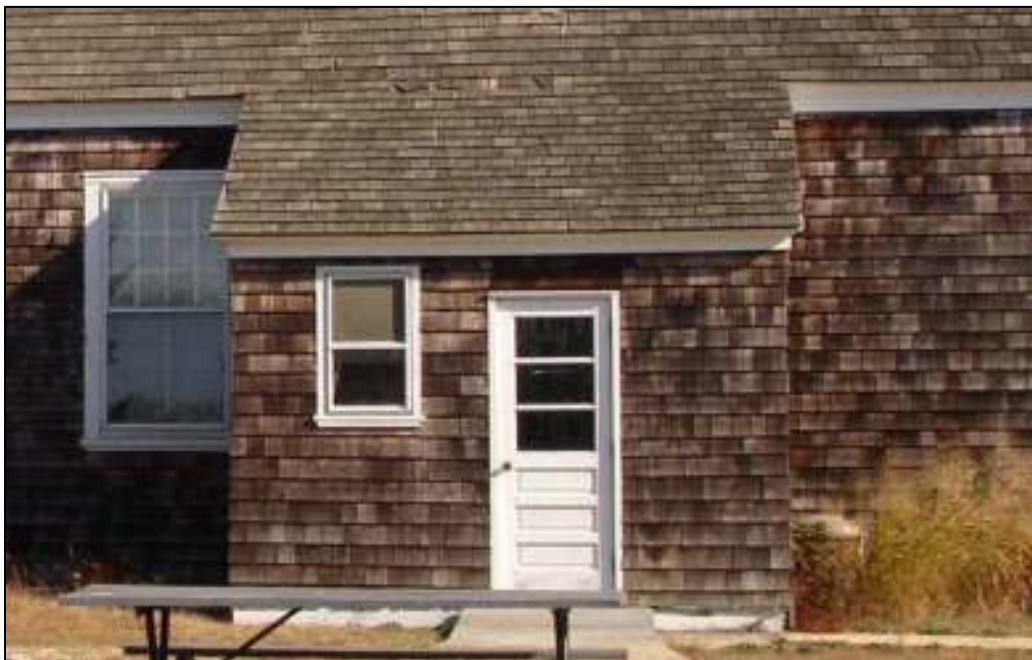
**Figure 35.** Spermaceti Cove Life-Saving Station, depicting west elevation exterior of enclosed back porch.

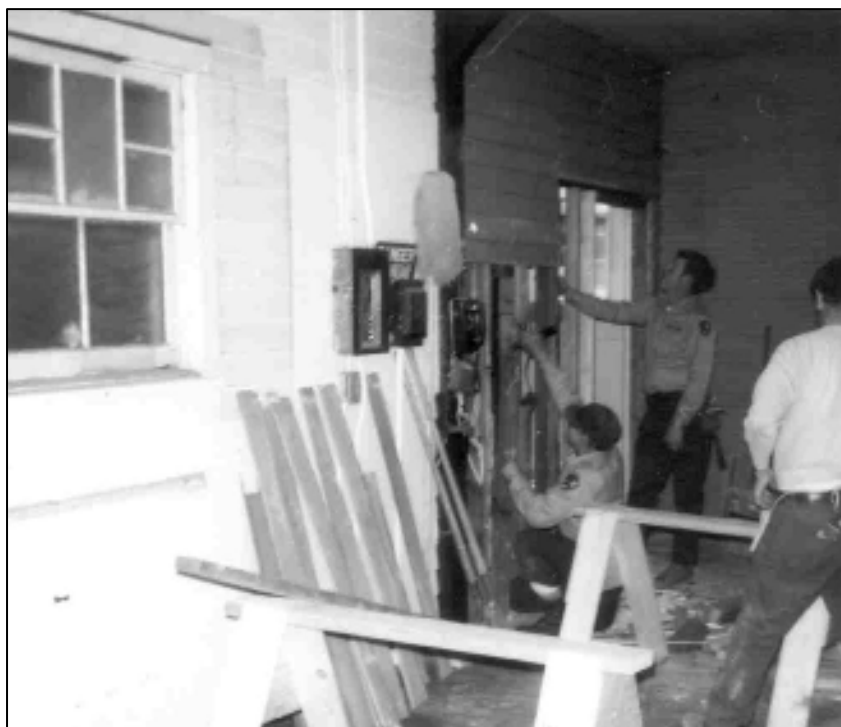
**Figure 36.** Spermaceti Cove Life-Saving Station, Feb/March 1975, depicting interior of Boat Room during rehabilitation looking west; note the window opening from the Keeper's Office into the Boat

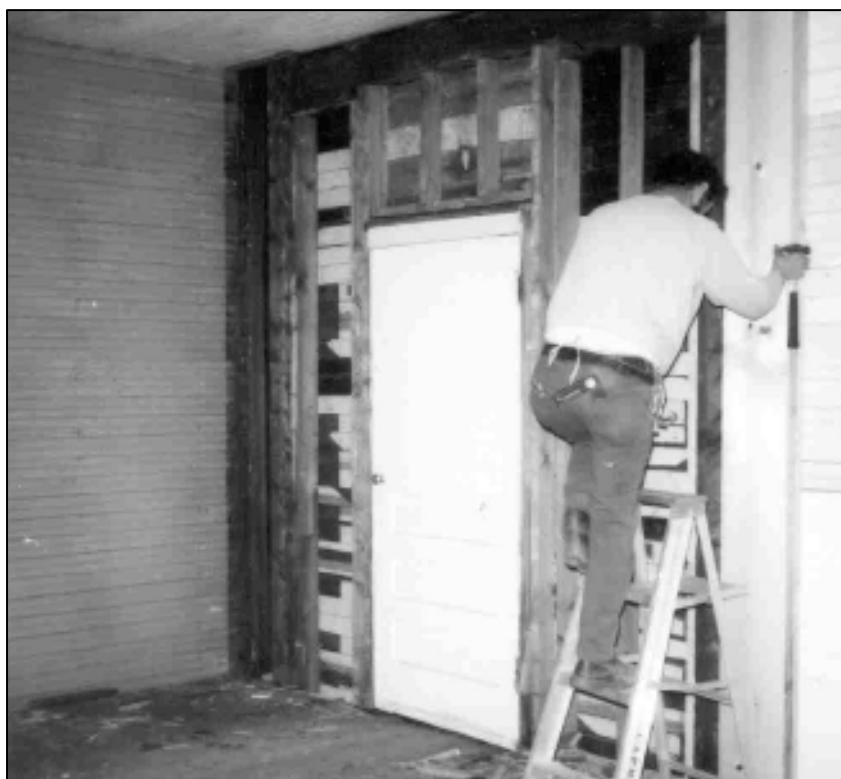
**Figure 37.** Spermaceti Cove Life-Saving Station, Feb/March 1975 depicting interior of Boat Room north wall enclosing wide doorway.

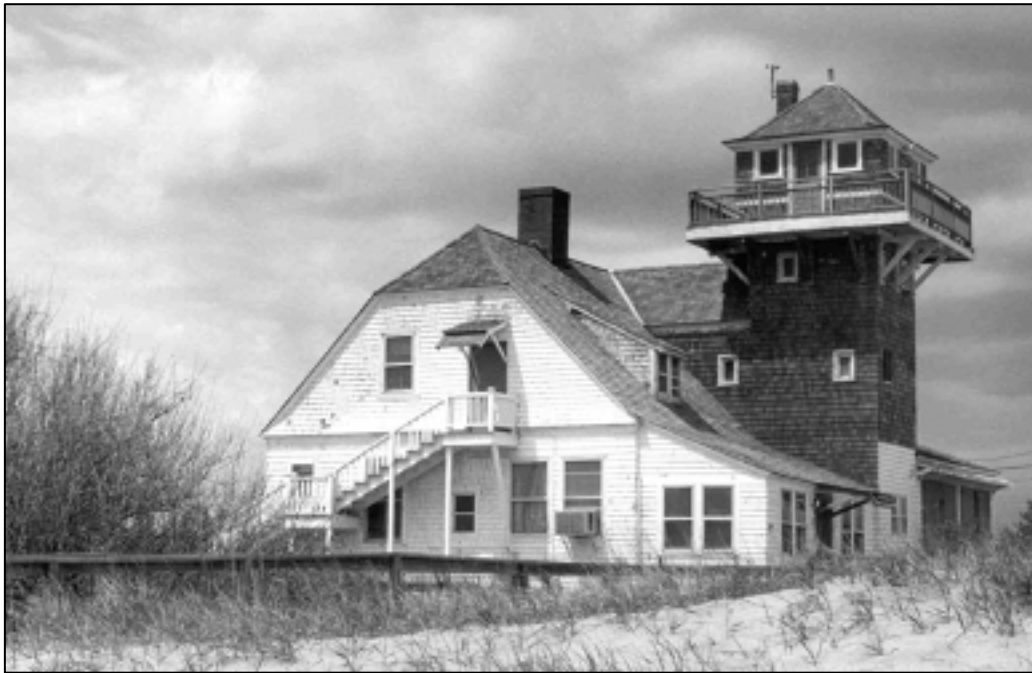
**Figure 38.** Spermaceti Cove Life-Saving Station, circa 1976, south and east elevations after re-shingling of Tower and roofs.

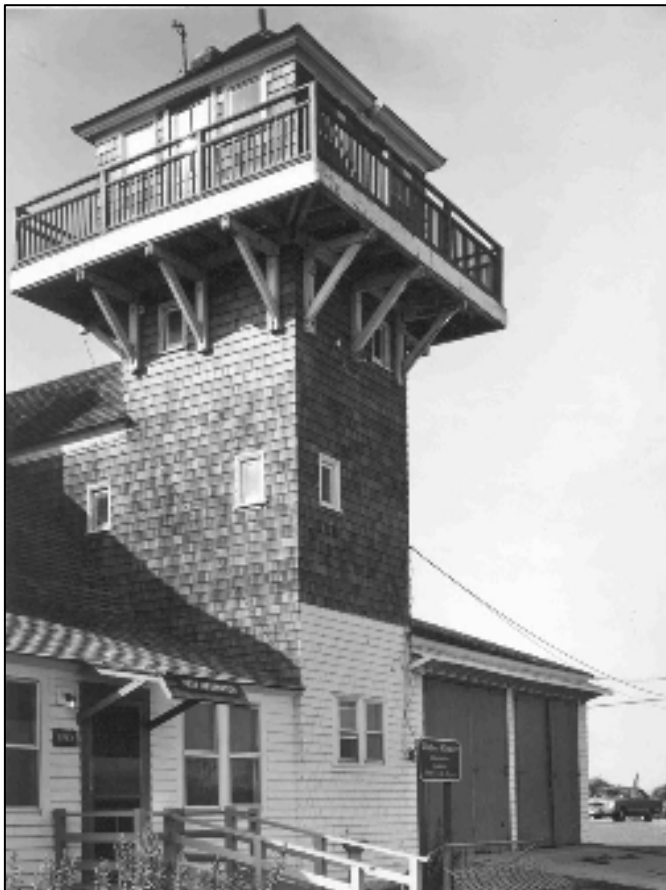
**Figure 39.** Spermaceti Cove Life-Saving Station, circa 1976 south and east elevations of Tower and connector after re-shingling of upper stories of Tower and roofs.

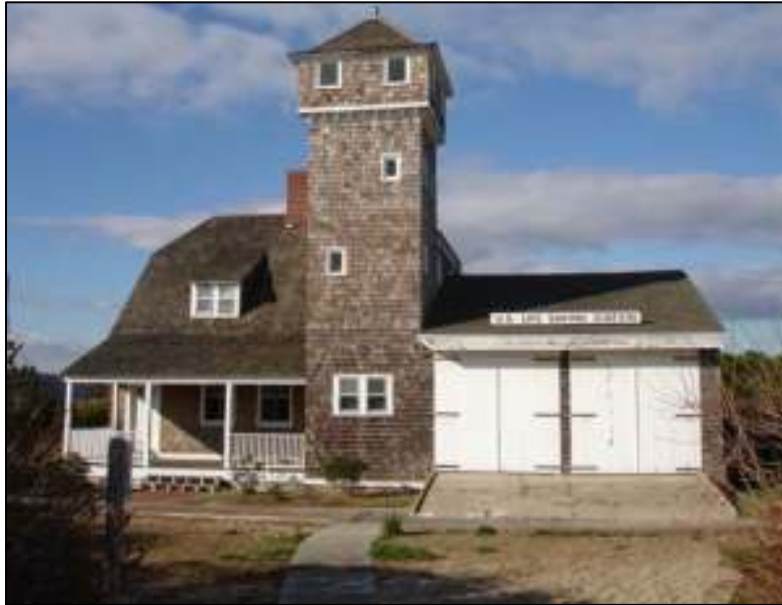
**Figure 40.** 1894 Spermaceti Cove Life-Saving Station  
east elevation.

The extant Spermaceti Cove Life-Saving Station retains its original configuration, which reflects the design elements of the Duluth-type Life-Saving Station (figs. 40 – 44).

All exterior walls of the Main Block are covered with unfinished wood shingles, which were installed by the NPS (figs. 40 - 42). The only section of shingles that was not replaced is on the west elevation inside the west porch enclosure. Those shingles have several layers of paint on them and are quite possibly original to the building. The side walls of the west and east dormers are also covered with unfinished shingles. A baseboard runs along the foot of the east wall above the porch floor.

The front porch is located on the east elevation of the Main Block and is connected to the south elevation of the Tower (figs. 40 & 41). The extant porch was restored by the NPS to copy the historic porch, which had been altered and enclosed in the 1960s. Some of the extant elements are original to the porch and others were replicated by the NPS based on physical and documentary evidence of the historic porch.

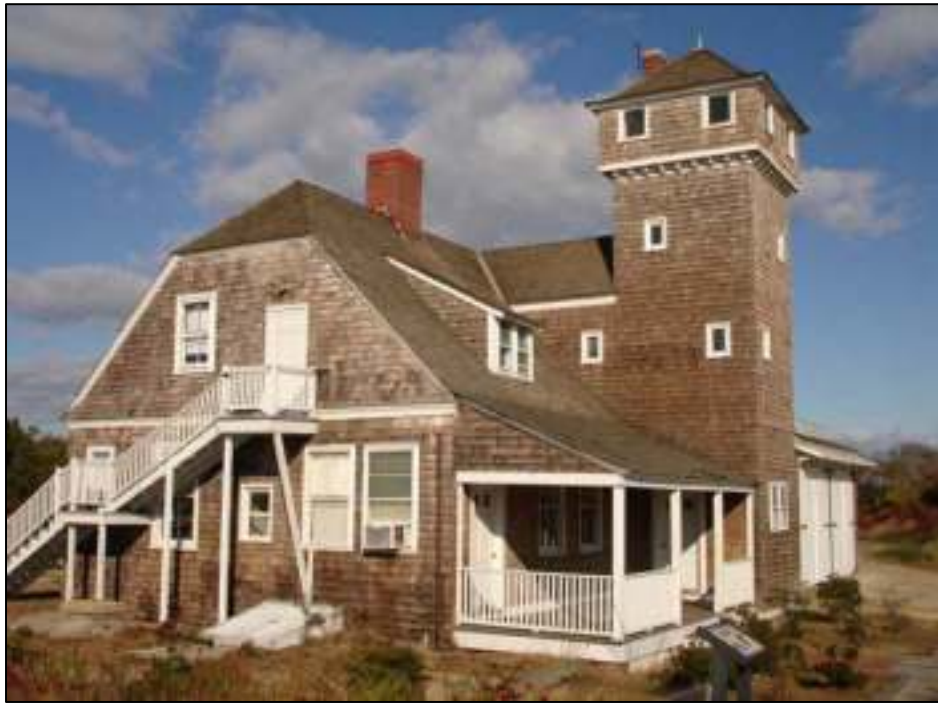
**Figure 41.** Spermaceti Cove Life-Saving Station, south and east elevations.

The Tower is a four-story square structure that has a look-out station at the top. As previously described it is attached to the east elevation of the Main Block (figs. 41 & 44). A small gable roof above the second story connects the west elevation of the Tower to the gable roof of the Main Block. The north elevation of the Tower abuts the Boat Room and the second, third and fourth stories of the north elevation rise above the slope of the Boat Room

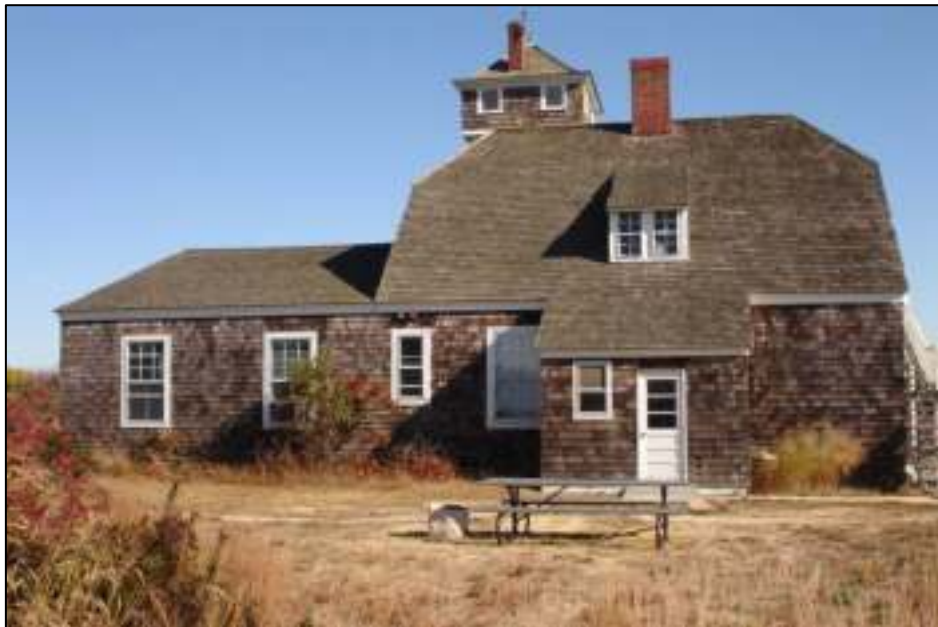
**Figure 42.** Spermaceti Cove Life-Saving Station, west elevation.

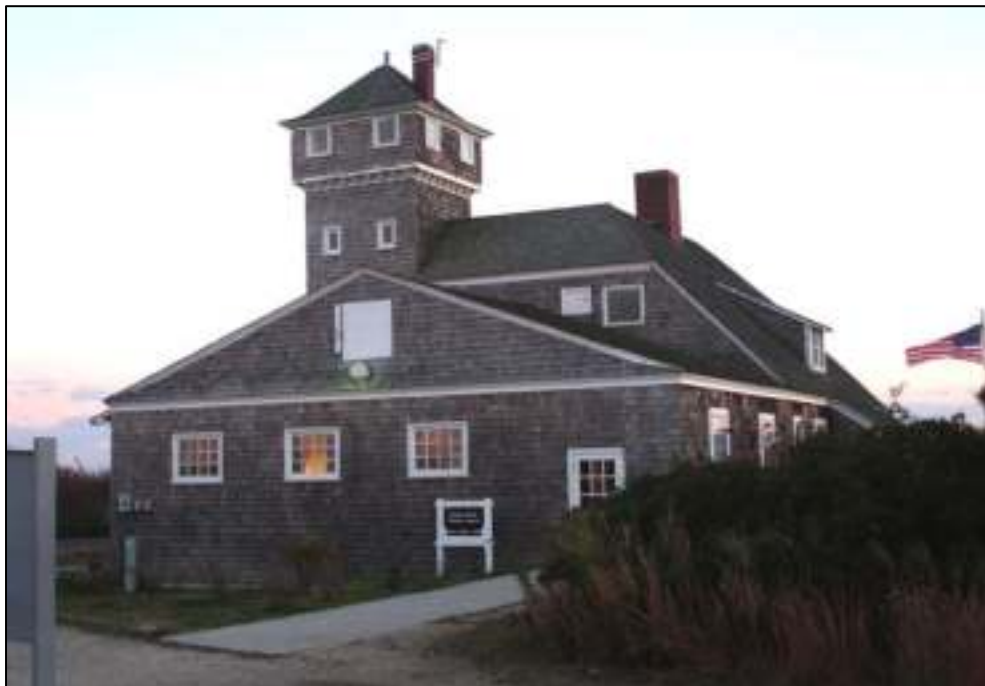
**Figure 43.** Spermaceti Cove Life-Saving Station, north and west elevations.

The Boat Room is attached to the north elevation of the Main Block (fig. 43). It is a one-story structure with a shallow-sloped gable roof that runs north-south. The east and west elevations are both one-story high. The east elevation faces the beach and has two large doorways and a boat ramp. The north elevation exhibits the wide gable roof and has an entry doorway near the west corner of the building. On the north elevation at the top of the first story wall is a molded belt course separating the first story wall from the gable-end. Just above the belt course the wall is slightly flared.

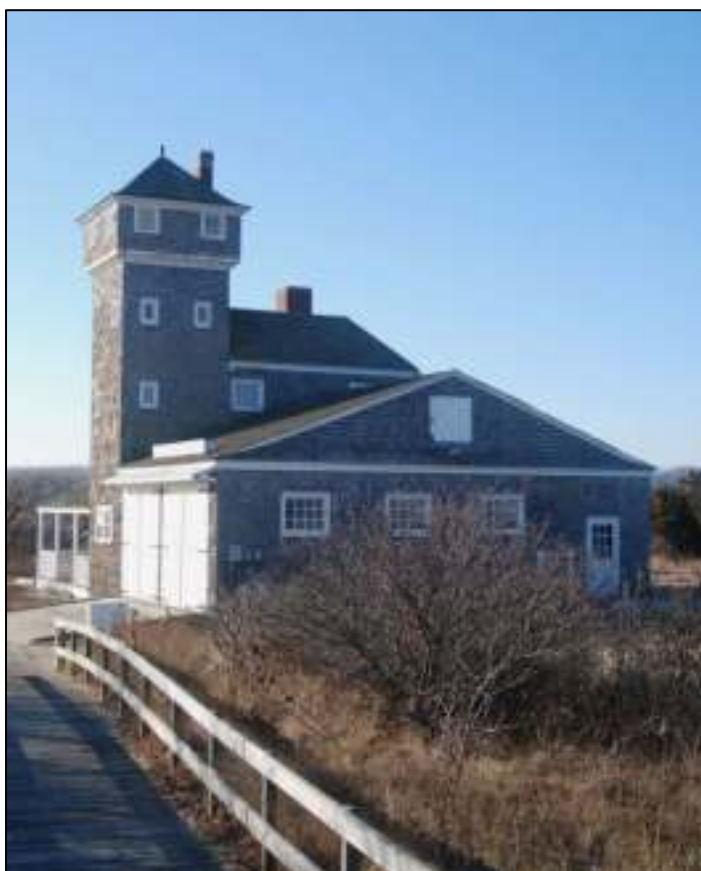
**Figure 44.** Spermaceti Cove Life-Saving Station, north and east elevations.

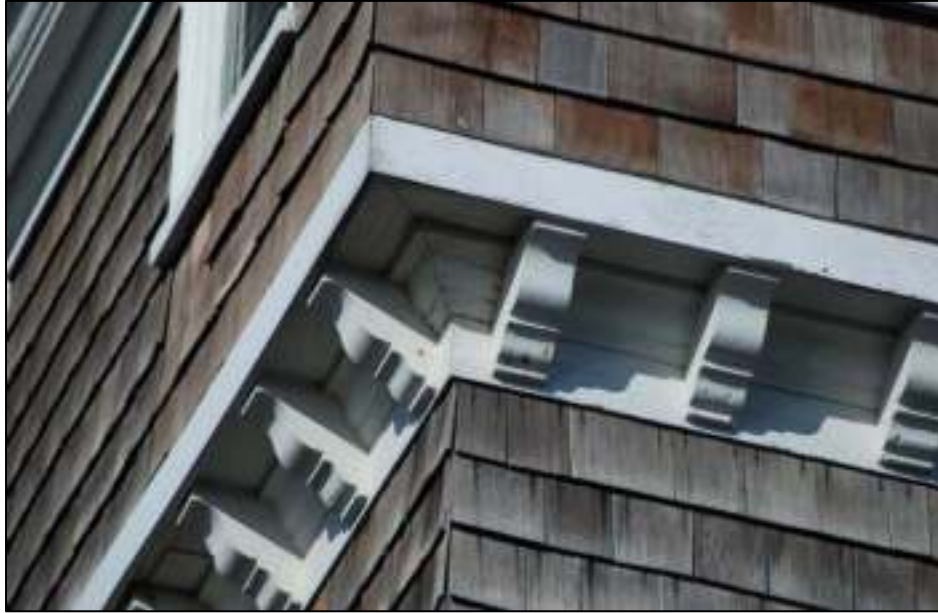
**Figure 45.** Spermaceti Cove Life-Saving Station, cornice below cantilevered section of Tower depicting brackets and molding.

roof. The south elevation of the Tower is four-stories high and has a doorway on the first story leading from the east porch to the interior of the Tower. The east elevation of the Tower is four-stories high and the fourth story of the west elevation rises above the small gable roof connecting the Tower to the Main Block. The lower stories of the Tower are pierced with small window openings and the lookout station at the fourth story has two window openings on all sides. All sides of the window section of the fourth story overhang the lower portion of the Tower and the overhang is supported by brackets (fig. 45). The Tower has a hip roof that flares at the eaves.

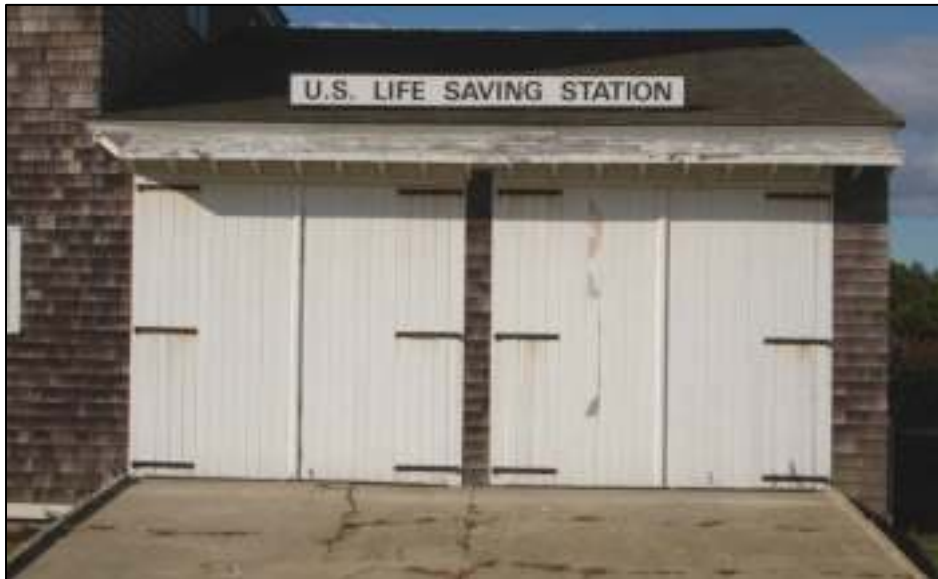
**Figure 46.** Spermaceti Cove Life-Saving Station, east elevation Boat Room doorways (D105 and D106).

The east elevation of the Boat Room is dominated by two wide doorways (D105 & D106) that served as access for the surf boats and boat carriages (fig. 46). Both of the doorways are 9 feet 9 inches wide and 9 feet 7 inches high. The doorways have plain board surrounds and wide lintel trim. A shed roof extends over both doorways and is an alteration from the original appearance (see the subsequent section “Roofs, Boat Room”).

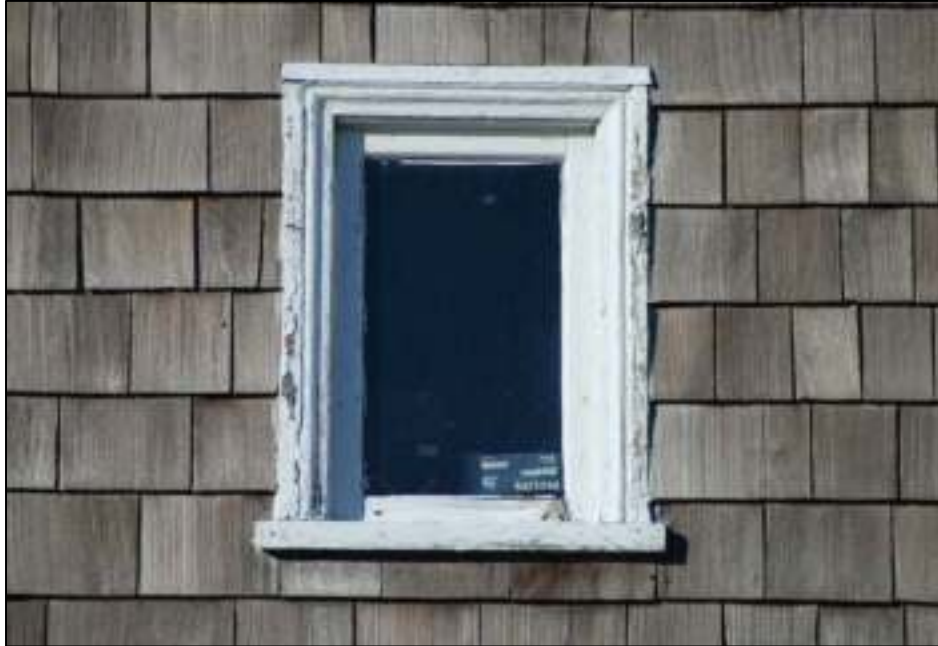
**Figure 47.** Spermaceti Cove Life-Saving Station, east elevation Tower window opening (W201) depicting historic molding.

The 1893 plans for the Duluth-type station and historic photographs of the Spermaceti Cove Life-Saving Station helped determine the original fenestration and identify alterations made to the building’s window openings. The plans for the station type depict several different window-opening sizes and sash types that range from two-light awning sashes to double-hung, twelve-over-two sashes. The extant window openings in the Spermaceti Cove Station represent both original fenestration and changes to the building (figs. 47 & 48).

Throughout the building some of the window elements have been repaired or replaced, but some original elements have been preserved. The window openings in the Tower correspond to the original arrangement and to those specified in the Duluth-type station plans (fig. 47). The window openings in the Main Block demonstrate both original openings and alterations to the building. The two window openings on the west side of the Boat Room were altered but the three first story window openings (W113 – W115) on the north elevation of the Boat Room are original to the structure and retain original elements. Those three window openings have molded surrounds that are representative of the original trim. The

Window Opening No. & Location	Window Description
W201, Tower, east elevation (fig. 47)	W201 is an original window opening on the east elevation of the Tower. Typical of the smaller window openings in the Tower it measures 1 foot 2¼ inches wide by 2 feet 1 inch high. Historic photographs and the plans for the Duluth-type station indicate that the window openings historically had casement sashes with six lights. Presently the W201 has a single fixed sash with one light. The exterior window surround was constructed with a molding that matches the historic elements on other windows (W113 – W115, etc.). Flashing is installed over the lintel trim of the window.
W202, Tower, south elevation	W202 is also an original window opening that historically had a six-light casement sash. The extant elements of W202 are similar to W201 including the one-light fixed sash. In addition W202 has an exterior wooden storm window.

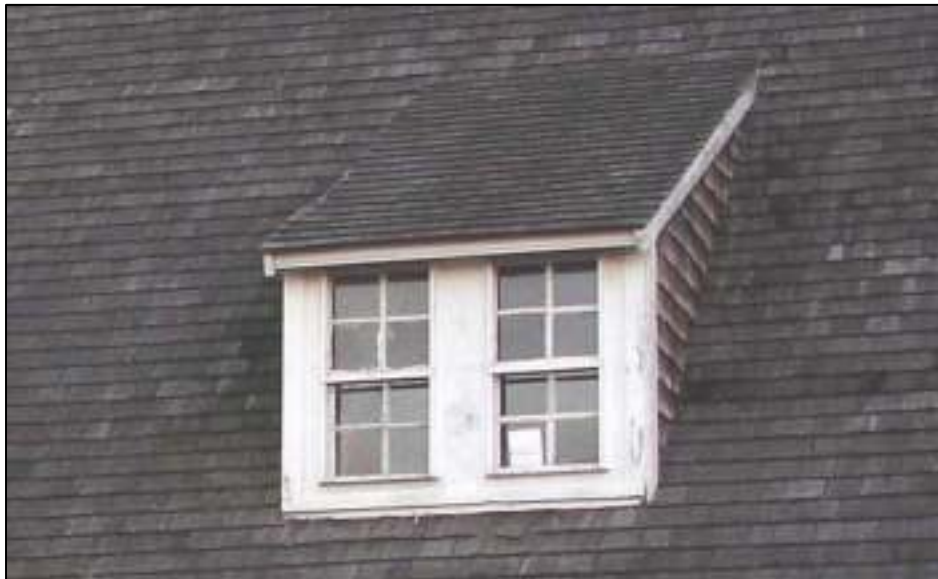
**Figure 48.** Spermaceti Cove Life-Saving Station, west elevation dormer window openings (W207 and W208).

W207 & W208, Main Block, west elevation dormer (fig. 48)	W207 and W208 form a double window in the west elevation dormer. Each window opening has double-hung, four-over-four sashes that appear to be the original sashes. The double window is trimmed with a plain board surround and a wide mullion separates the two window openings.
W209, Main Block, north elevation	W209 is located in the Main Block above the roof of the Boat Room. It is an original window opening that had a single sash with six lights. The window is currently closed off with plywood but retains what appears to be historic trim. The window surround is constructed with a cyma reversa molding that is similar to other original trim on the building. The lintel trim is flashed.
W210, Main Block, north elevation	W210 is located on the north elevation of the Main Block. It is not an original window opening and was probably installed when the second story restroom was added in 1930. Presently the window is blocked off with plywood. The window opening is trimmed with a plain board surround and the lintel trim is flashed.

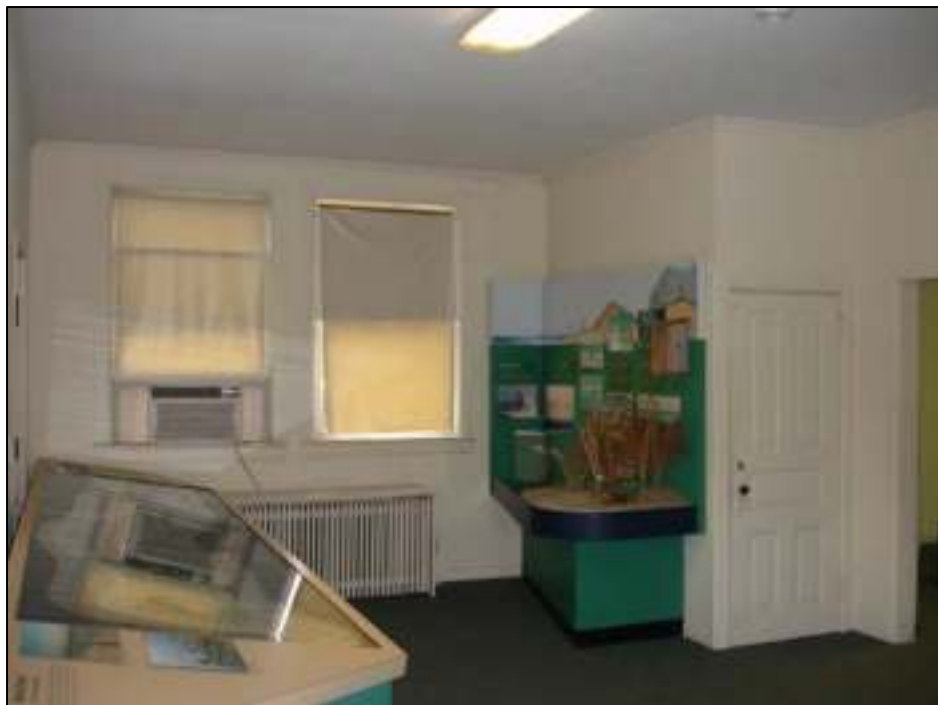
**Figure 52.** Spermaceti Cove Life-Saving Station, Room 104 looking south.

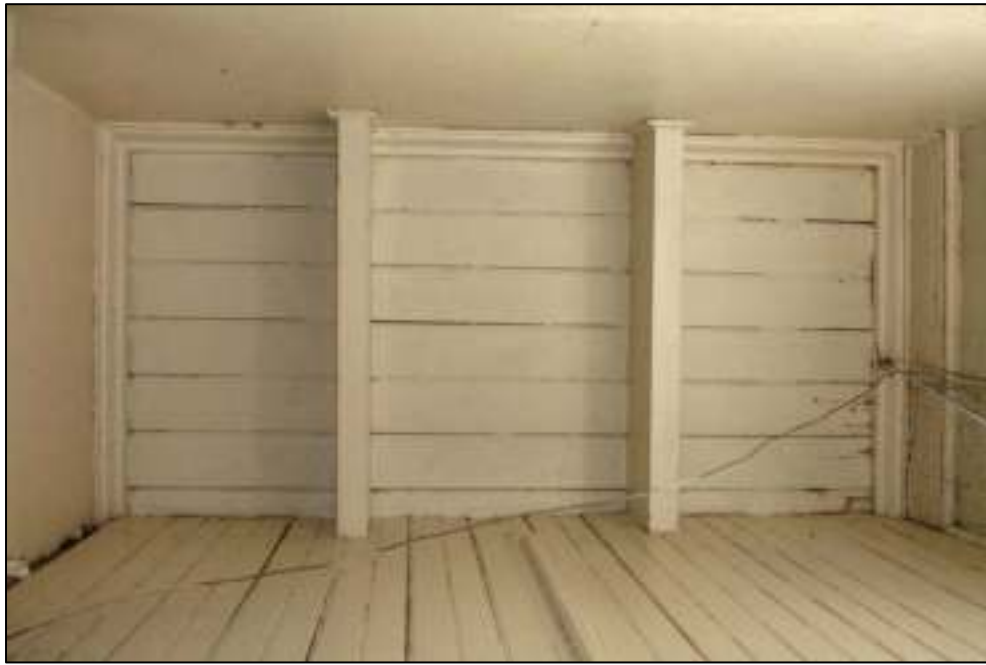
Figure 53. Spermaceti Cove Life-Saving Station, Room 104a ceiling.

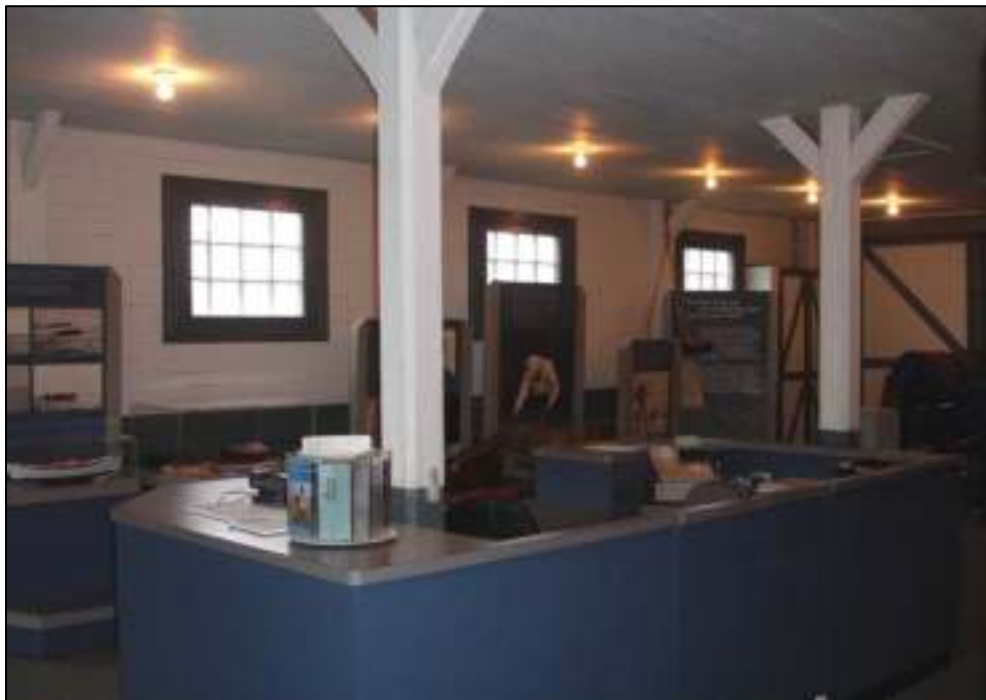
**Figure 56.** Spermaceti Cove Life-Saving Station, Boat Room/Room 109 looking northeast.

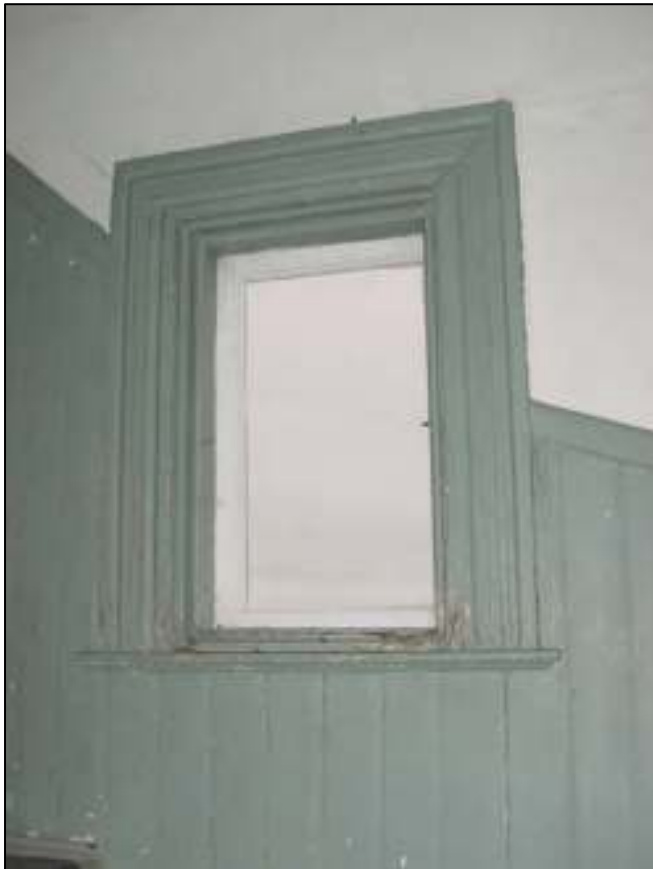
**Figure 57.** Spermaceti Cove Life-Saving Station, Room 201 W212 depicting window opening elements typical of Tower windows.

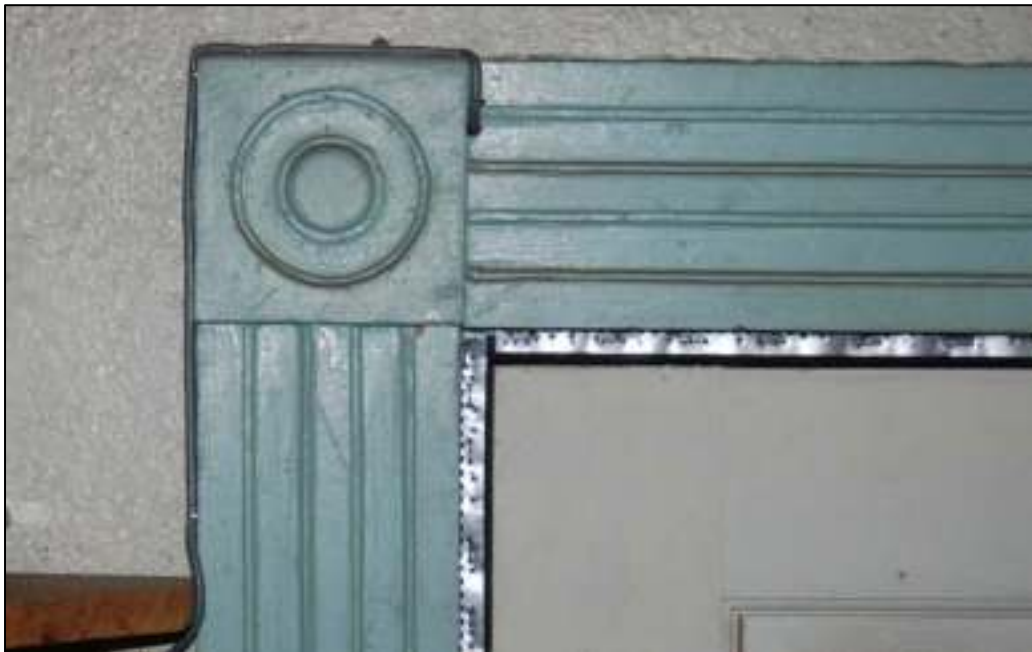
**Figure 58.** Spermaceti Cove Life-Saving Station, Room 205 D204 depicting doorway trim typical of interior doorway elements.

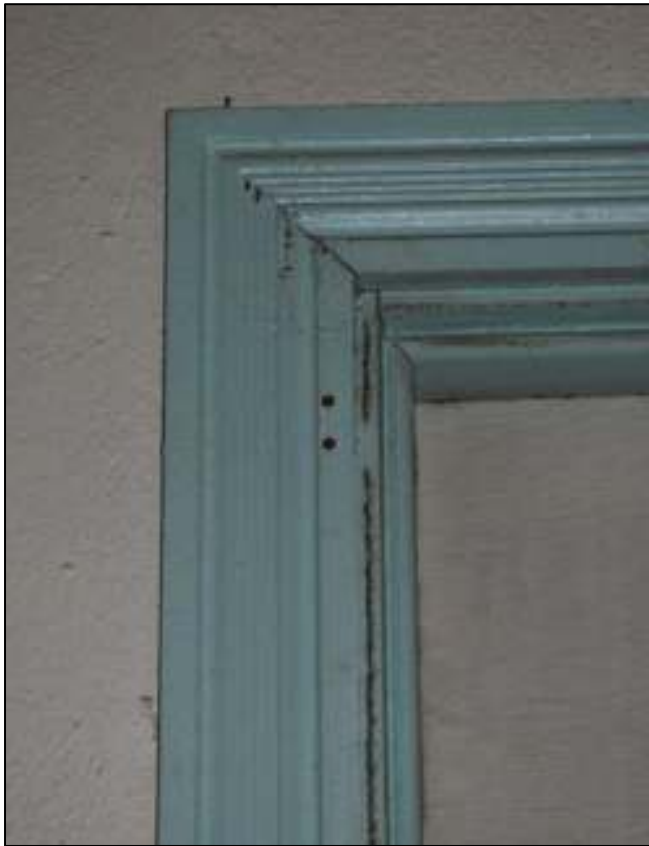
**Figure 59.** Spermaceti Cove Life-Saving Station, Room 205 W209 depicting window opening molded surround.

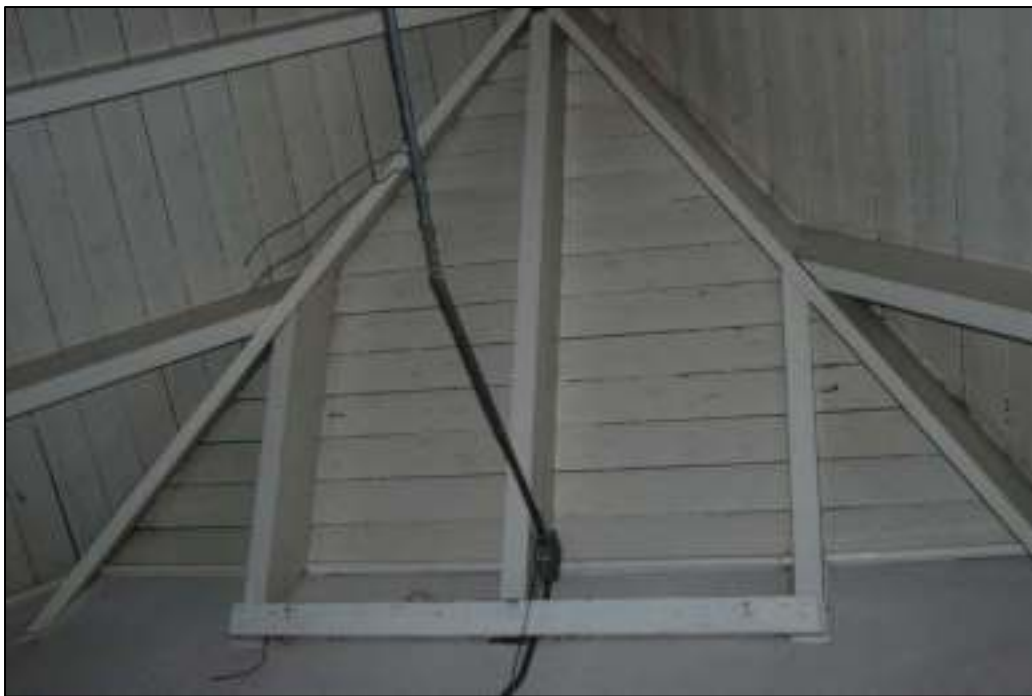
**Figure 60.** Spermaceti Cove Life-Saving Station, Room 206 interior view of clipped-gable roof framing looking south.

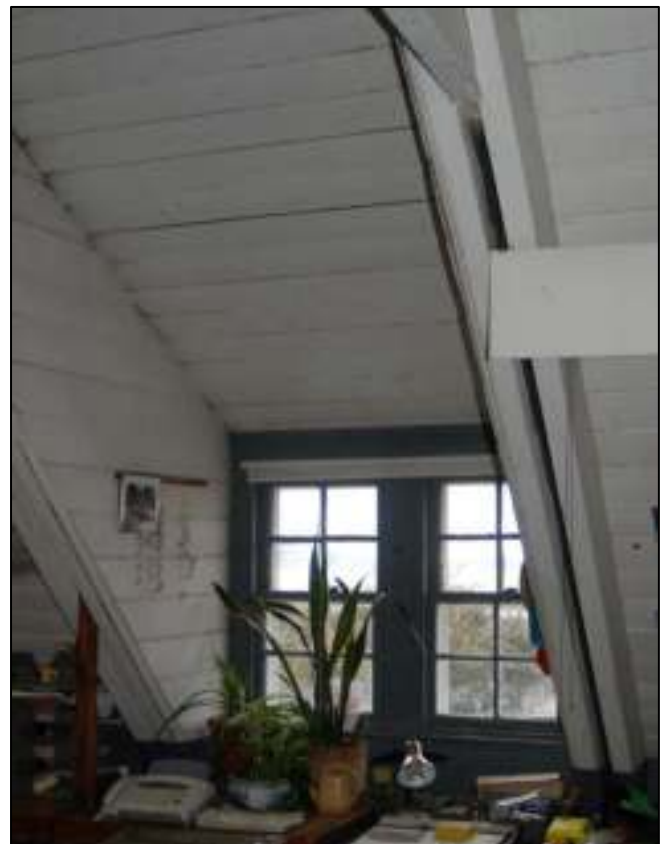
**Figure 62.** Spermaceti Cove Life-Saving Station, Room 206 interior view of west dormer (W207 & W208).

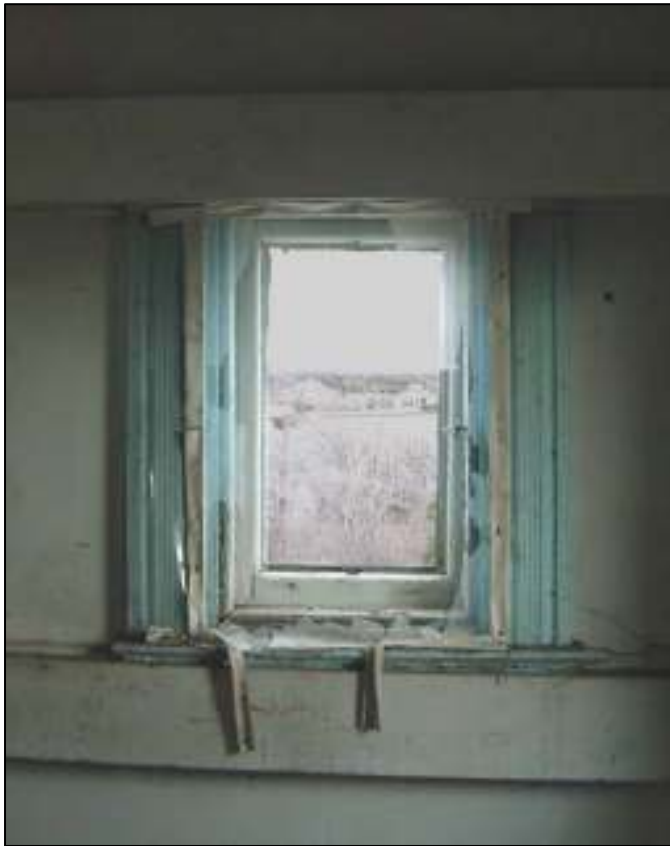
**Figure 63.** Spermaceti Cove Life-Saving Station, Room 301 W304 depicting window opening elements and alterations typical of third-story windows.

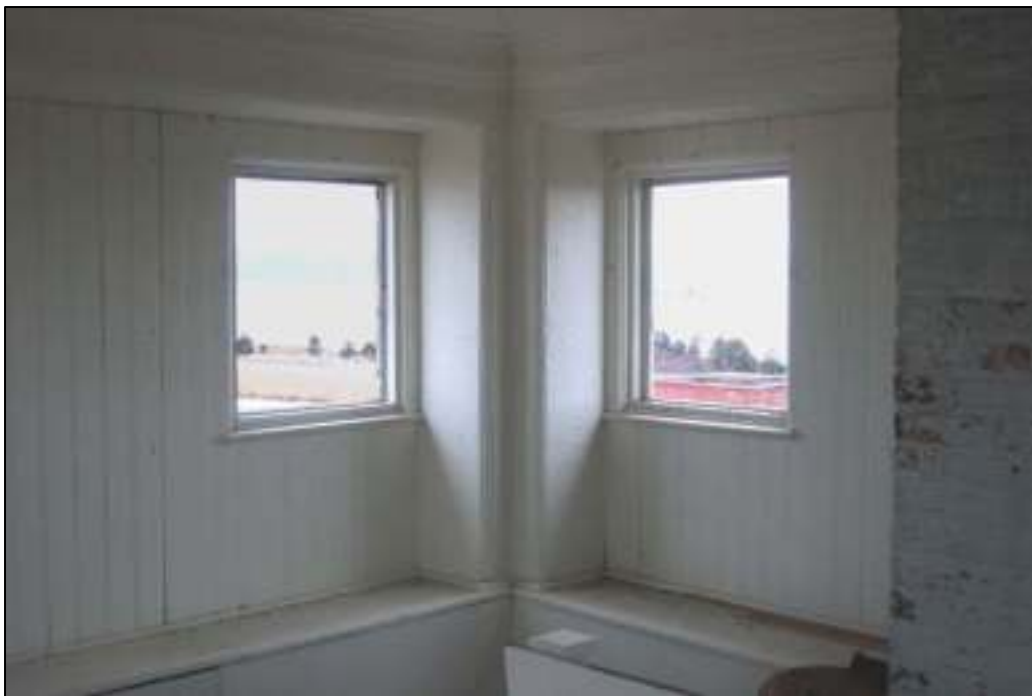
**Figure 64.** Spermaceti Cove Life-Saving Station, Watch Room/Room 401 looking southwest depicting cantilevered window section and typical woodwork for the fourth story.

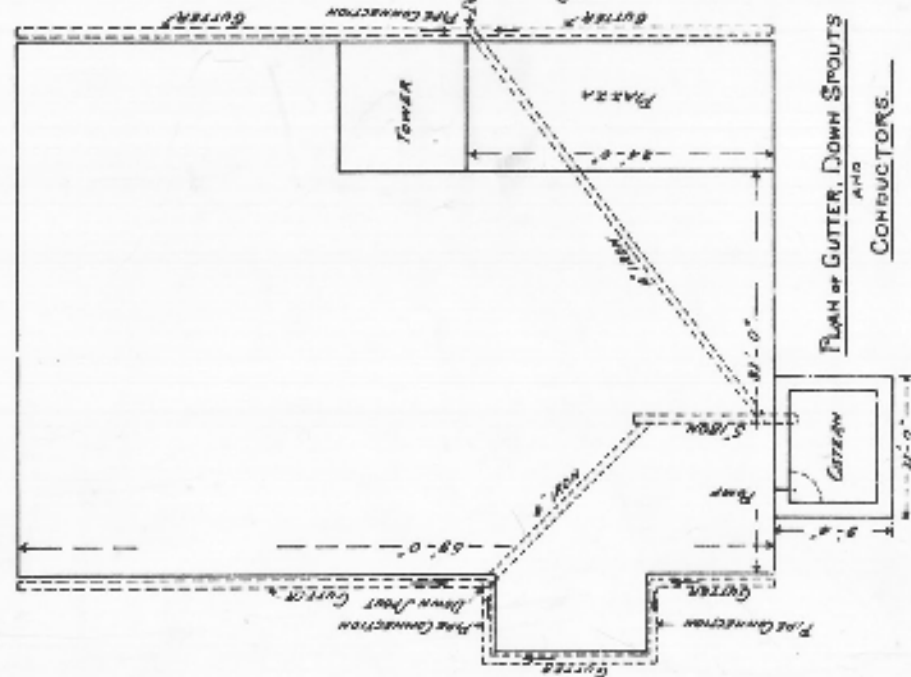
# CISTERN.

PLAN OF CISTERN.

*Note:*  
Place the cistern as low as the grade of the wall will allow, and set inlet and overflow pipes in accordance with it.

The cistern to be built on well-ramped concrete, 6 inches thick, made of good Rosendale cement, clean sand, and broken stone, in the proportion of 1 cement to 2 sand to 5 stone.

The cistern to be built with best hard-burnt brick and Rosendale-cement mortar; the brickwork to be well bonded and laid solid with joints not exceeding  $\frac{1}{4}$  inch in thickness. The bricks to be soaked in water before laying; the outer faces of joints struck smooth.

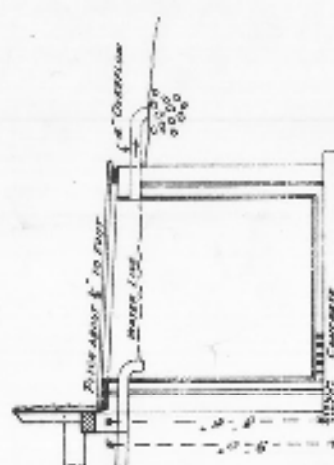
TRANSVERSE SECTION.

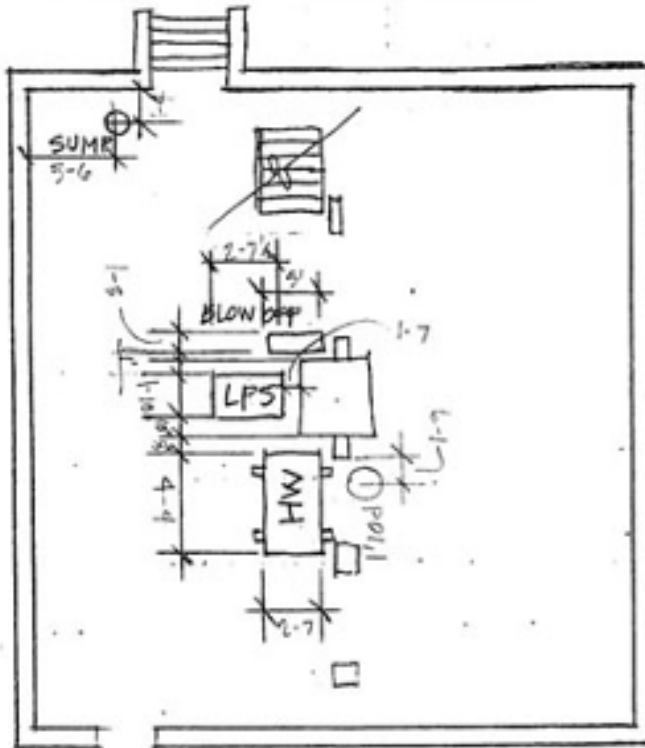
## CELLAR PLAN 4

CRAWL SPACE

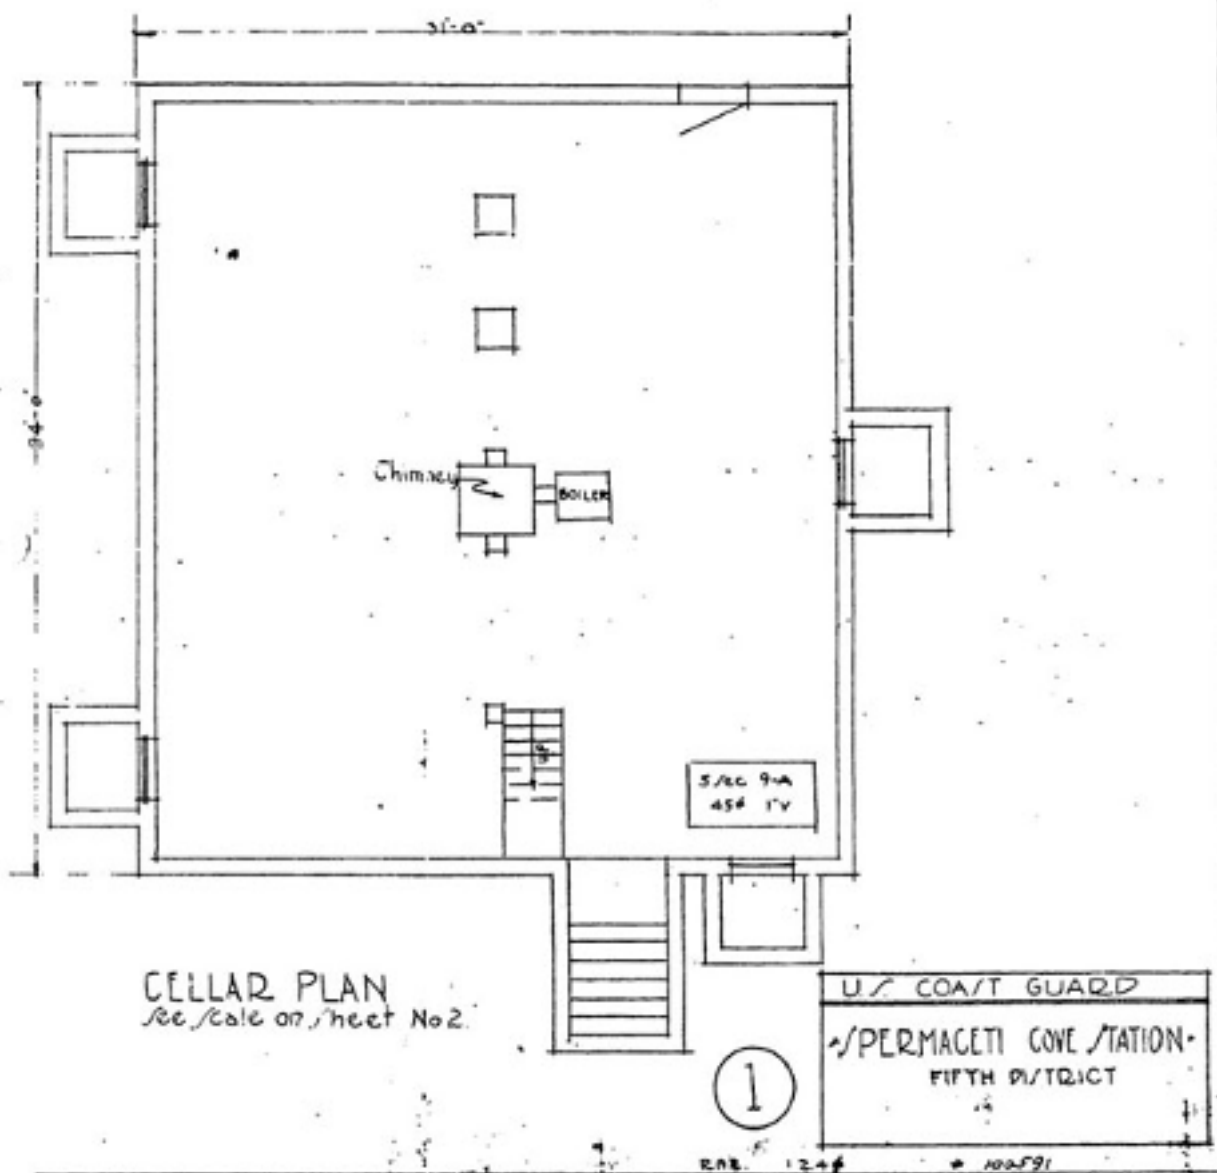
Plan of Spermaceti Cove Life-Saving Station, Fifth District, U. S. Coast Guard, April 24, 1928. Courtesy U. S. Coast Guard.

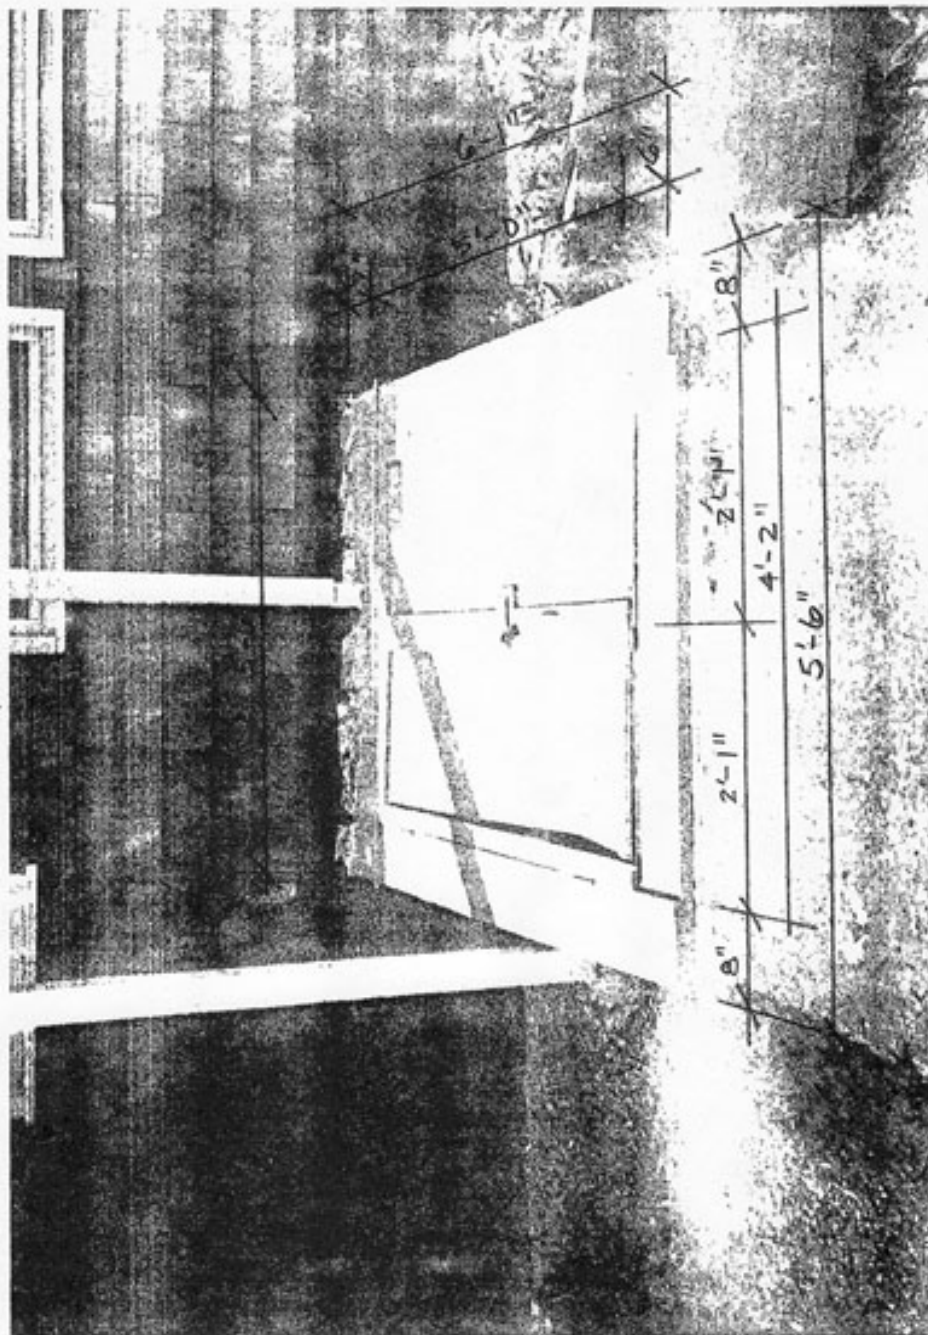
EXTERIOR BASEMENT DOORS - SOUTH ELEVATION  
 LIFESAVING STATION - SPERMACEY COVE  
 SANDY HOOK UNIT/NPS - GNRA.

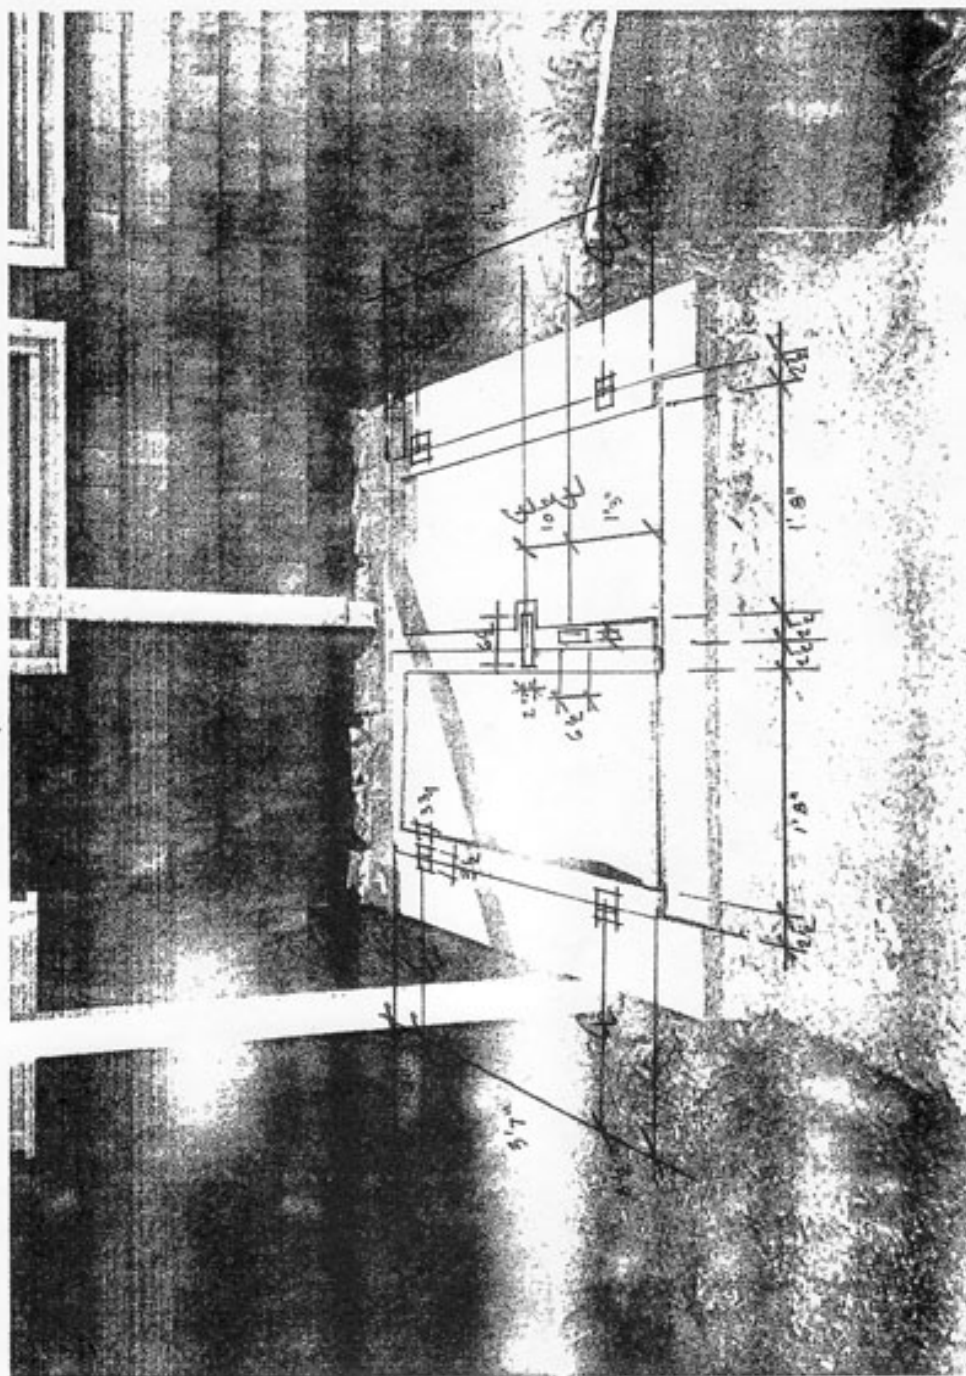
EXTERIOR BASEMENT DOORS - SOUTH ELEVATION  
 LIFESAVING STATION, SPERMACEITI COVE  
 SANDY HOOK UNIT, NPS/GINRA.
