# SPERMACETI COVE LIFE-SAVING STATION

Fort Hancock, New Jersey  
Sandy Hook Unit, Gateway National Recreation Area

## **HISTORIC STRUCTURE REPORT**

**James J. Lee III  
Architectural Conservator**

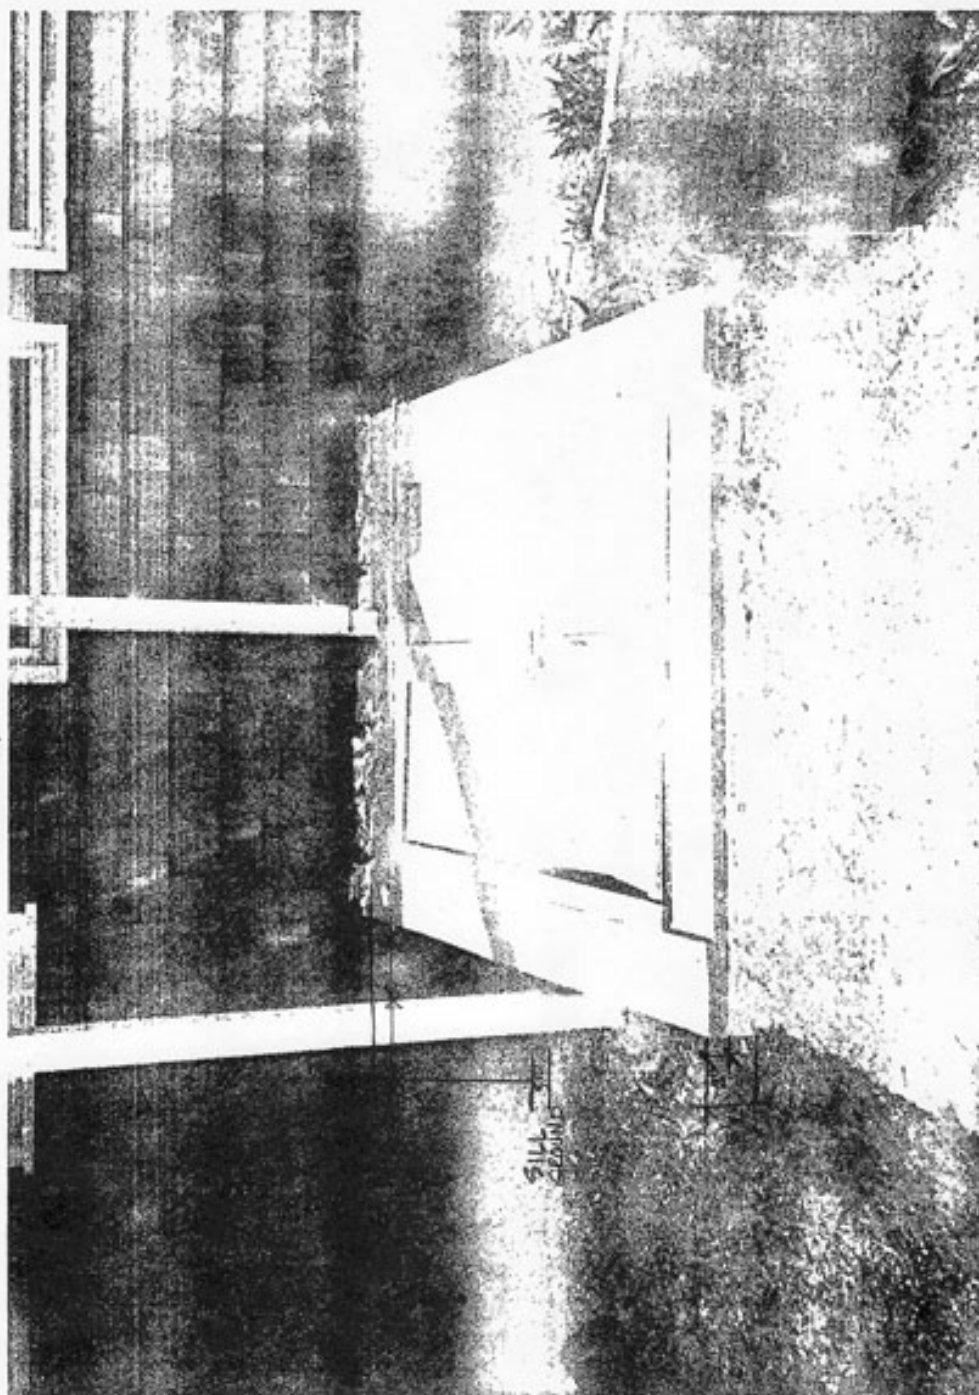
EXTERIOR BASEMENT DOORS- SOUTH ELEVATION  
LIFESAIVING STATION, SPERMACEETI COVE  
SANDY HOOK UNIT, NPS/ENRA.

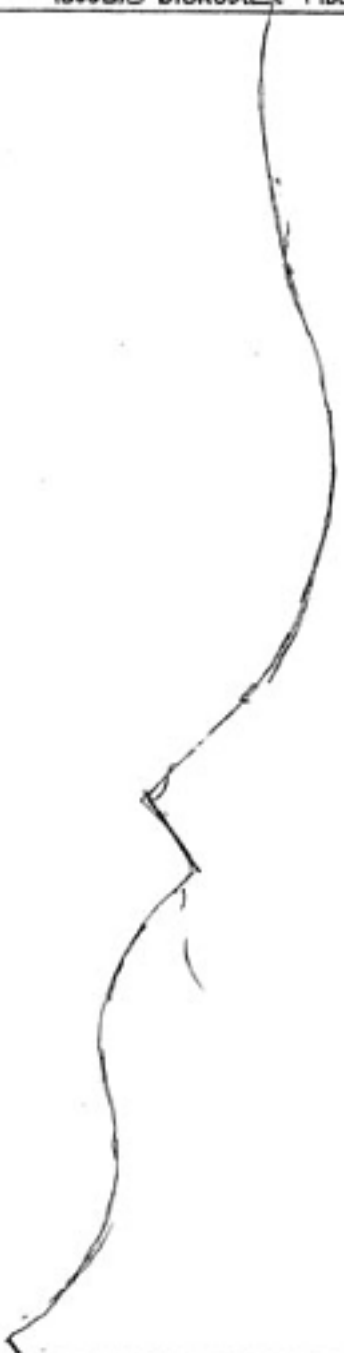
Park	GATEWAY NRA/NPS		NATIONAL PARK SERVICE		Sheet
Area	SANDY HOOK UNIT		DENVER SERVICE CENTER		of
Project	SPERMACEITI COVE HSR	By	R. WELLS	Date:	pkg.
Feature	TOWER BRACKET PROFILE	Check:		Date: JUNE 17, 1988	Account //

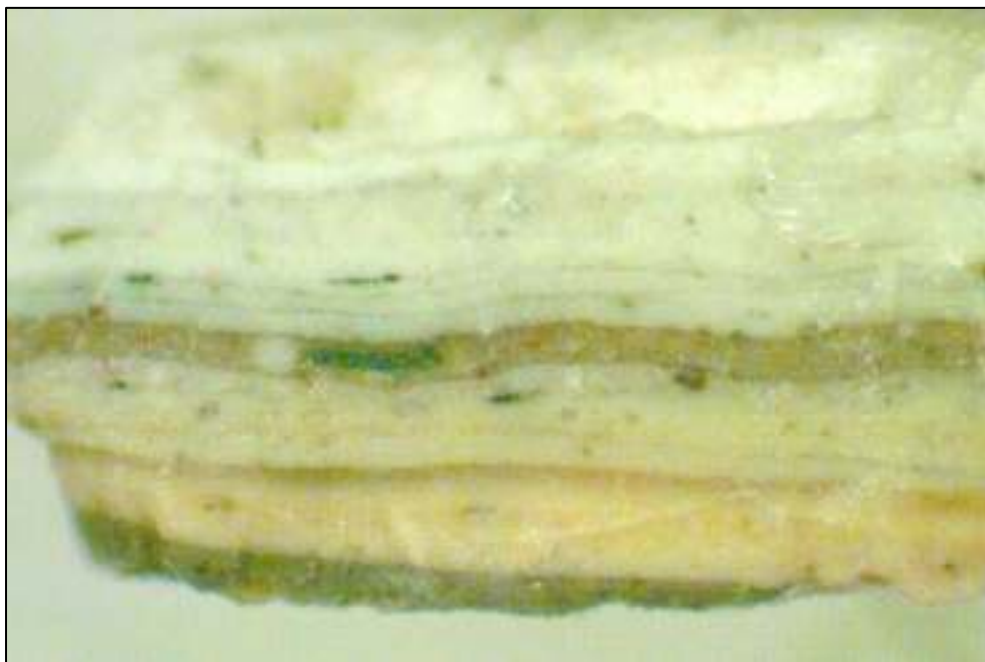
**Figure 65.** Spermaceti Cove Life-Saving Station, sample P087 taken from the East/Front Porch original northeast half-post.

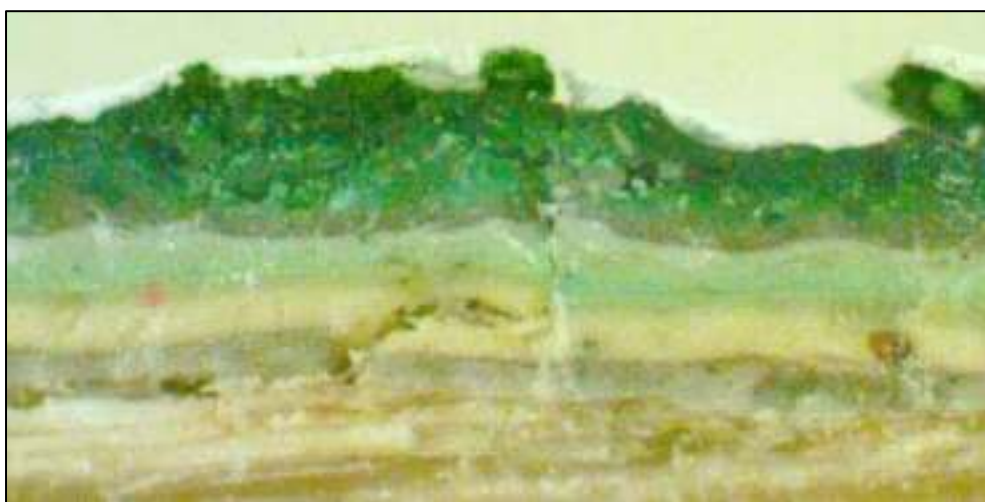
**Figure 66.** Spermaceti Cove Life-Saving Station, sample P089 taken from verge board and rafter on East/Front Porch.

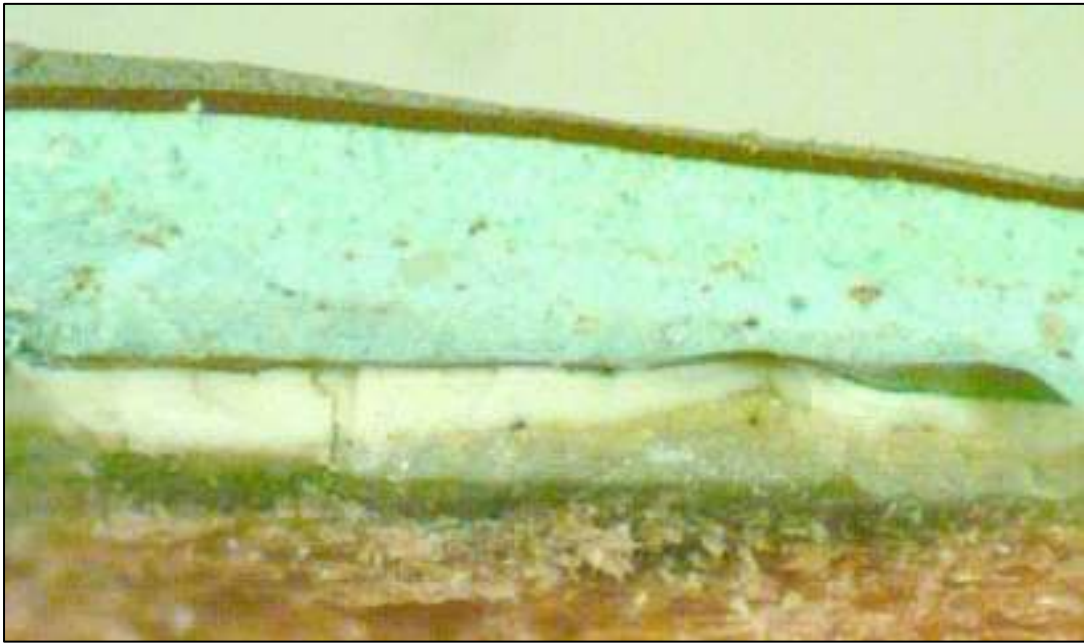
**Figure 67.** Spermaceti Cove Life-Saving Station, sample P002 taken from D101 interior trim.

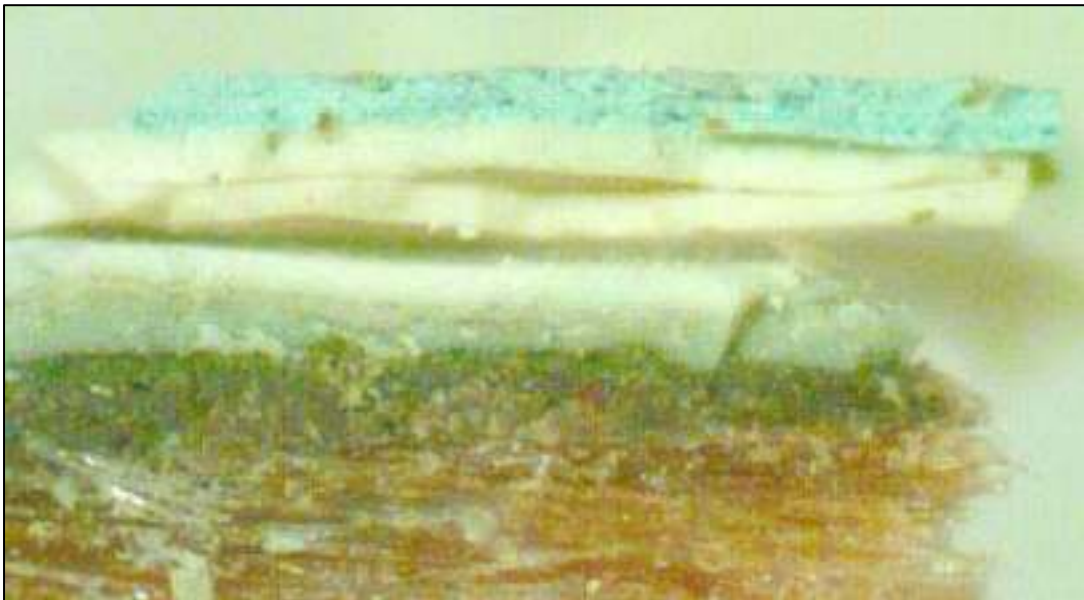
**Figure 68.** Spermaceti Cove Life-Saving Station, sample P006 taken from wainscoting in Staircase Hallway closet/Room 101a.

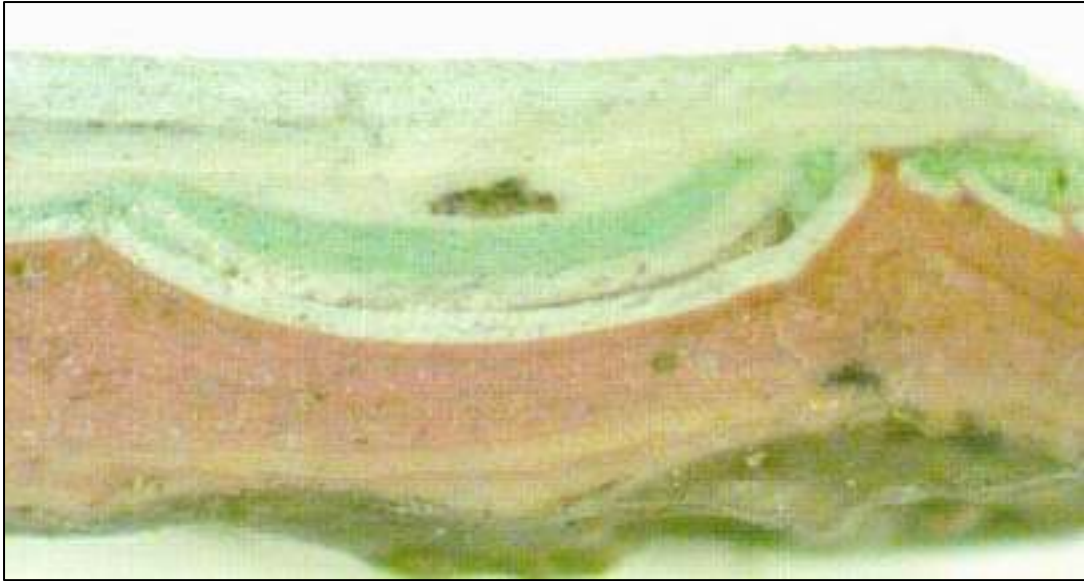
**Figure 69.** Spermaceti Cove Life-Saving Station, sample P014 taken from Room 102 plaster wall above D110.

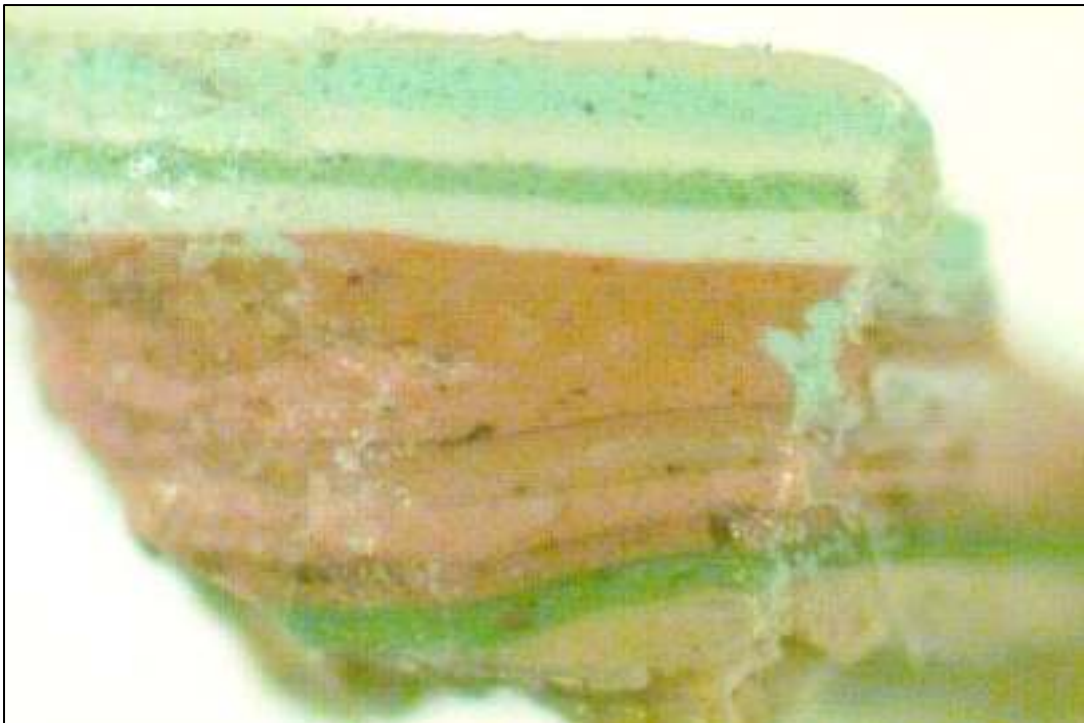
**Figure 70.** Spermaceti Cove Life-Saving Station, sample P039 taken from Room 106 north plaster wall.
